Re: Report for October 20 – 22, 2004 Field Reconnaissance
Lower Passaic River Restoration Project

**LOWER PASSAIC RESTORATION PROJECT
POTENTIAL RESTORATION SITE FIELD DATA FORM**

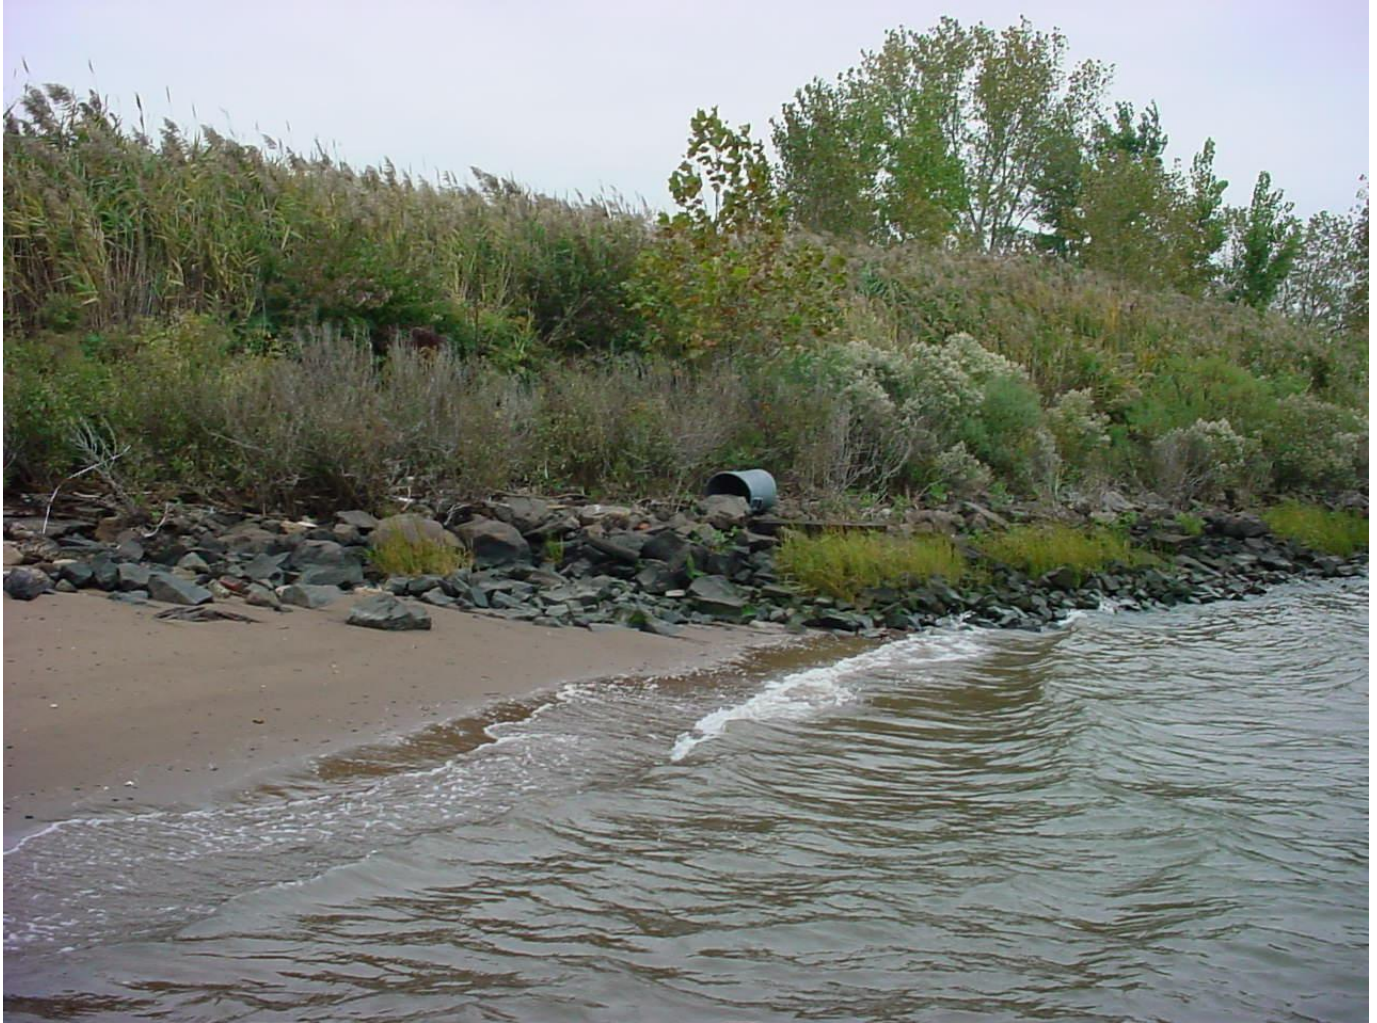
Oak Island Shoreline

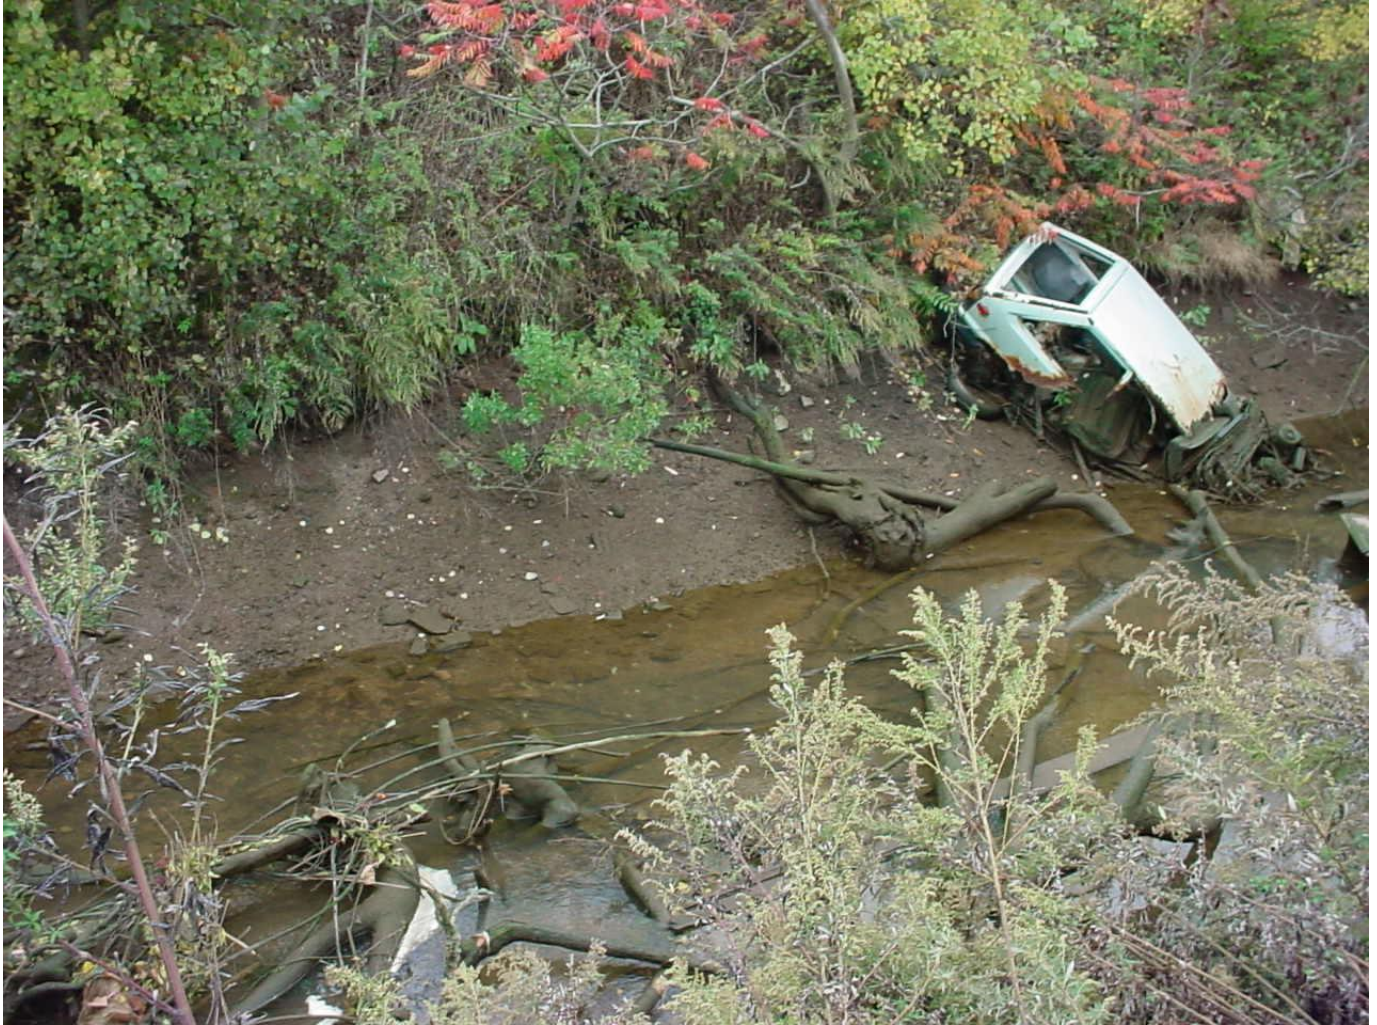
Oak Island –Tidal Creek on western edge of site

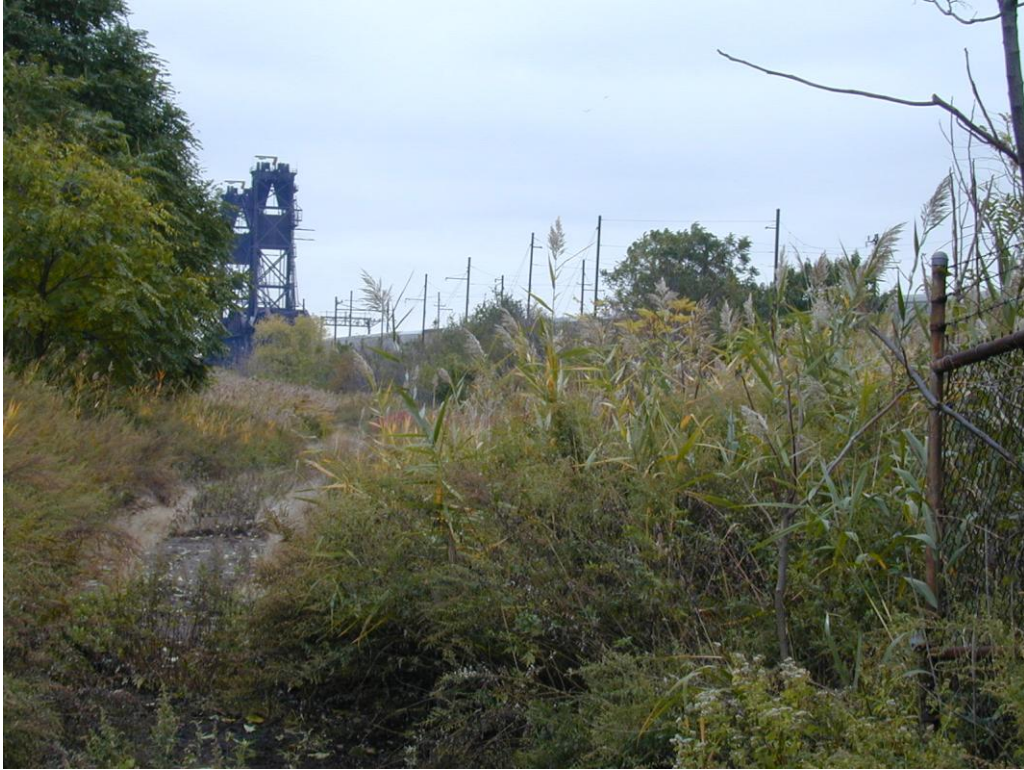
Interior of Oak Island: Western portion of site, looking South

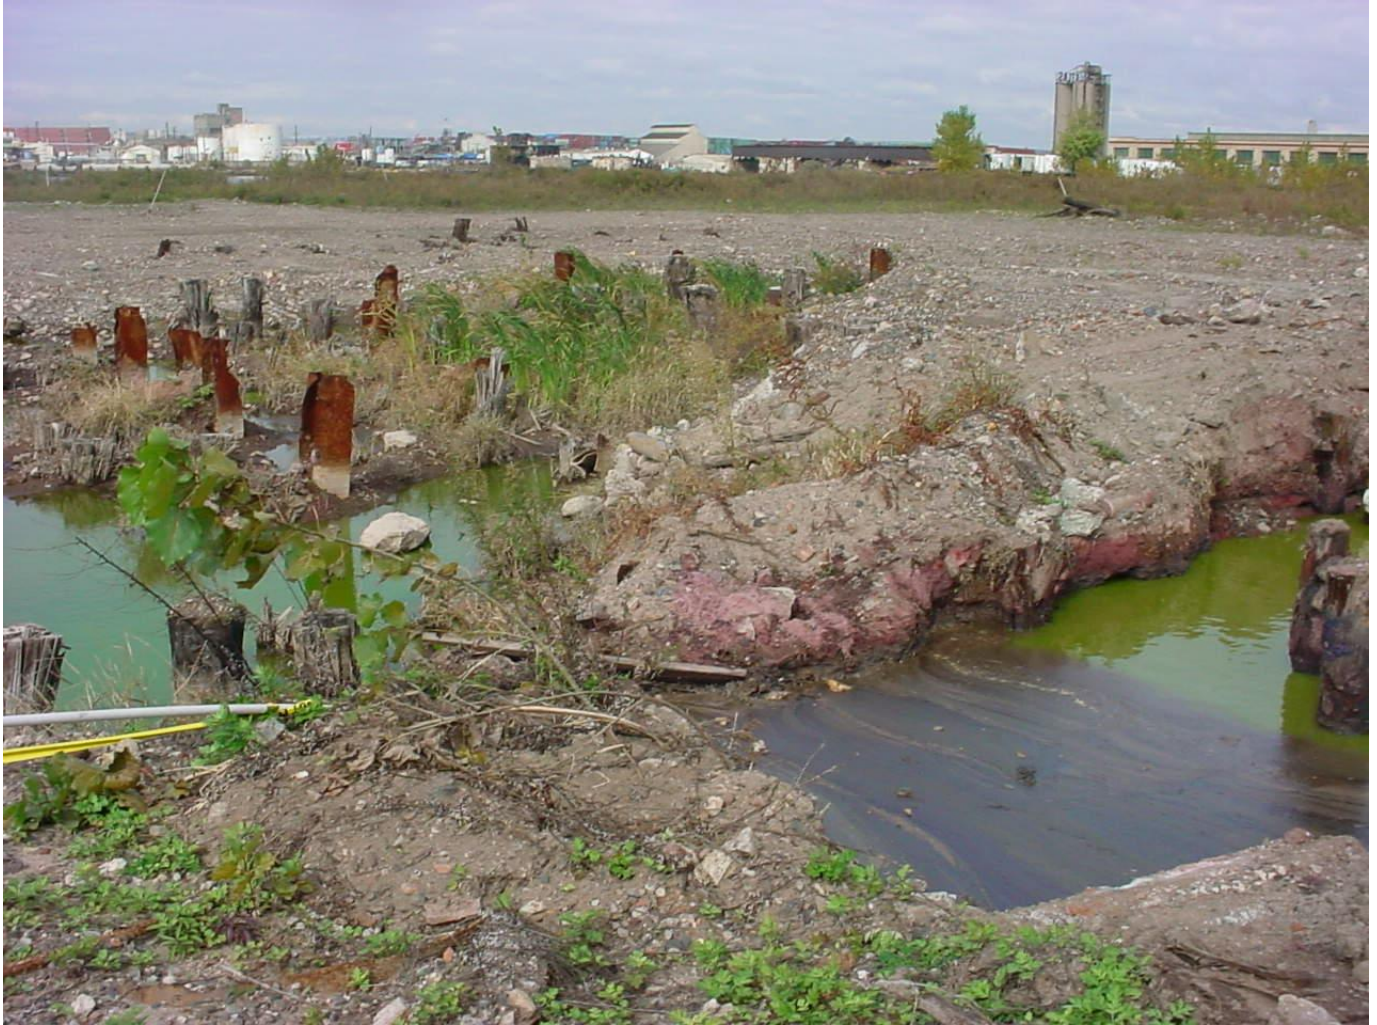
Kearny Point Interior, looking North (colors are due to industrial dyes)

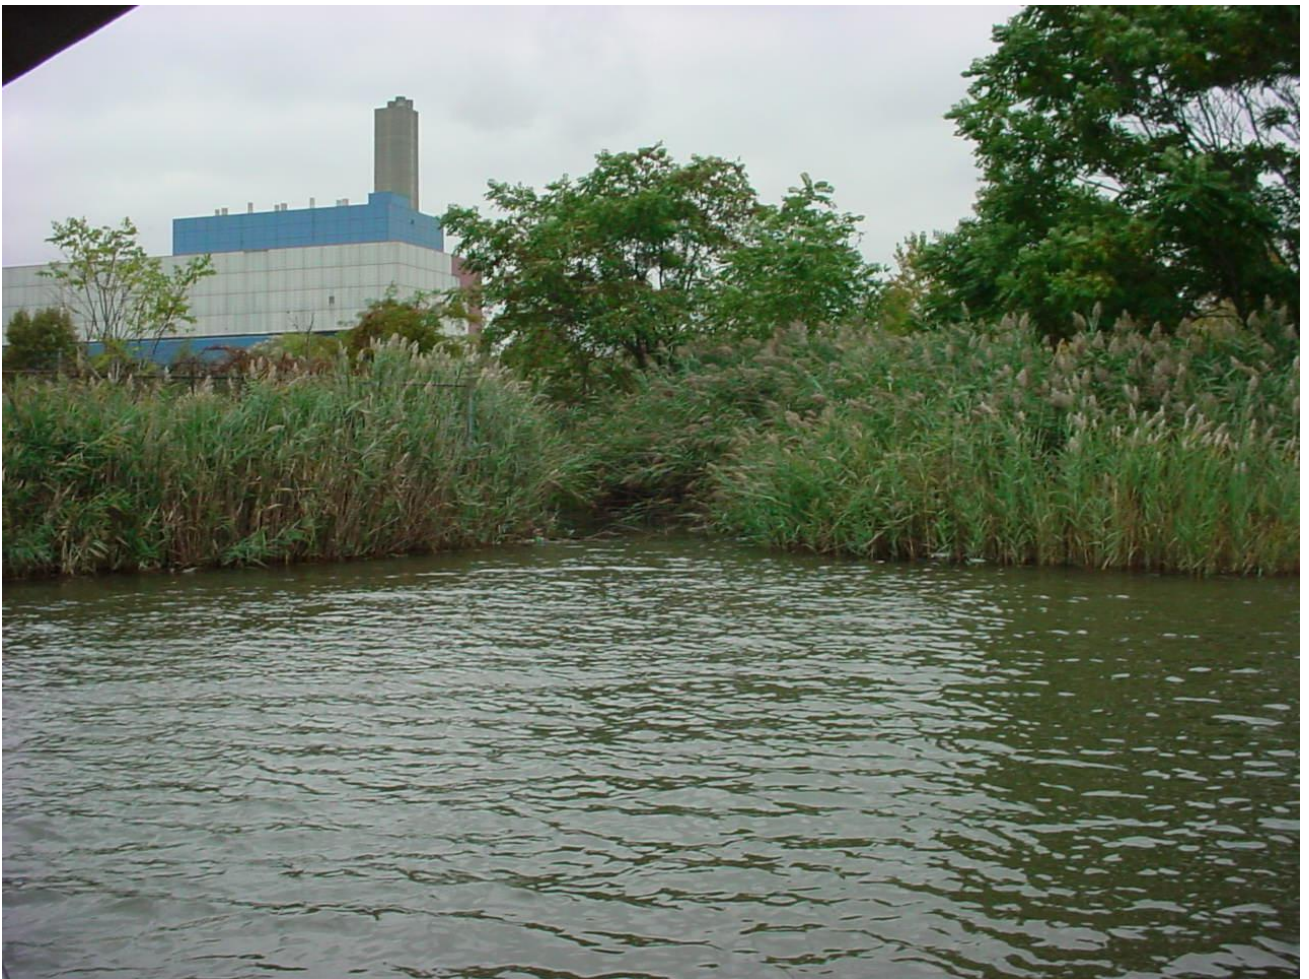
Possibly contiguous with 19 and 18.

20TMS (tidal creek in center of picture)

Invasive removal

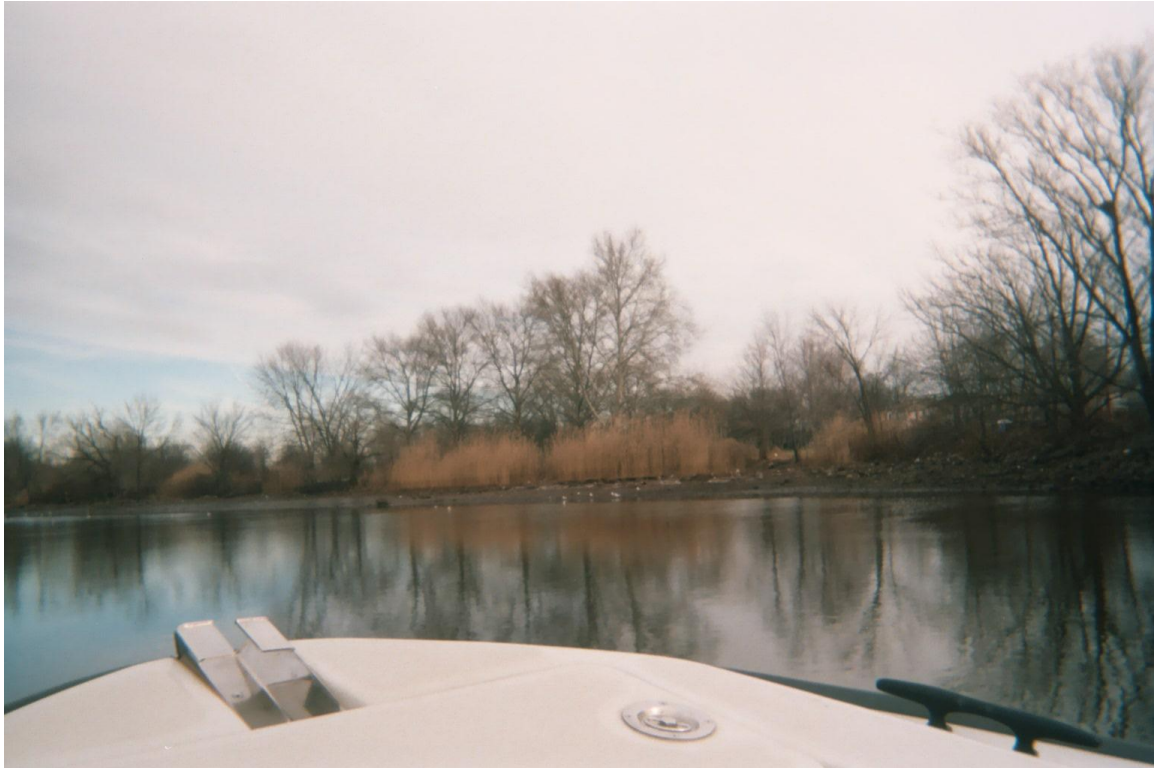
No rooted aquatic/emergent vegetation

Site 15N looking East

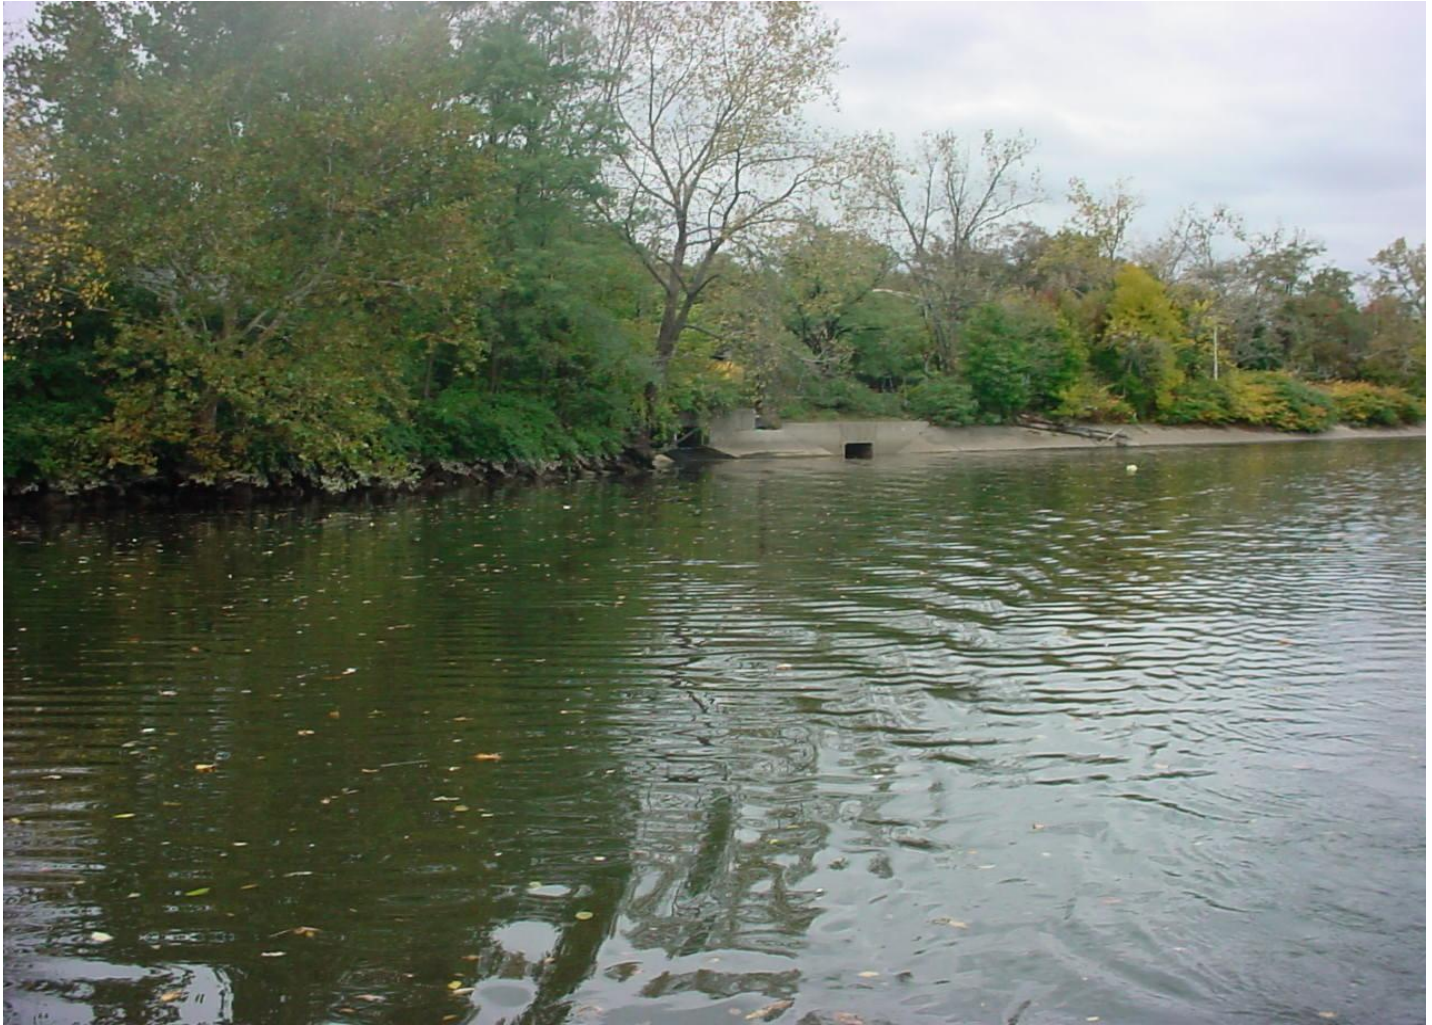
Creek Inland

Covered by roads from river to ~ 300' inland

Site 12N looking West

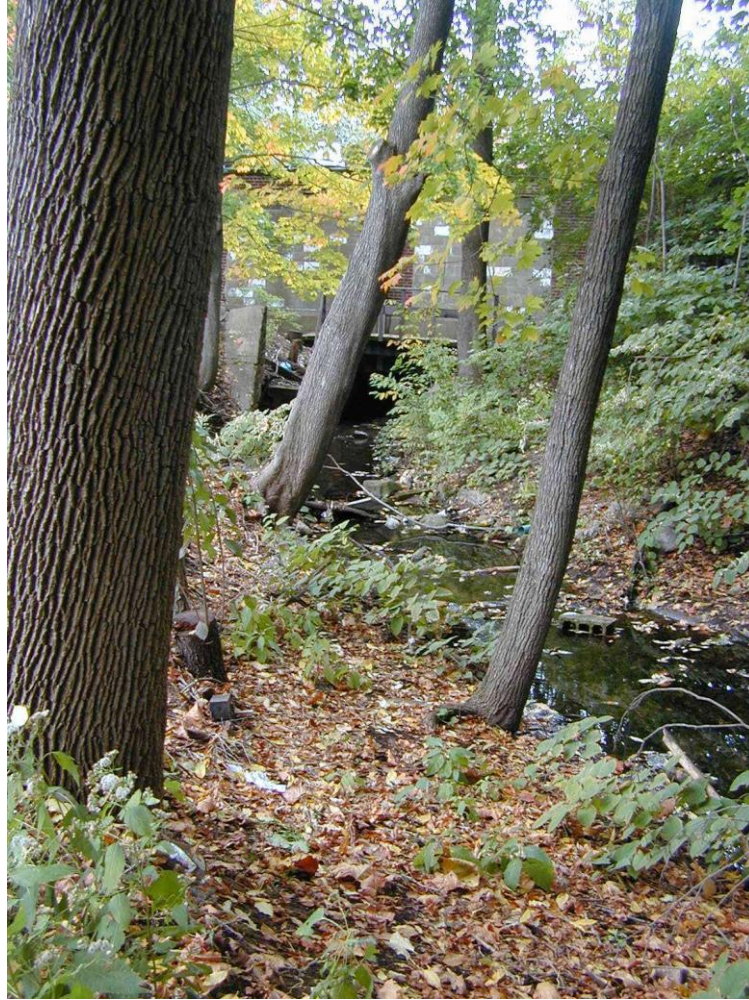
Stream running through interior of 12N

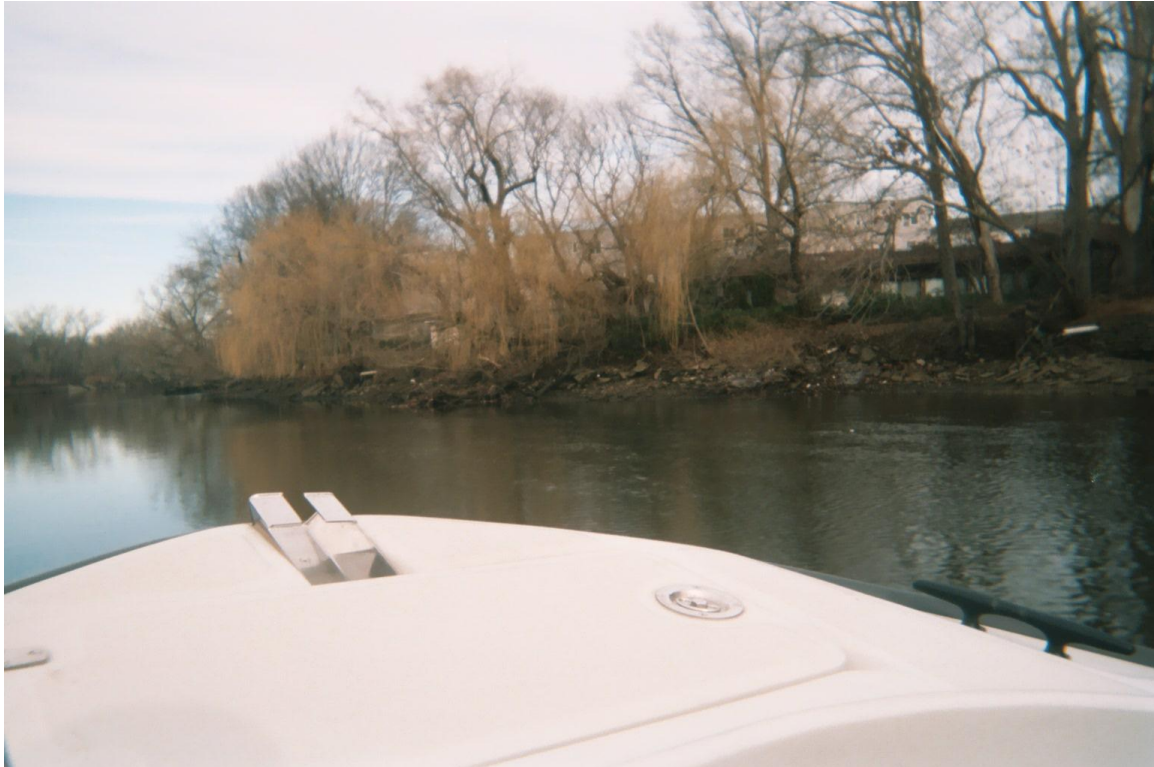
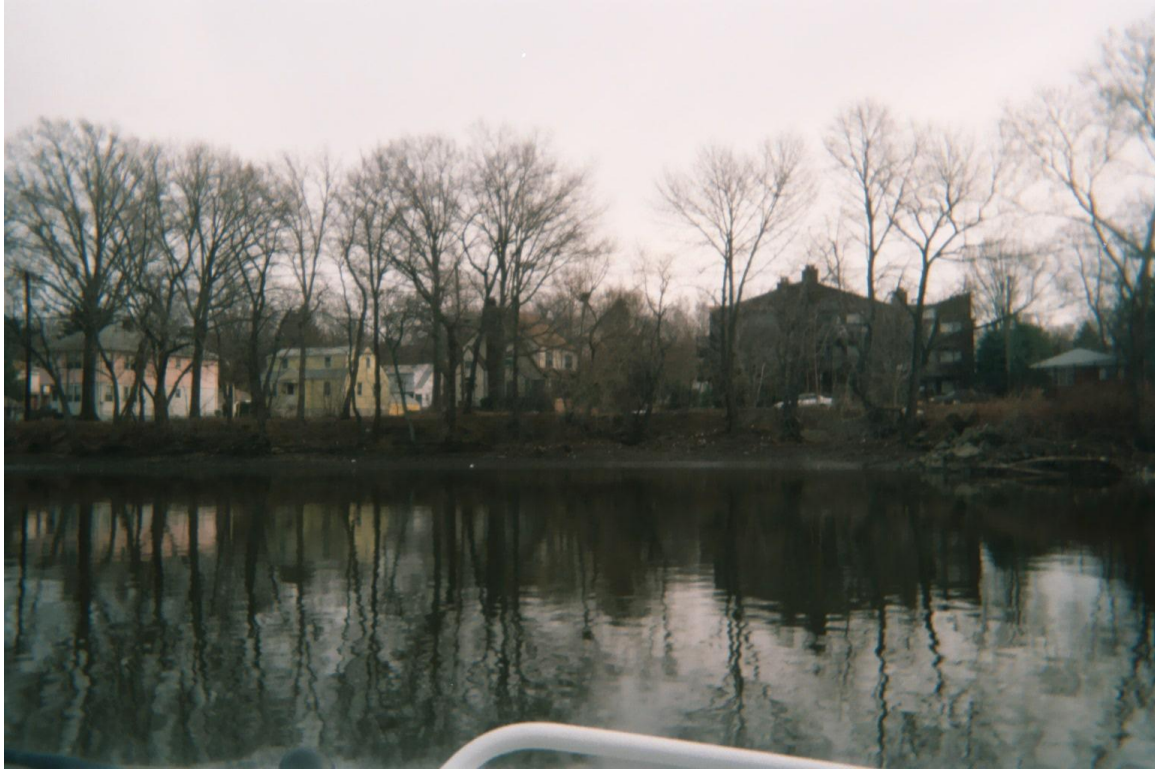
**Concrete bank 1/3 of length (park)
Natural bank 2/3 (residential)**

Some mudflats

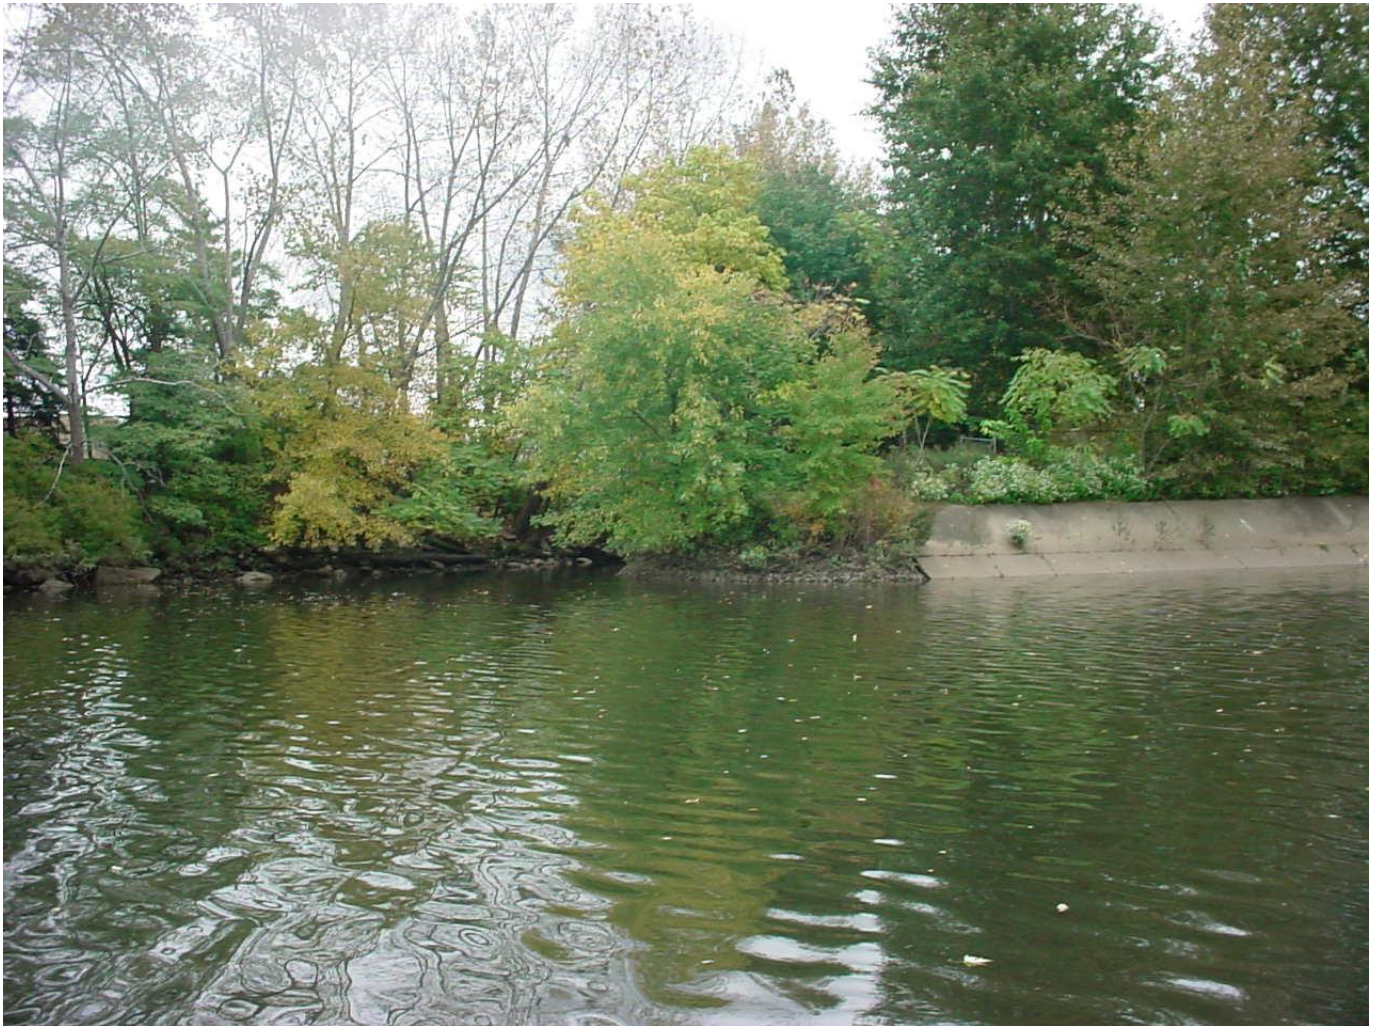
Residential area

Mudflats water ward

Shore line

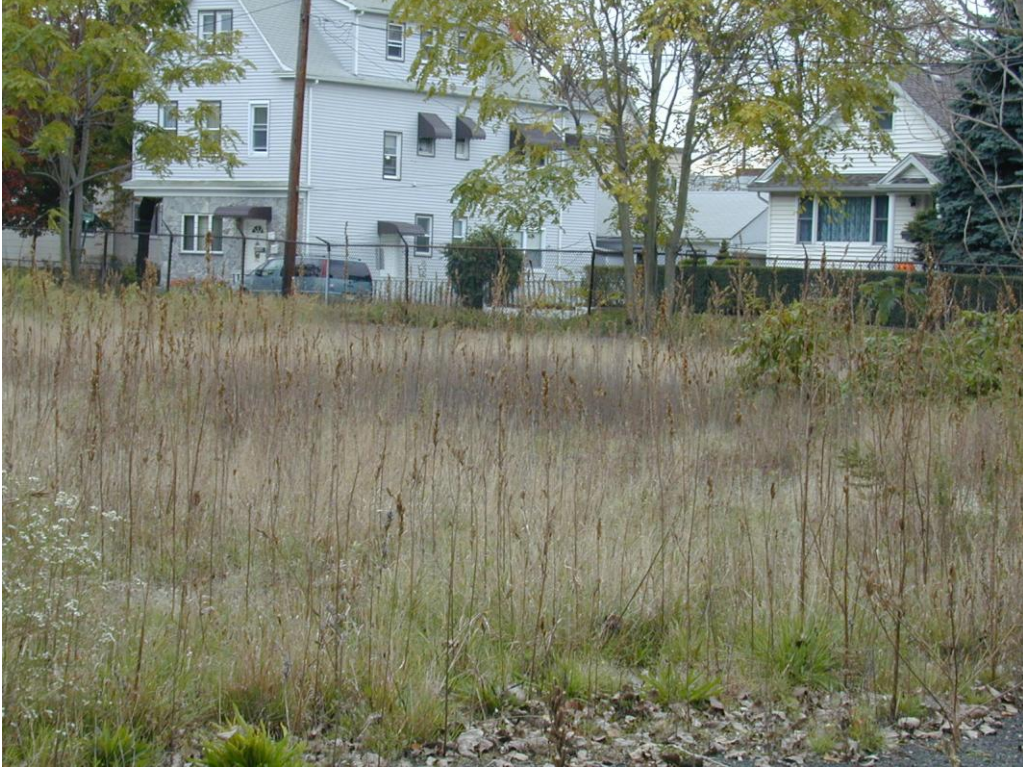
Urban meadow – possibly former parking lot

6N: Site Interior
