February 28, 2005

Re: Report for December 14, 2004 – February 24, 2005 Field Reconnaissance
Lower Passaic River Restoration Project
NJDOT Agreement No. 2001-NJM02

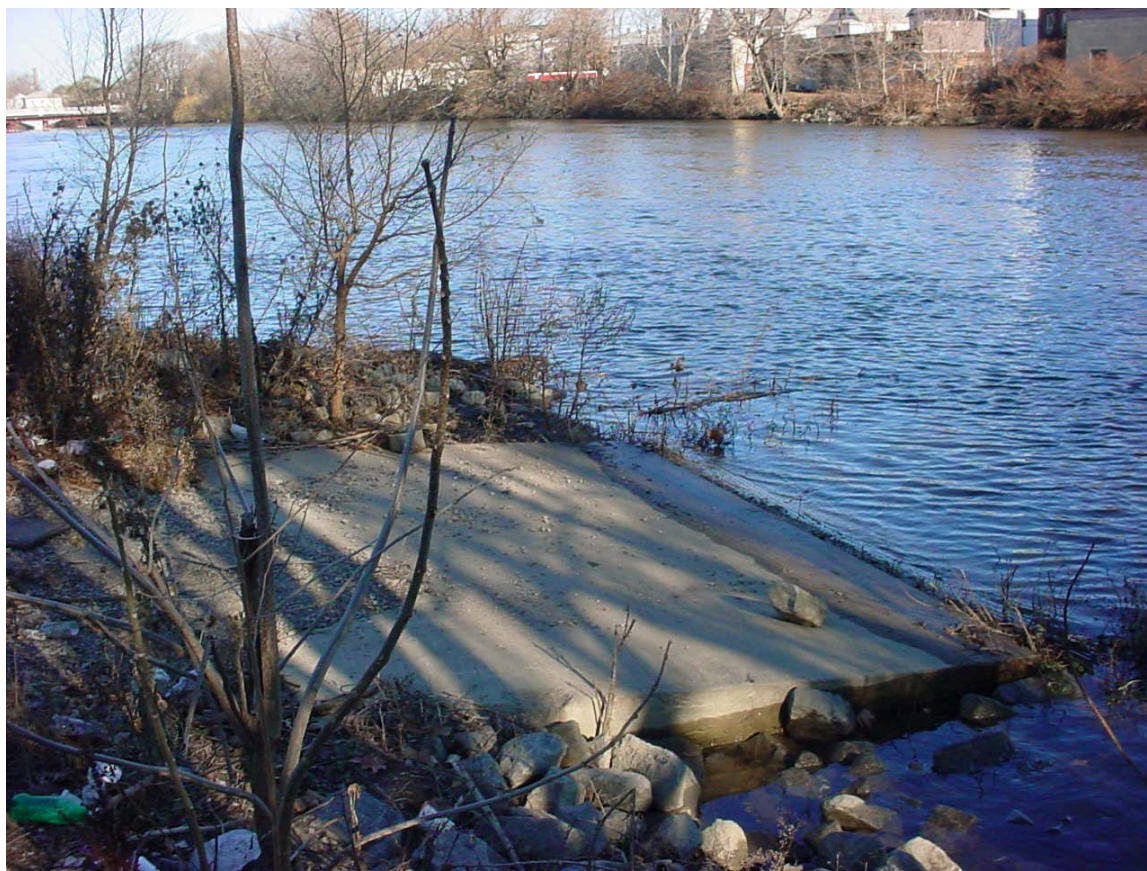
Boat ramp in park.

Site 3TMS: Boat Ramp

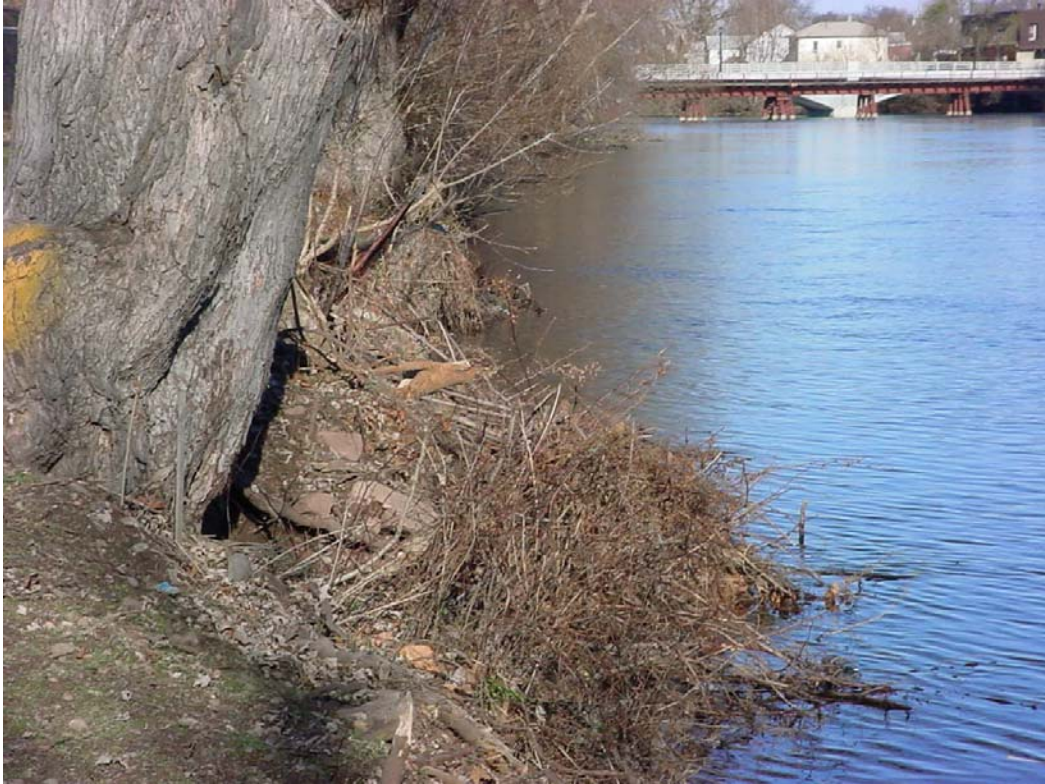
Site 3TMS: Shore line

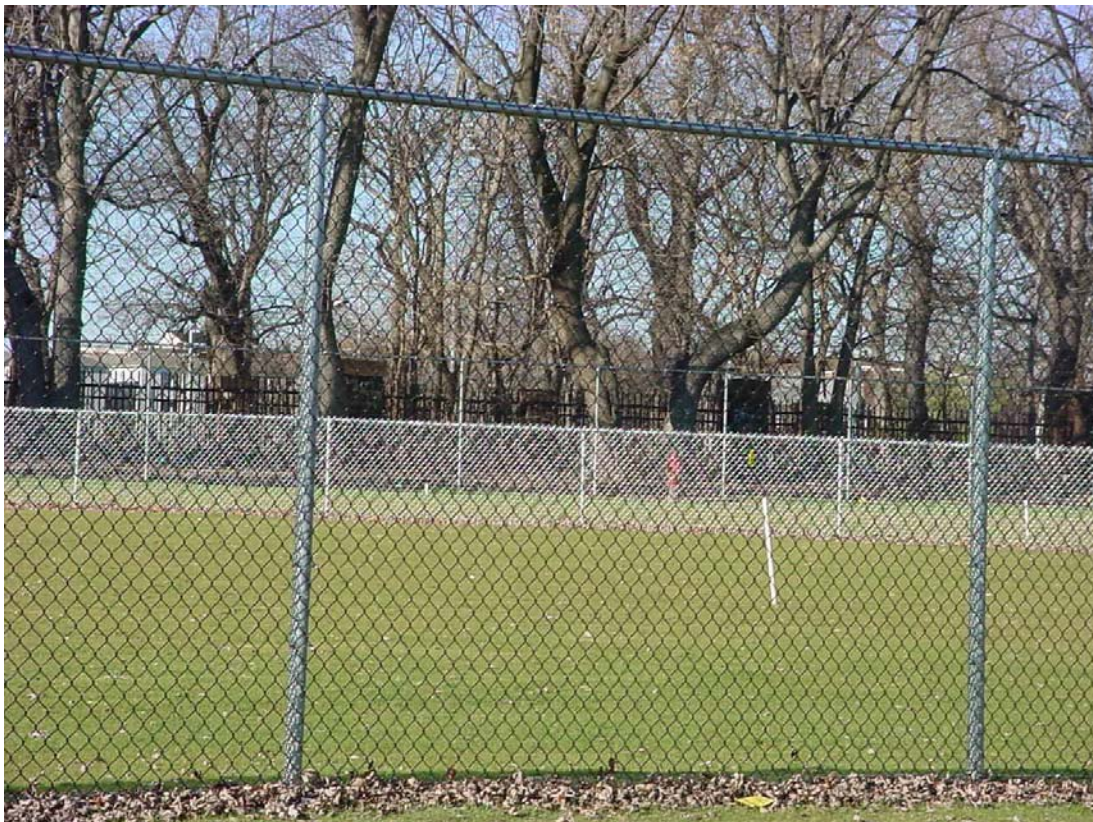
Site 3TMS: Fields near site

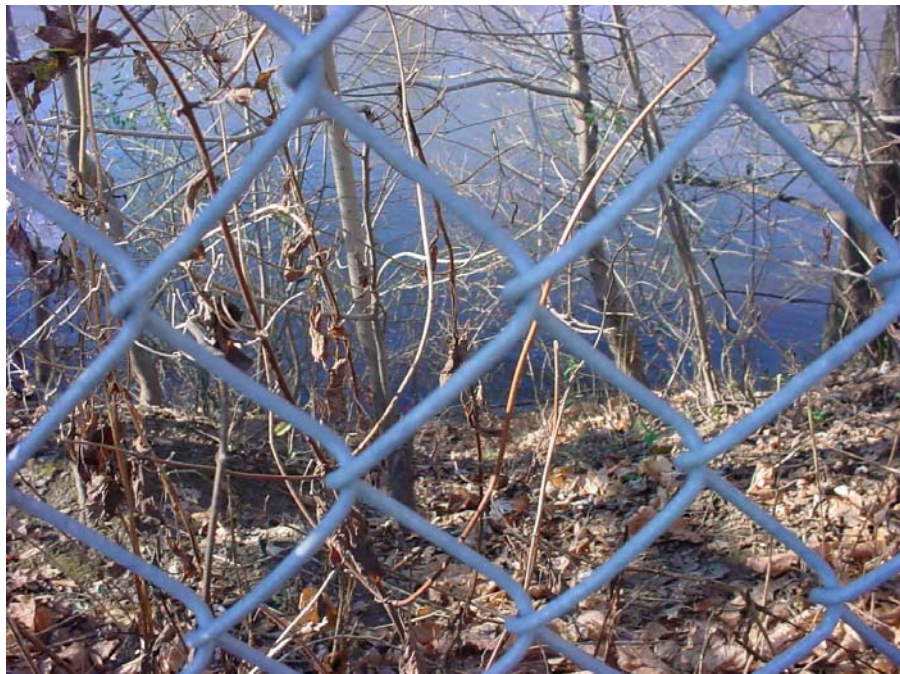
River bank is nearly vertical and covered with woody species.

Site 4C: Bank which is a “cliff”

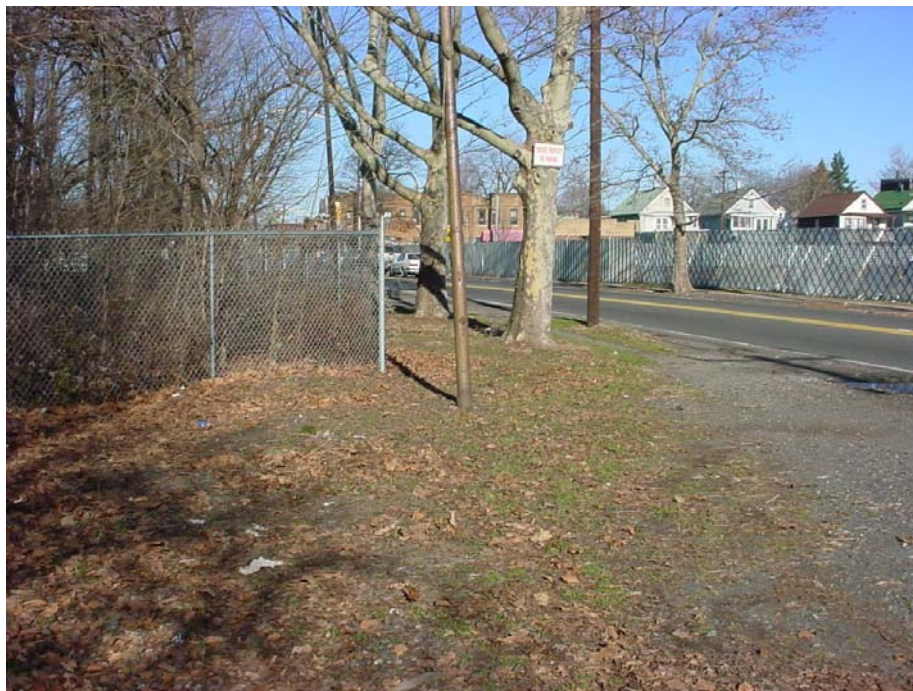
Site 4C: Flat area acting as a parking lot

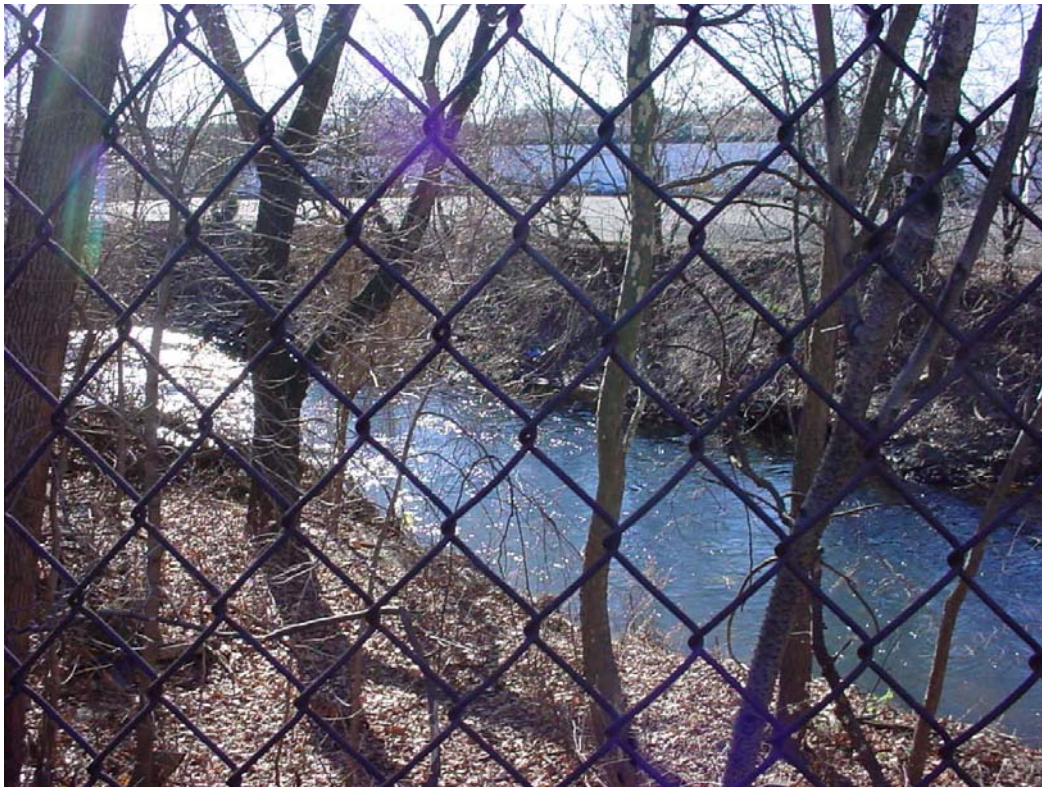
Site 2C: Bank of the Saddle River

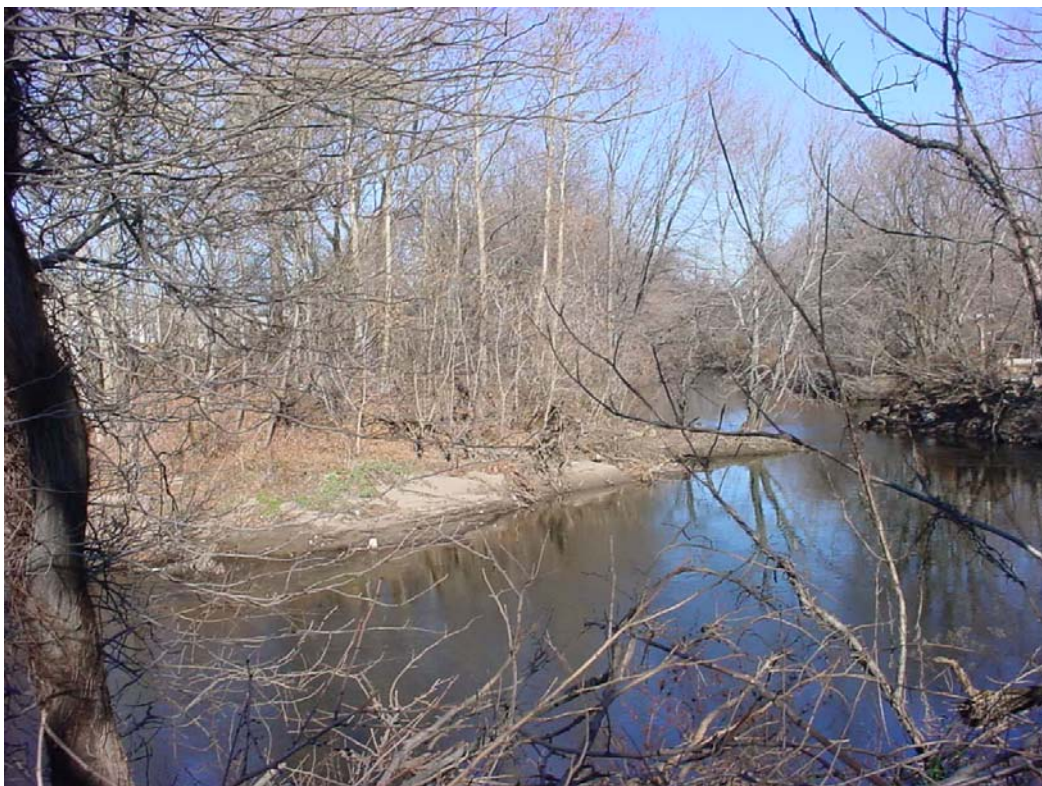
Site 2C: Opposite wall at the site

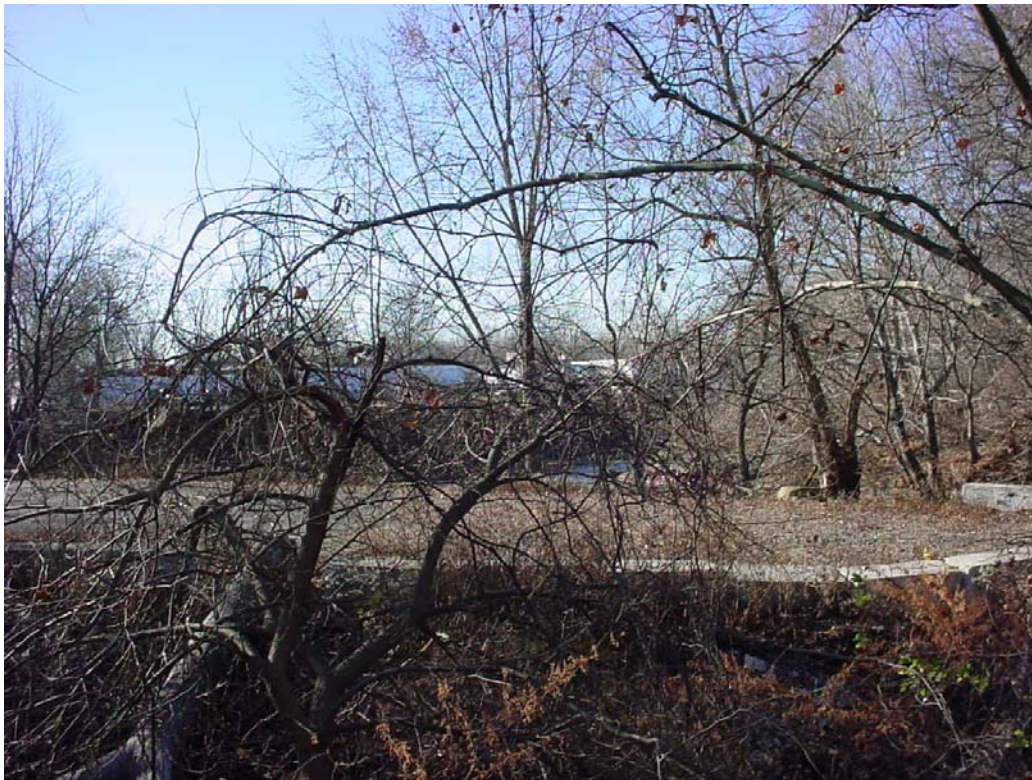
Site 3C: Area acting as a parking lot

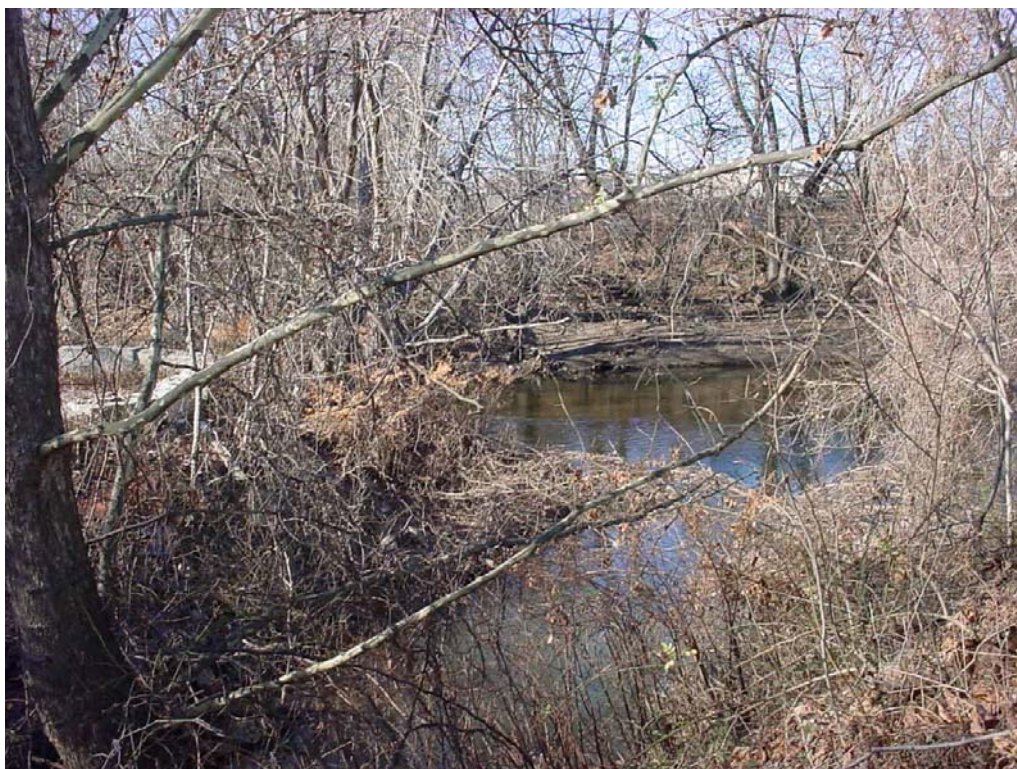
Site 3C: Confluence on adjacent site

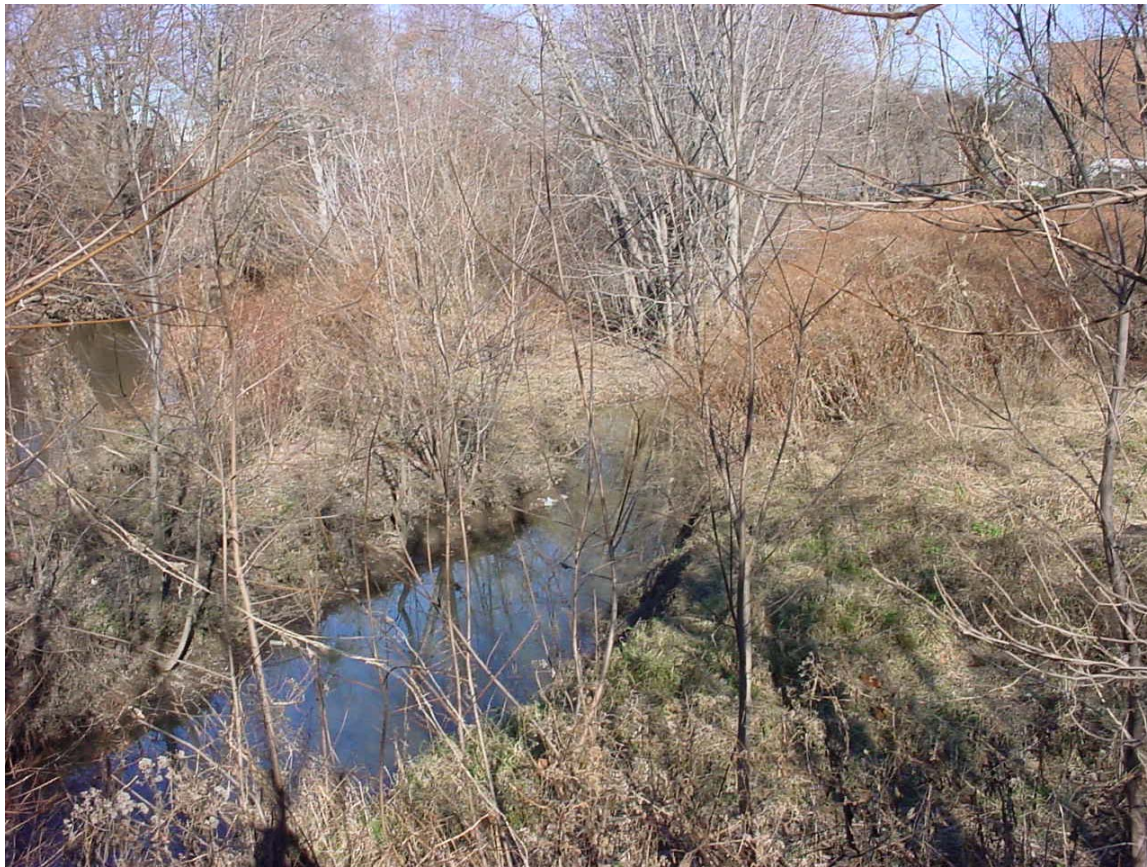
Site 3C: Wetland area adjacent to site

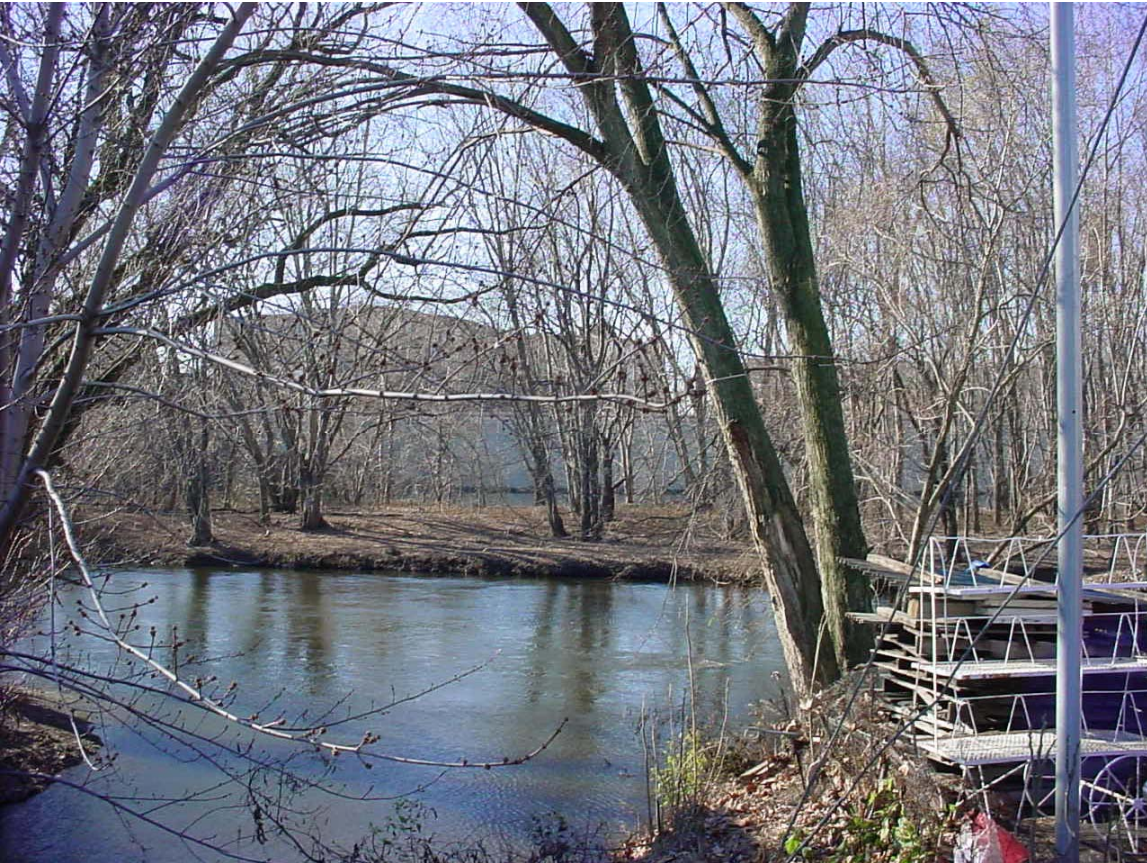
Habitat untouched

Site 5C: Island (view from east looking west from River Road in Garfield, NJ)

Minimal removal of trash would be beneficial.

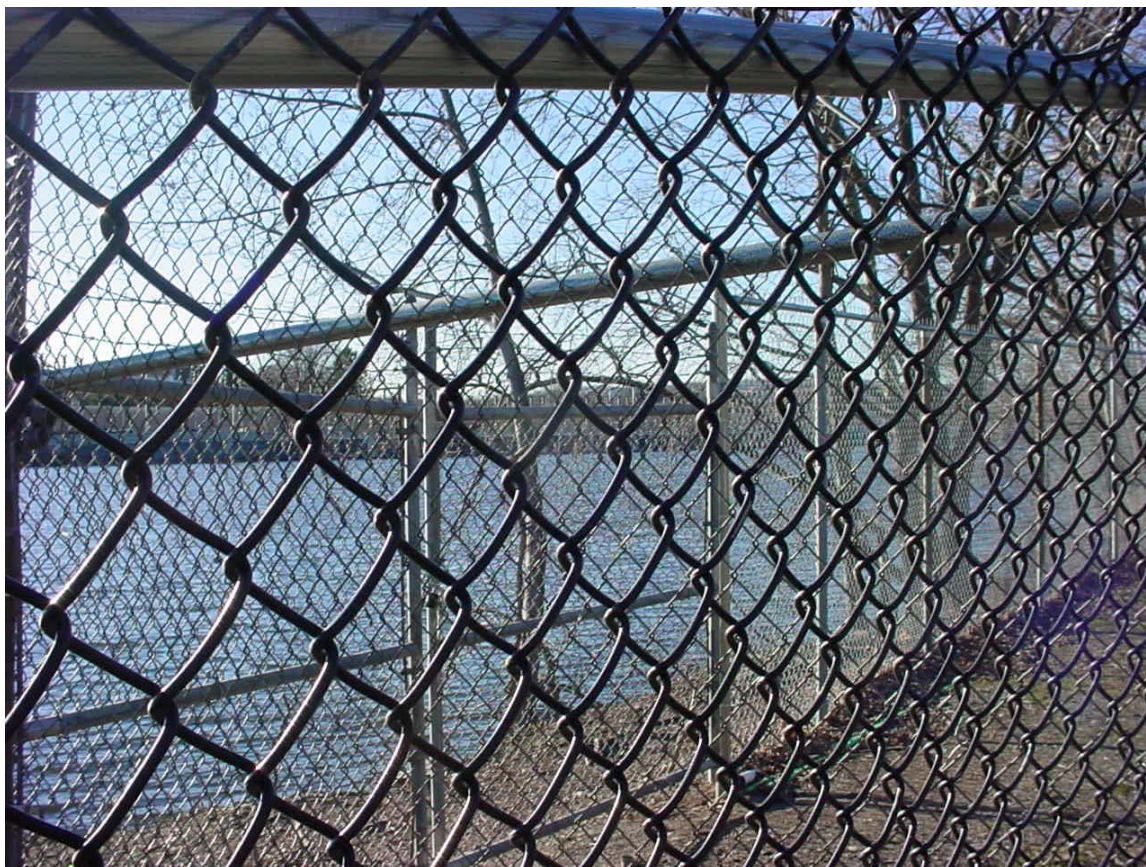
Site 2N (Dundee Dam) and Site 1N

Land area small – limited restoration potential

Site consists of a thin strip of river bank.

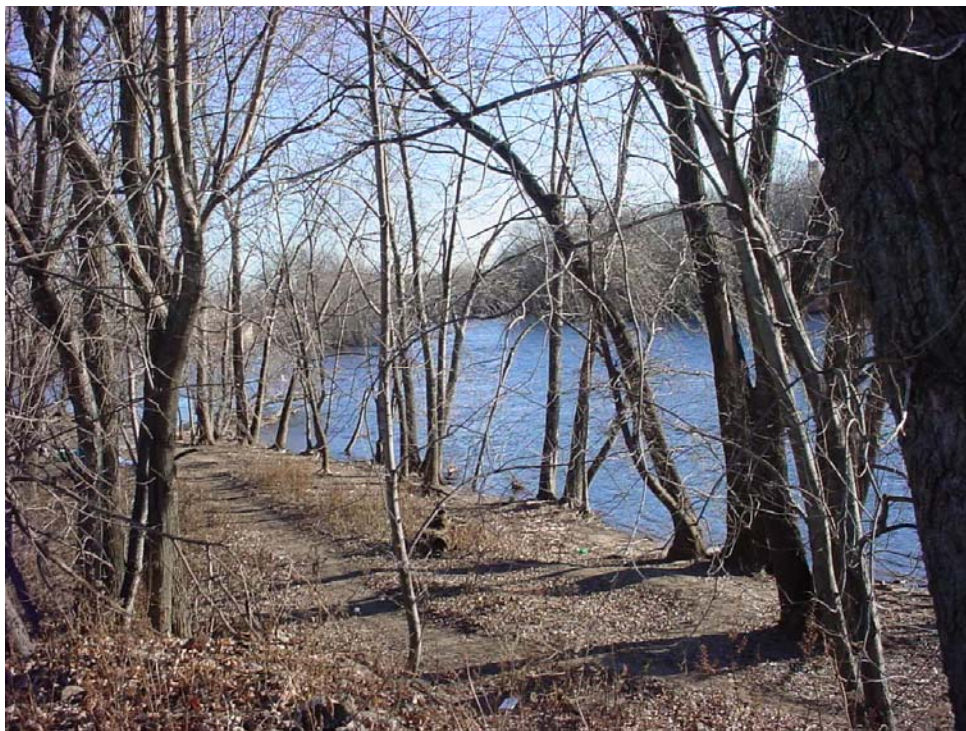
Site 6C/5N: Bank of Passaic River

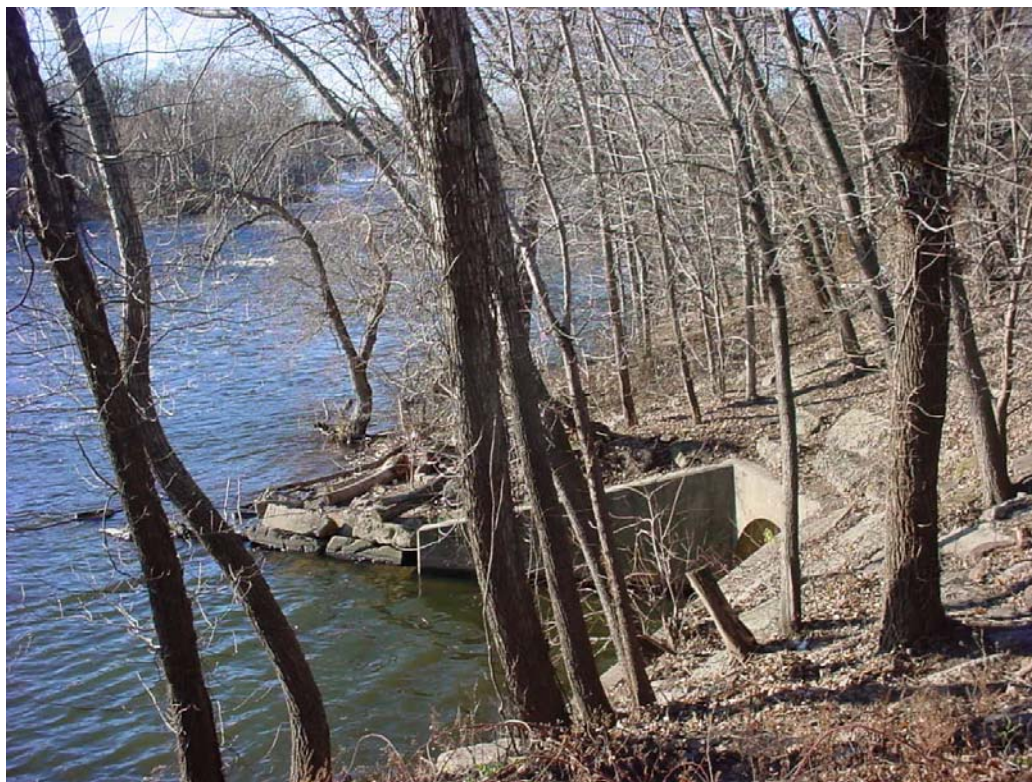
Site 6C/5N: Outfall located at site

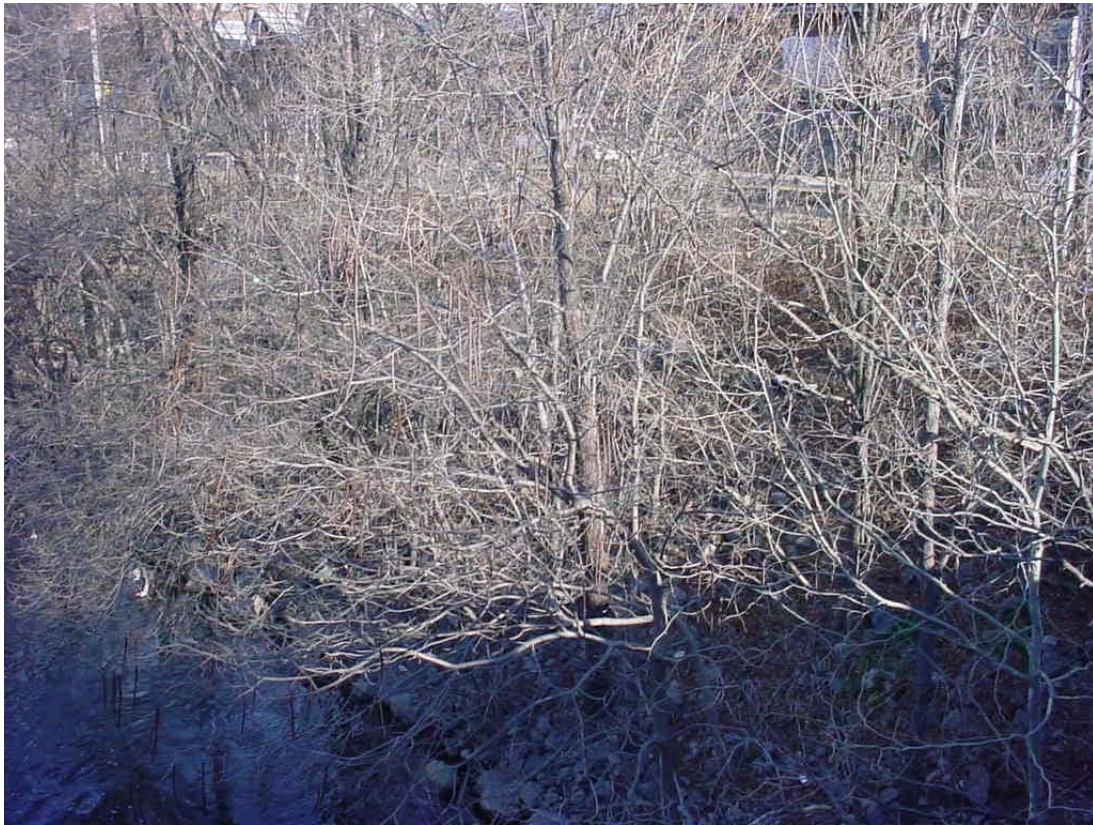
Site 6C/5N: Shoreline with homeless camps in background

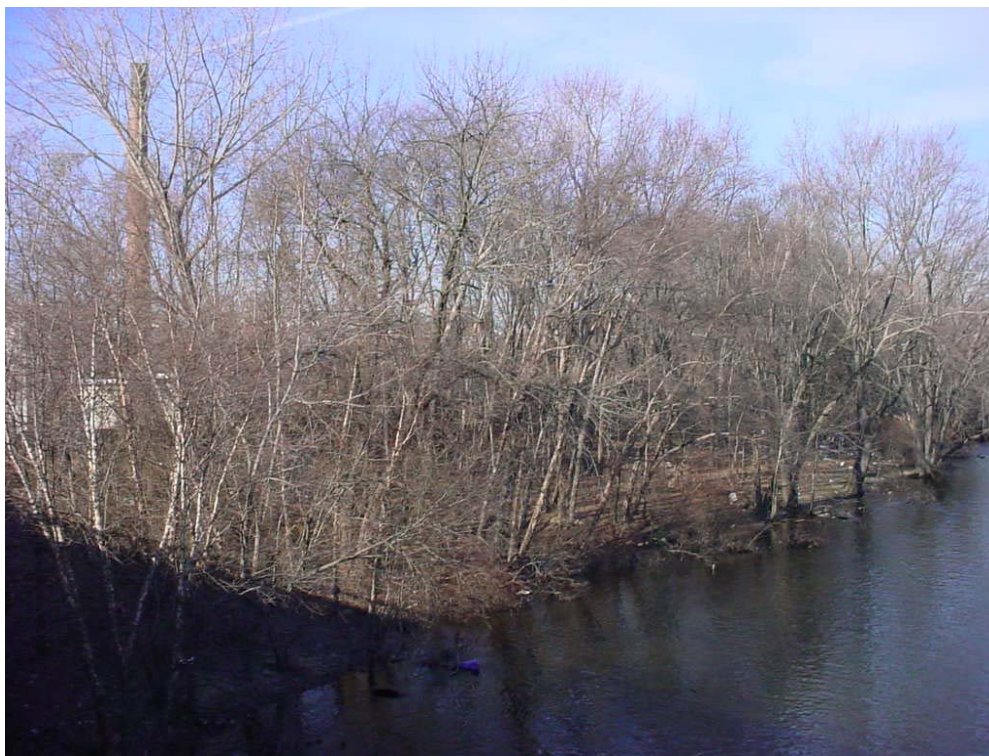
Site 4N: General shoreline

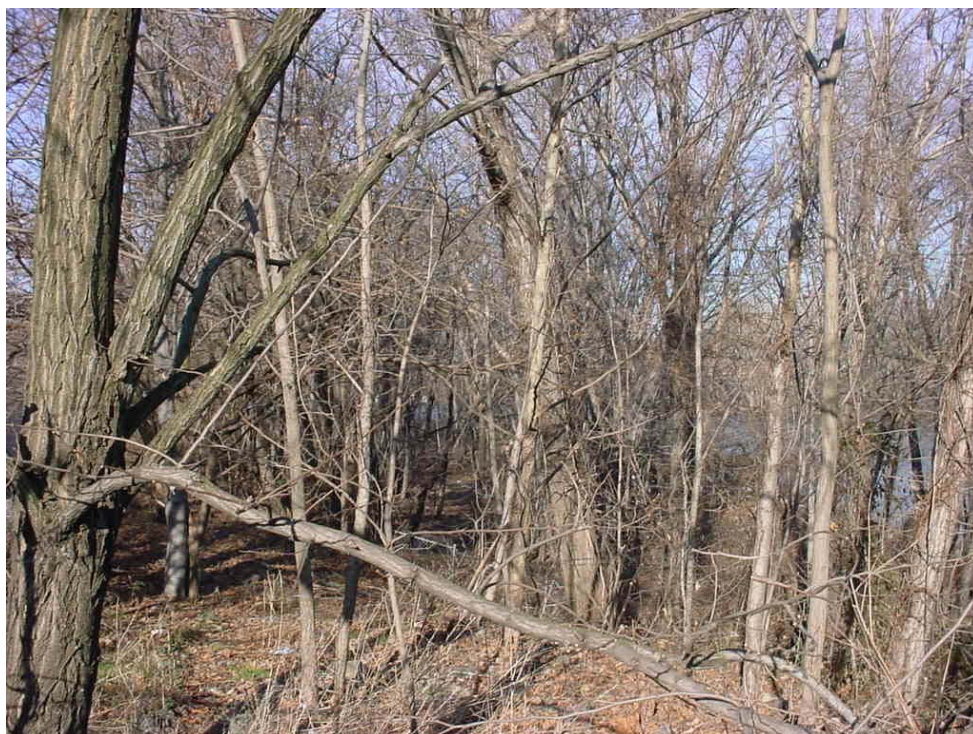
Site 4N: Interior of site - more flat area than opposite bank (sites 6C/5N). Evidence of homeless camps here as well.

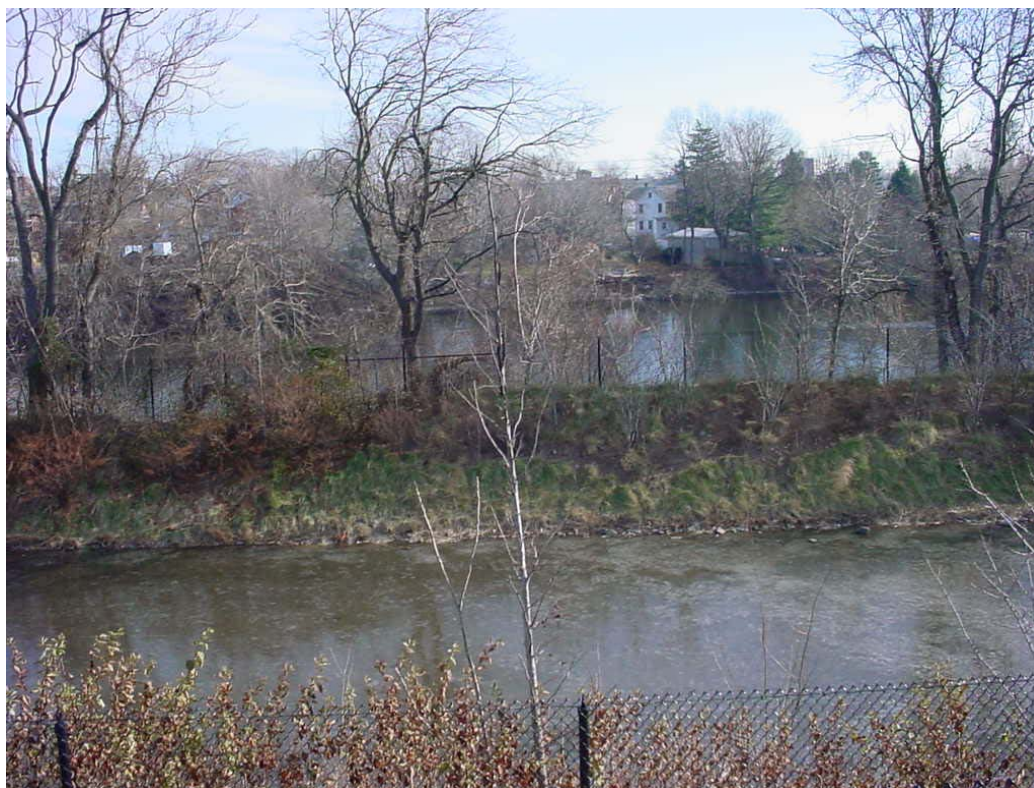
Site 2TMS: Shoreline (channel looking east from road)

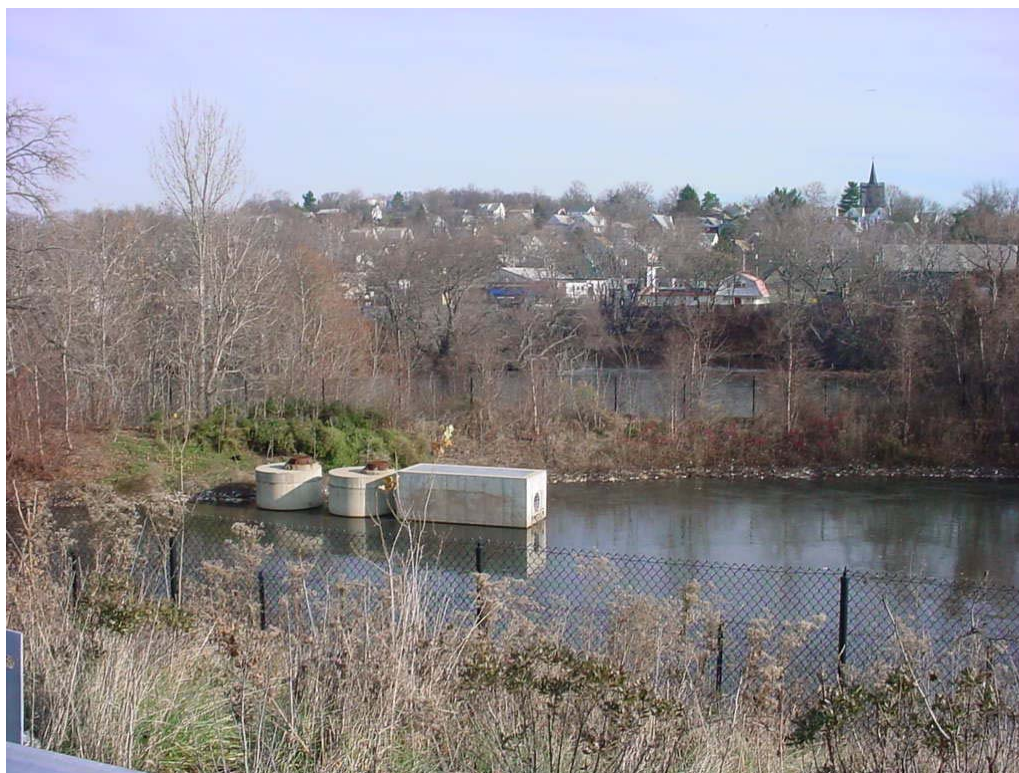
Site 2TMS: Northern end of 2TMS taken from site 21N

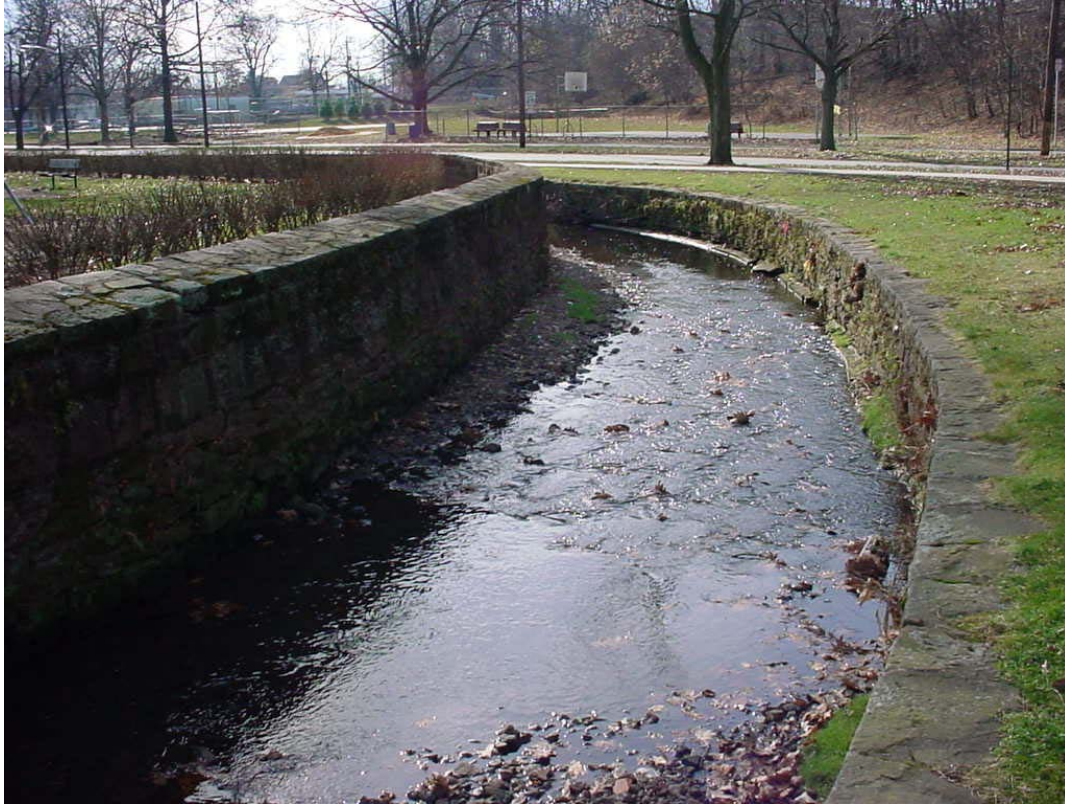
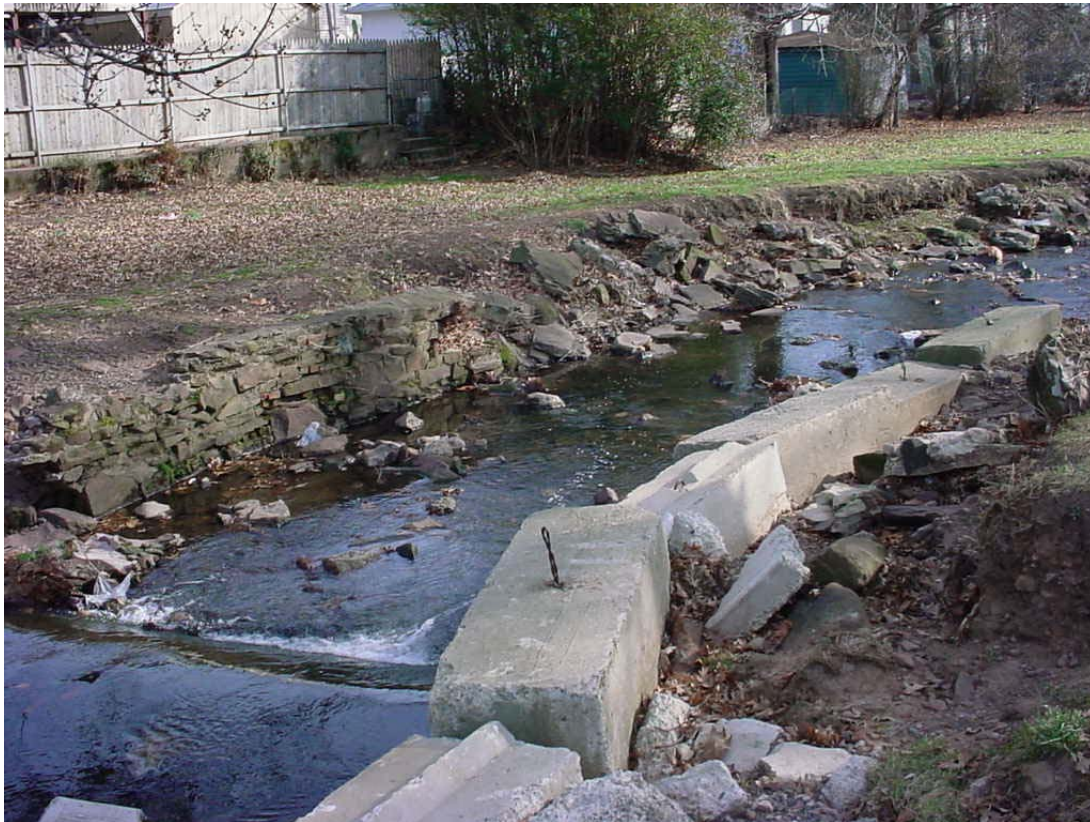
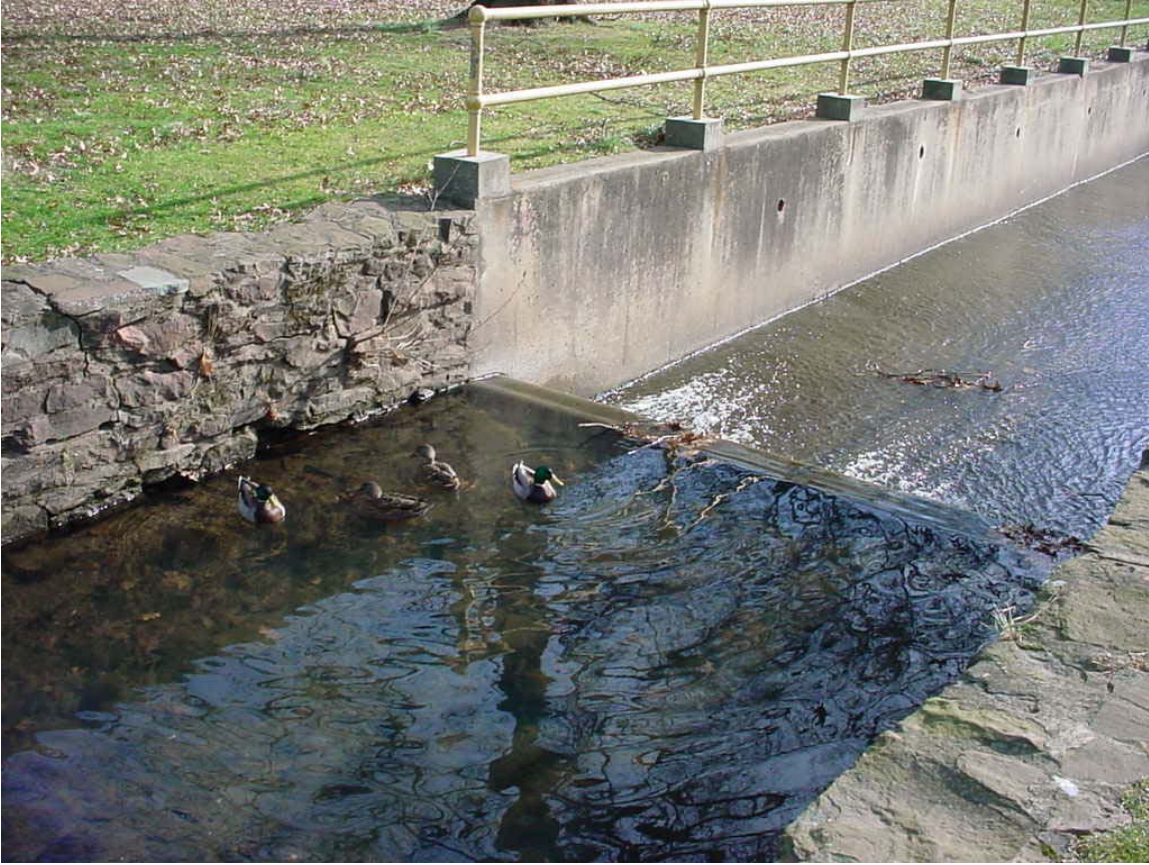
Site 11N

This site contains a small brook that is a tributary of the Passaic River. For almost the entire length of the site, the brook flows through Memorial Park in the municipality of Passaic. The brook is approximately 20 feet wide and usually less than 1 foot in depth. Numerous riffles are present throughout the brook. The brook's bed was rocky with coarse sediment material. No evidence of rooted aquatic vegetation or facultative vegetation was observed in the brook. If facultative vegetation is present within the brook's bed during the growing season, it is likely sparsely vegetated.

The brook's banks are approximately 2 to 4 feet in height and nearly vertical. The banks are comprised of maintained or dilapidated rock walls and natural materials subject to active scour. The tops of the banks are vegetated with a combination of maintained lawns, isolated native trees, and ornamental tree and shrub species. Within the entire area of the park, no wooded areas were observed.

In the western half of site 11N there is a large, man-made reflecting pond. The pond is the result of the damming of the brook. Here too, no evidence of rooted aquatic vegetation or facultative vegetation was observed on the pond's shore. Numerous waterfowl were observed utilizing the pond. As such, organic nutrients, fecal coli, etc., likely occur at high levels in the pond.

- Planting of native trees and shrubs for anupland forested and scrub/shrub habitat.
- Minor damming and widening of the stream in select locations to permit herbaceous and scrub/shrub facultative species.
- Cleanup of reflecting pond (removal of nuisance water fowl, planting of rooted aquatic vegetation, addition of fish).
- Installation of nature/interpretive walk along river.
- Bank stabilization.

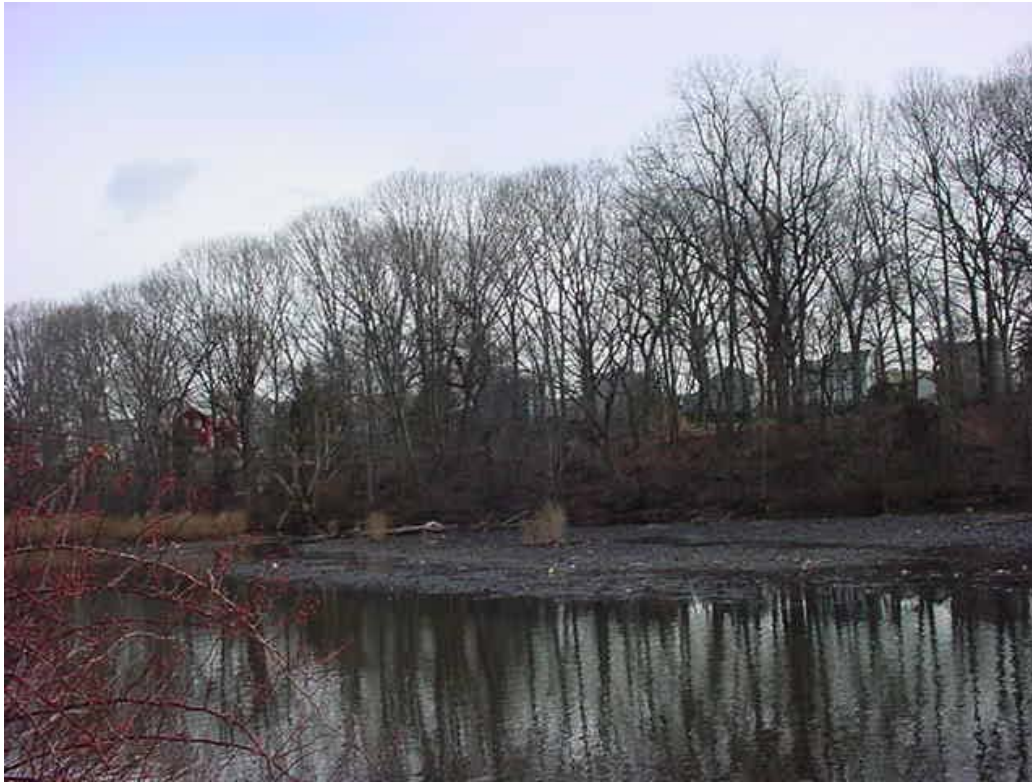
In the north-central portion of the pond, there is a vegetated island. The island consists of a mix of facultative herbaceous and woody vegetation. The bottom of the pond consists of soft sediments. These sediments likely have built up since the presence of the dam. It is anticipated that sedimentation will become an issue in the future with the pond. Also, shopping carts and other trash were located along bottom and shoreline of the pond.

Middle of pond (west bank looking east) island in center of pond

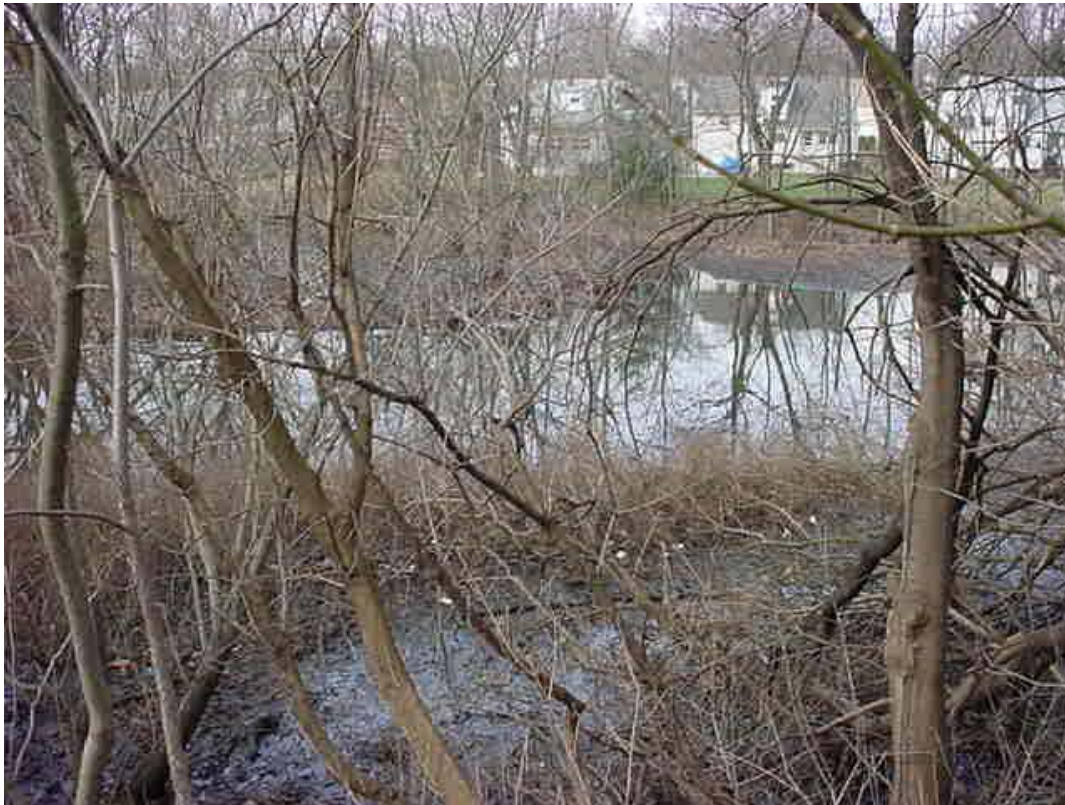
North edge of pond looking southwest

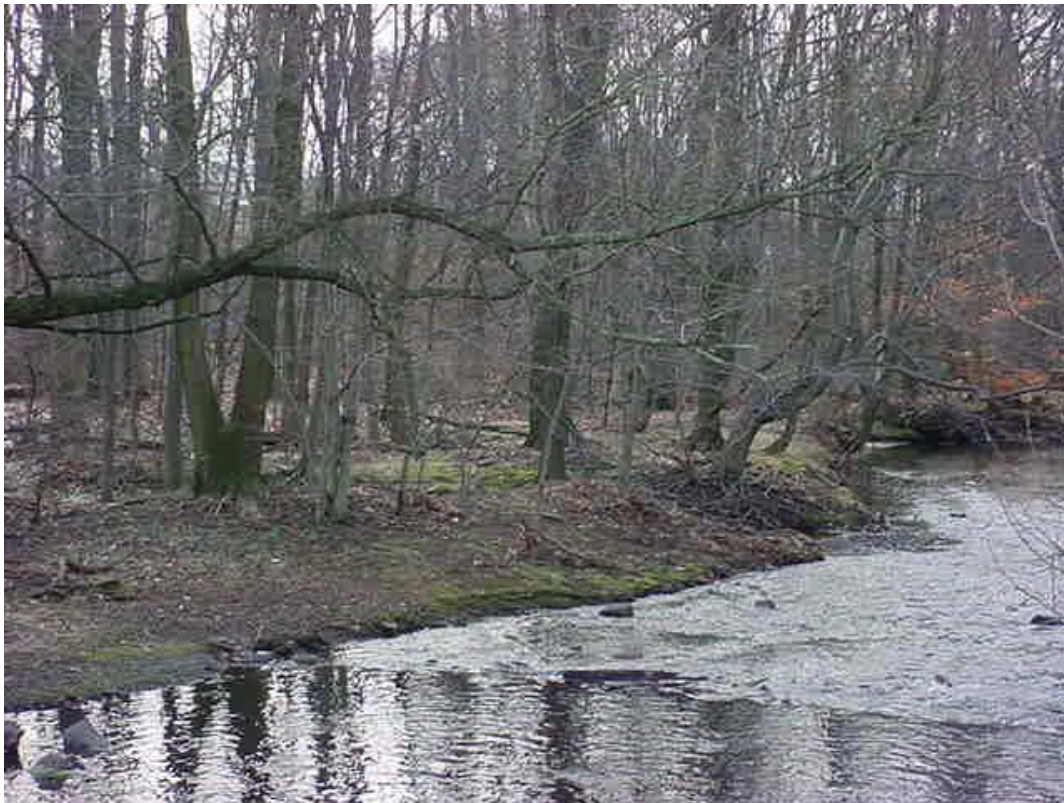
South of Rt. 3, the river flows through a small wooded area until flowing through an industrial area and meeting the Passaic River. The tidal portion of the Third River is limited and occurs downstream of the River Road bridge in Nutley. Riffles were observed immediately downstream of the bridge.

Third River looking southeast

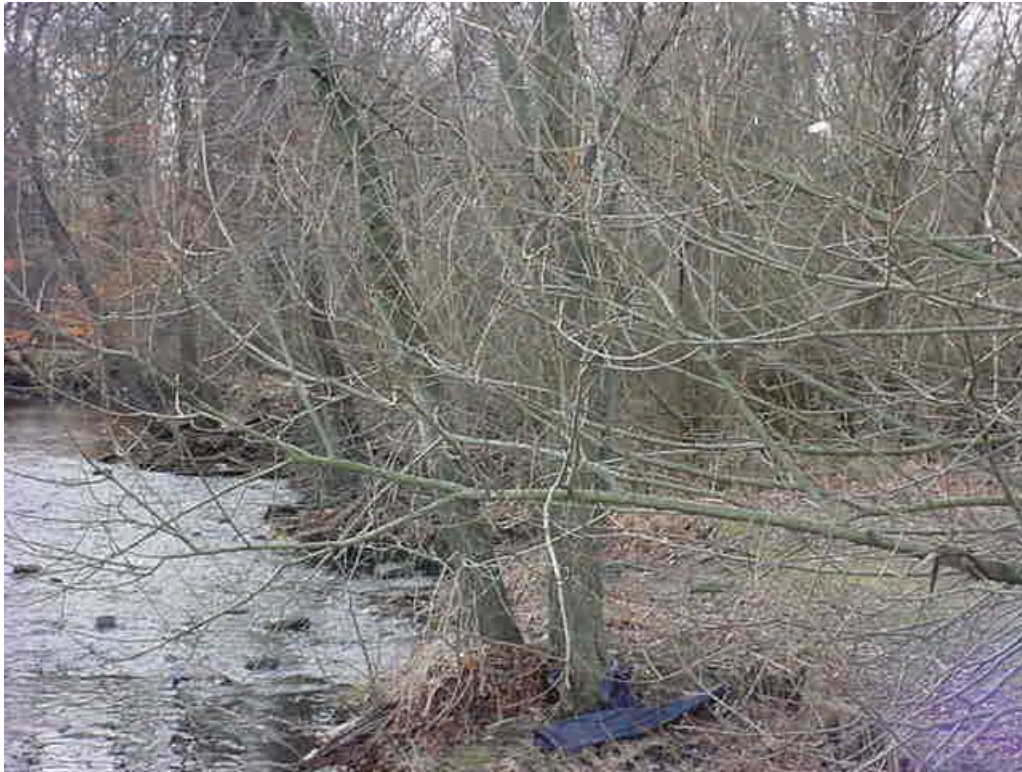
Third River looking southwest
