February 28, 2005

Re: Report for December 14, 2004 – February 24, 2005 Field Reconnaissance
Lower Passaic River Restoration Project
NJDOT Agreement No. 2001-NJM02

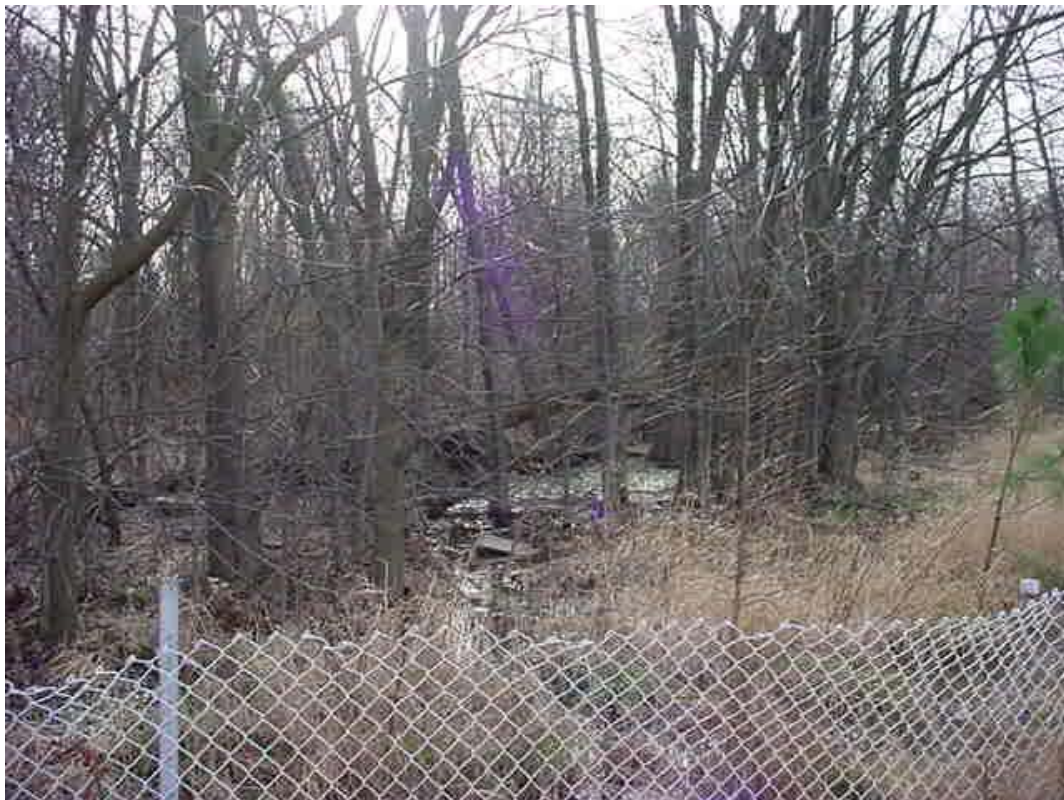
Wetlands on southwest edge of pond / Third River

- Clifton (the area of the Third River north of Rt 3).
- Restoration activities should be limited to trash and debris removal as well as the removal of invasive species. Japanese knotweed and common reed were observed in these areas. Replanting of native species in select locations too would be beneficial. However, large-scale changes to the topography should be closely studied as the area currently serves as an oasis for fauna in a dense urban area.

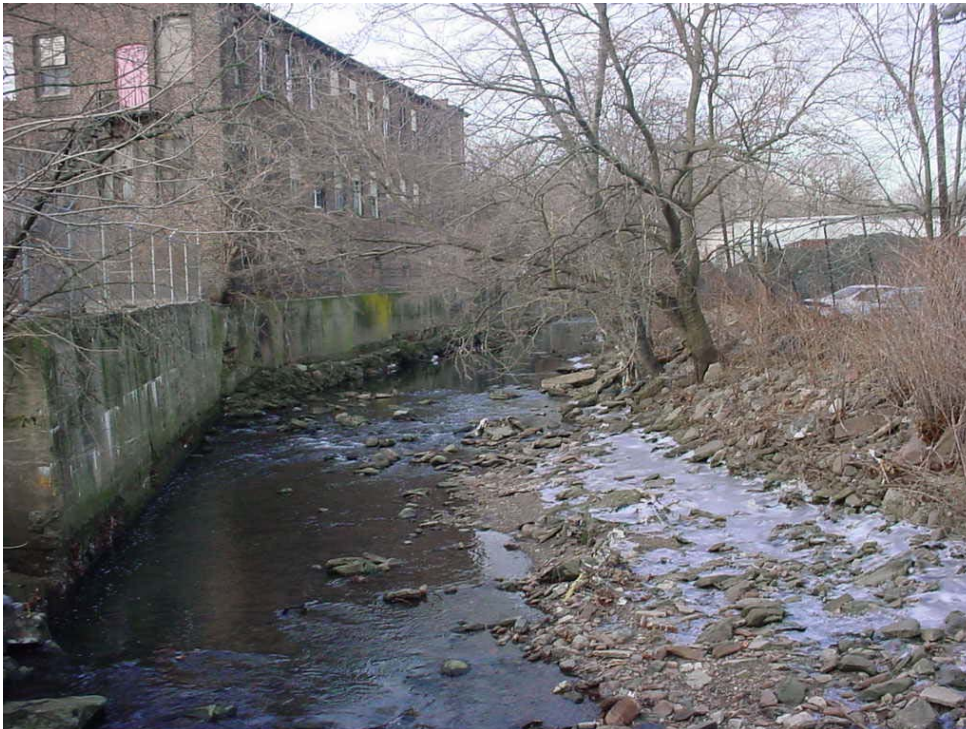
The Second River flows generally west to east from Watsessing Park in Bloomfield to its confluence with the Passaic River. Within this stretch, the river's banks are abutted by numerous local parks. From Watsessing Park to approximately the Main Street Bridge (Belleville/Newark), the river's banks almost completely consist of concrete vertical walls and bulkheads of differing heights (approx 6-15 ft) in height. Numerous stormwater outfalls were observed within the culverts, walls, and bulkheads along the Second River.

Second River (looking upstream) at the Main Street Bridge

- Removal of garbage and debris through the entire length of the water body.
- Water quality improvements – upgrade/removal of outfalls along the river banks.
- Removal of invasive species. Japanese knotweed observed periodically along the river banks.

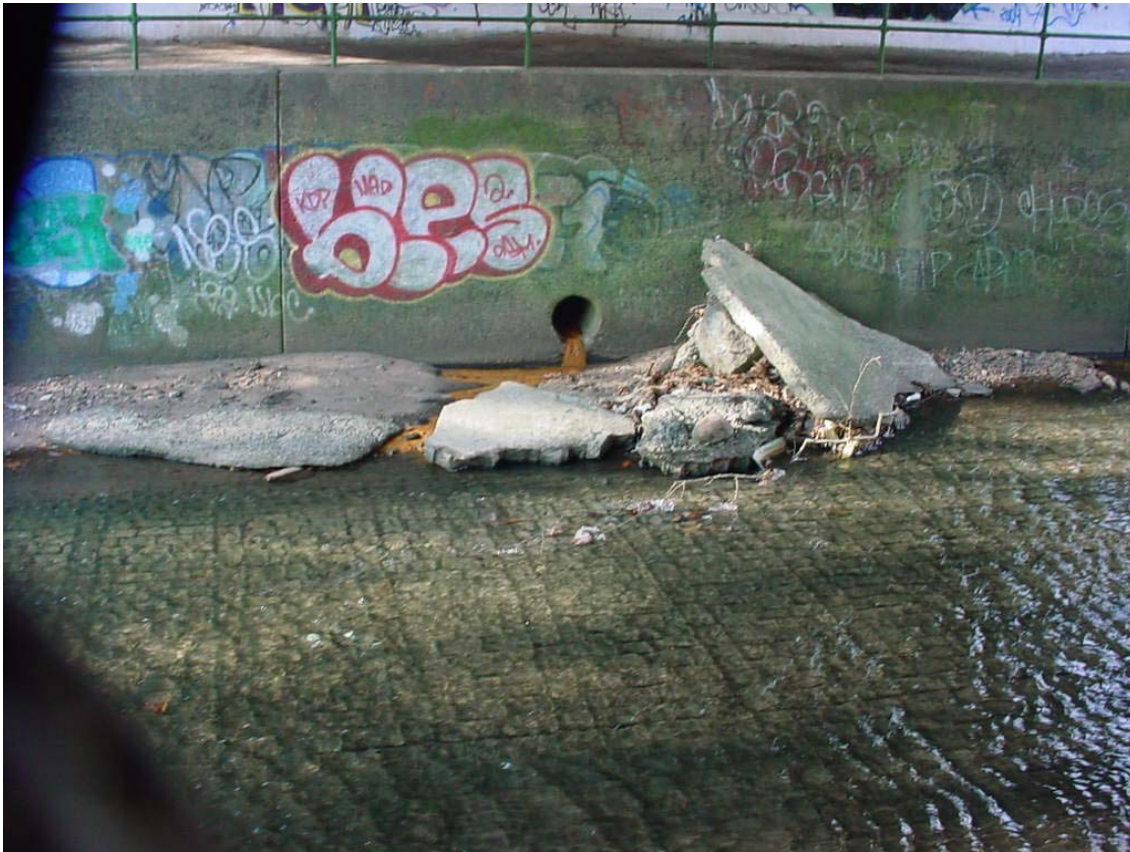
Outfall on the Second River

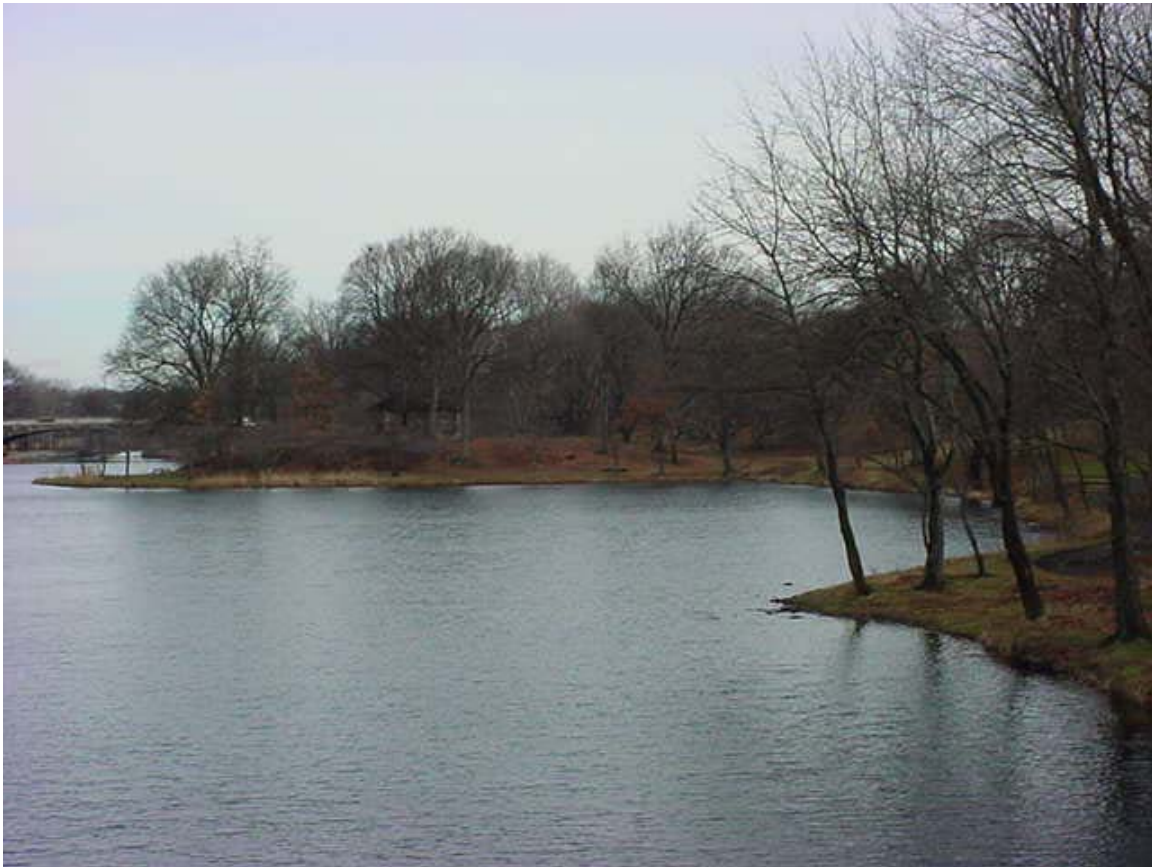
Site 30N: Eastern shore of lake looking north

Restoration would consist of removal of storm water outfalls, removal of debris, and planting of natural forested, shrubs/scrubs upland.

Wetlands could consist of herbaceous vegetation.

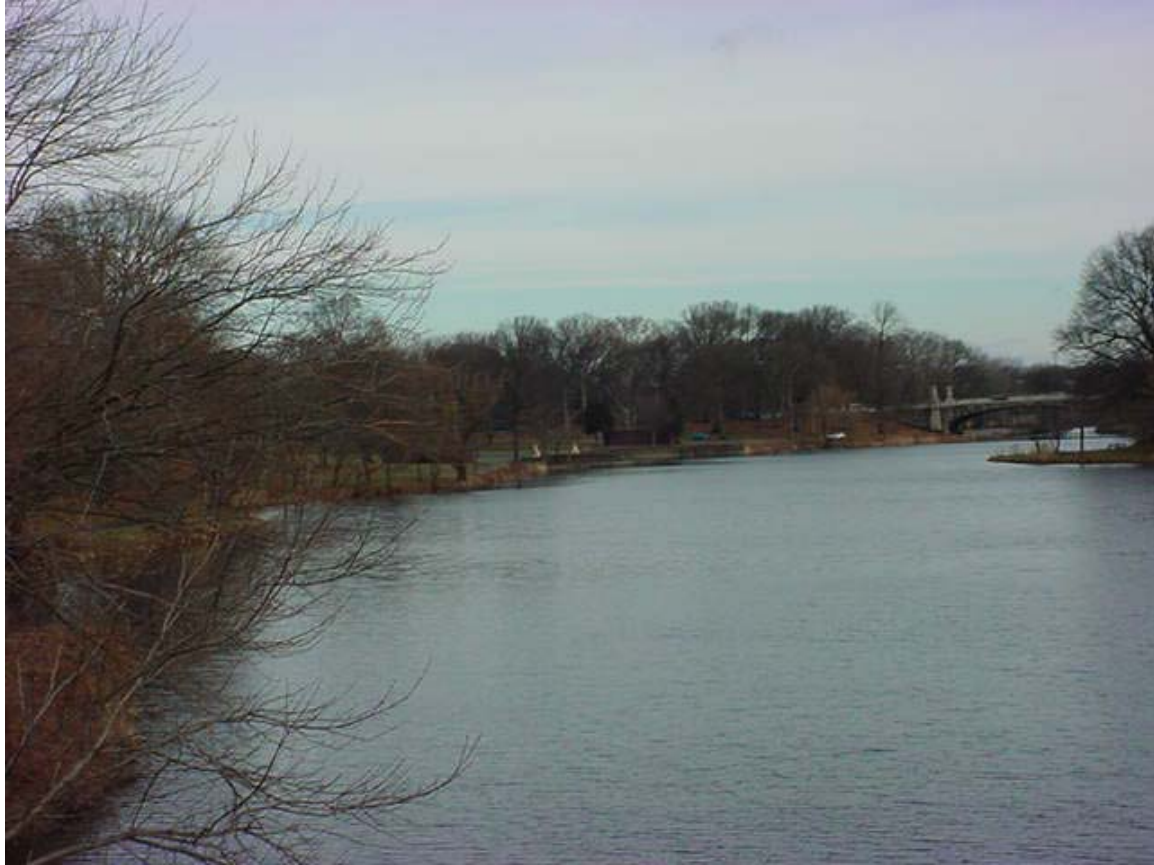
Site 30N: Western shore of lake looking north
