Lower Passaic River Restoration Project

Vegetation Sampling, Wetland Delineation, and Bio-Benchmark Report

December 2008

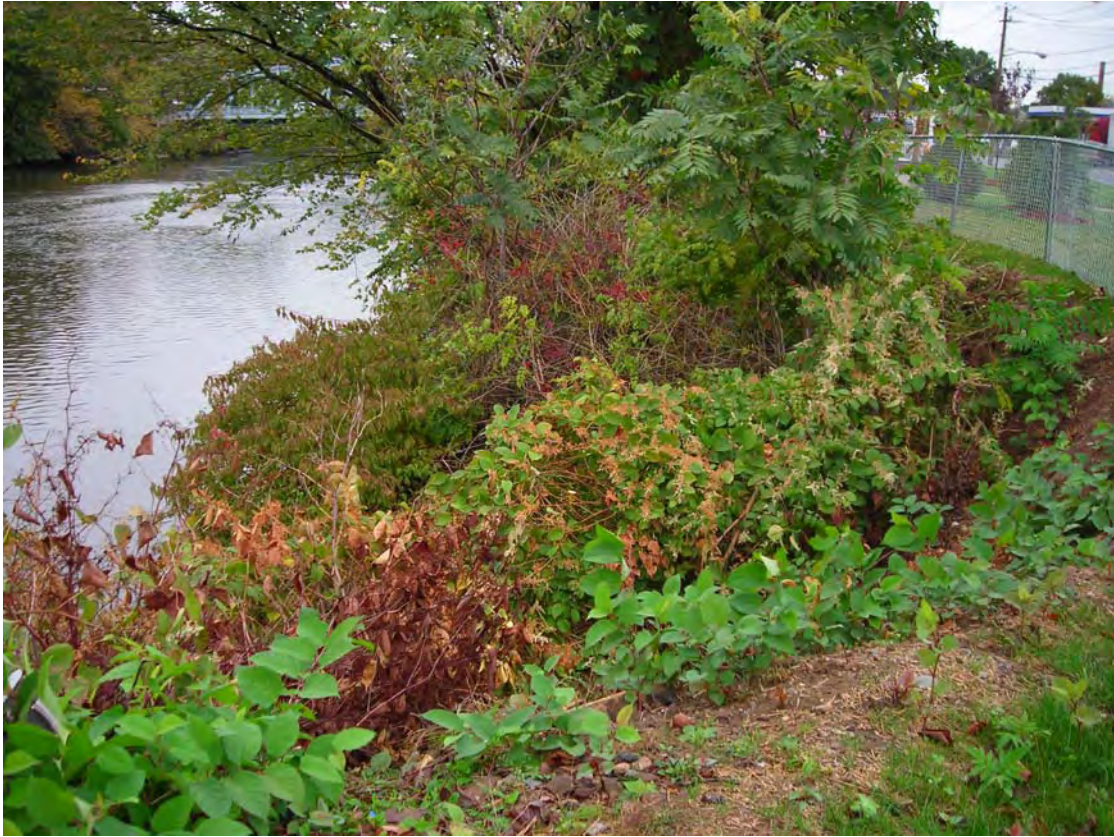
Photo 3. Representative vegetation at north portion of RM14.1 (Liberty Crossing Park).
Note shoreline erosion.

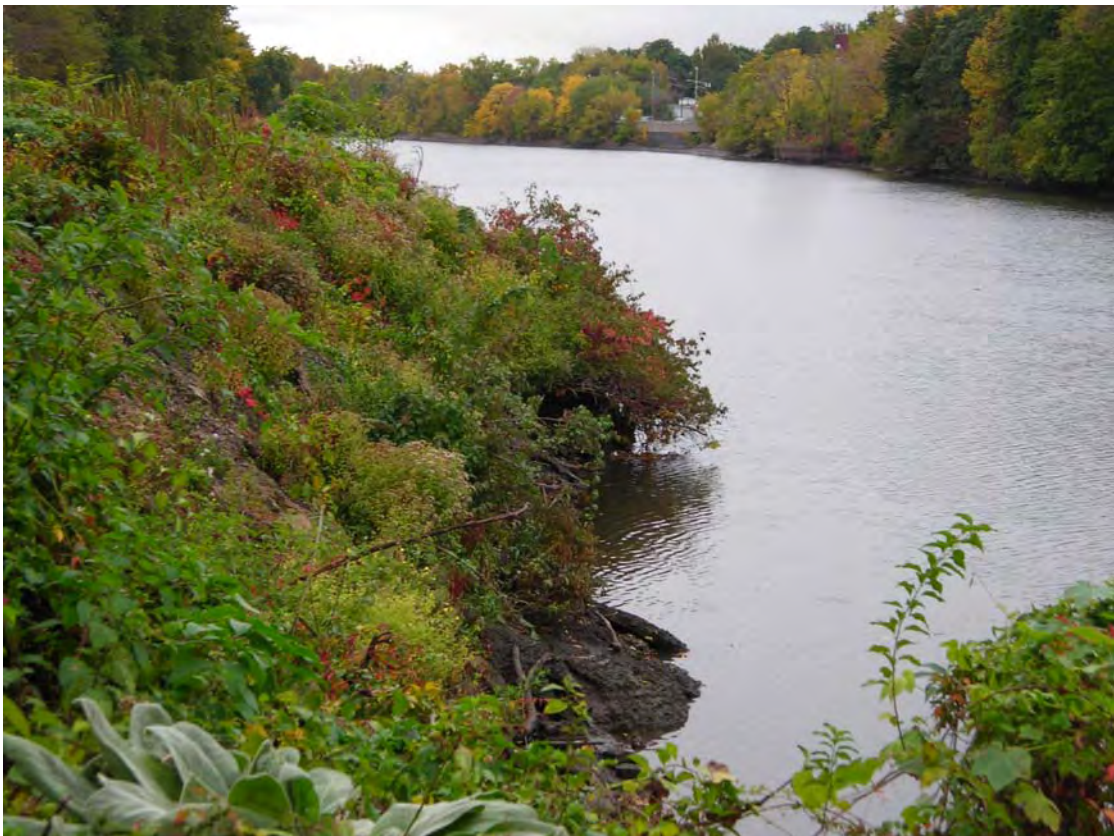
Photo 4. Shoreline and vegetation at south end of RM14.1 (Liberty Crossing Park).
Shoreline very steep and no woody vegetation present.

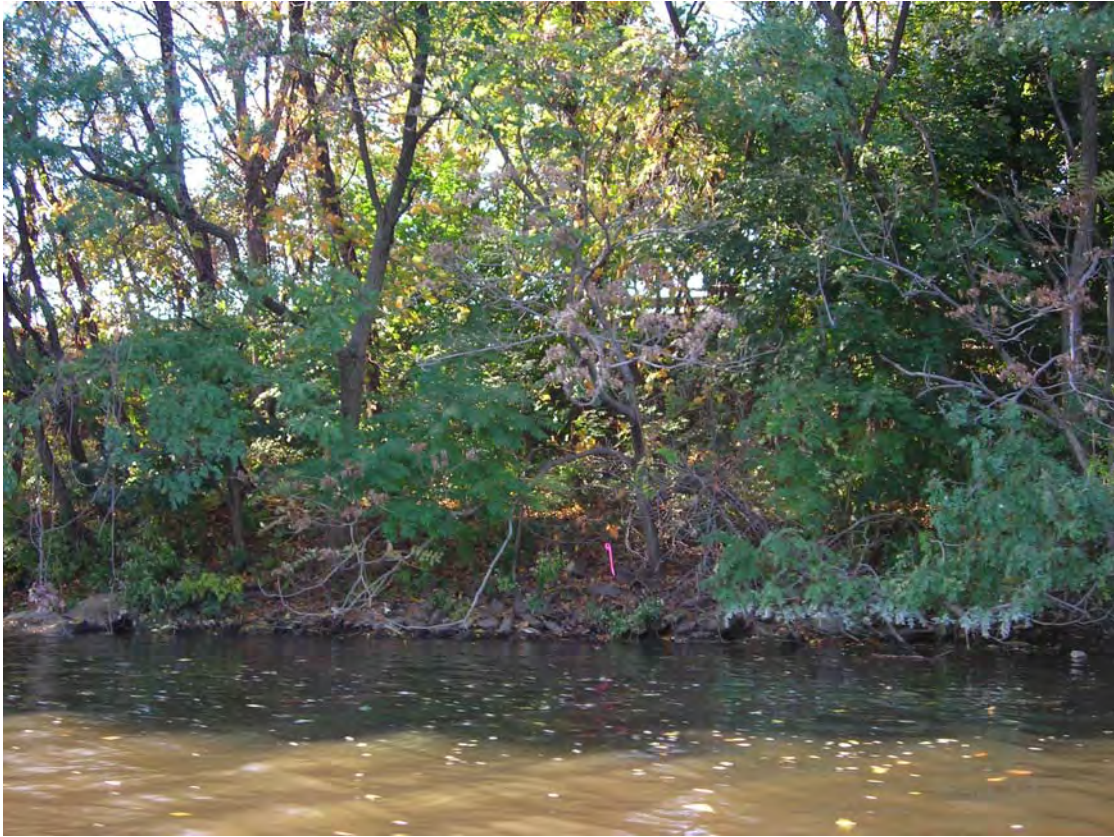
Photo 5. Shoreline and vegetation at RM13.8; located on the west bank. Low hanging branches and fallen trees create good fish/benthic habitat.

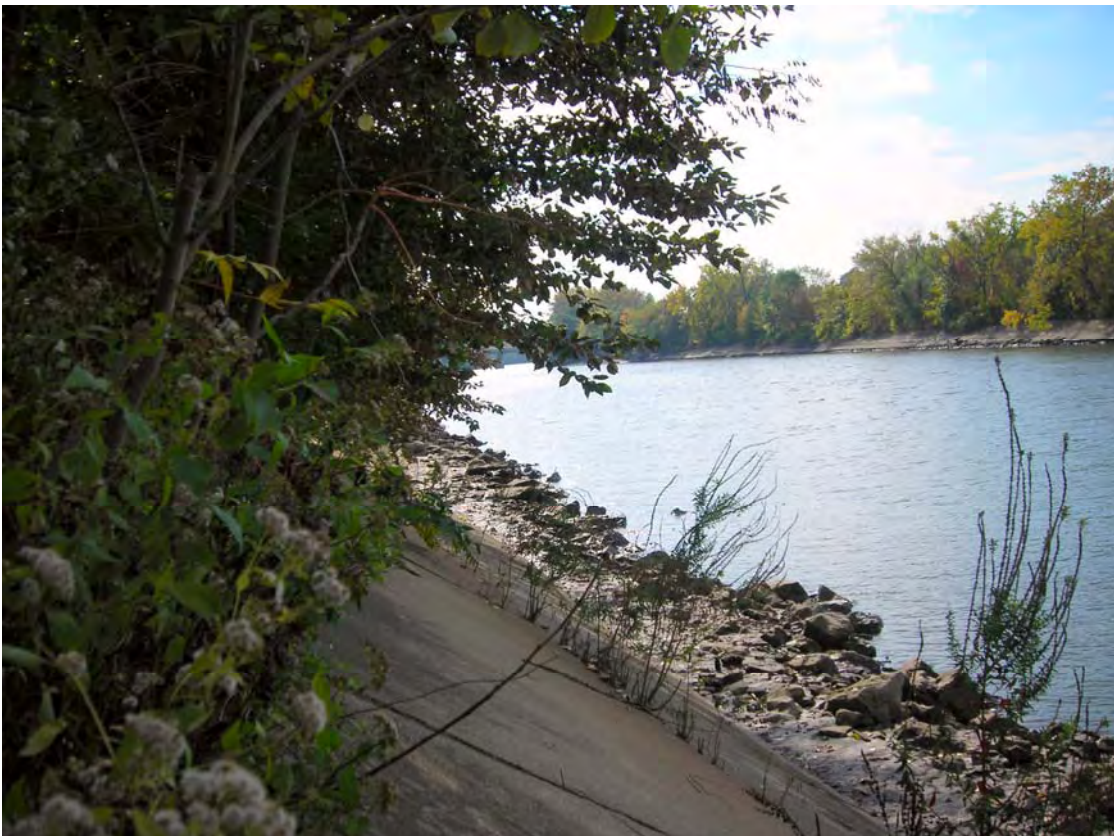
Photo 6. Concrete stabilization wall at RM13.6 (Memorial Park). Wall extends along the entire area sampled.

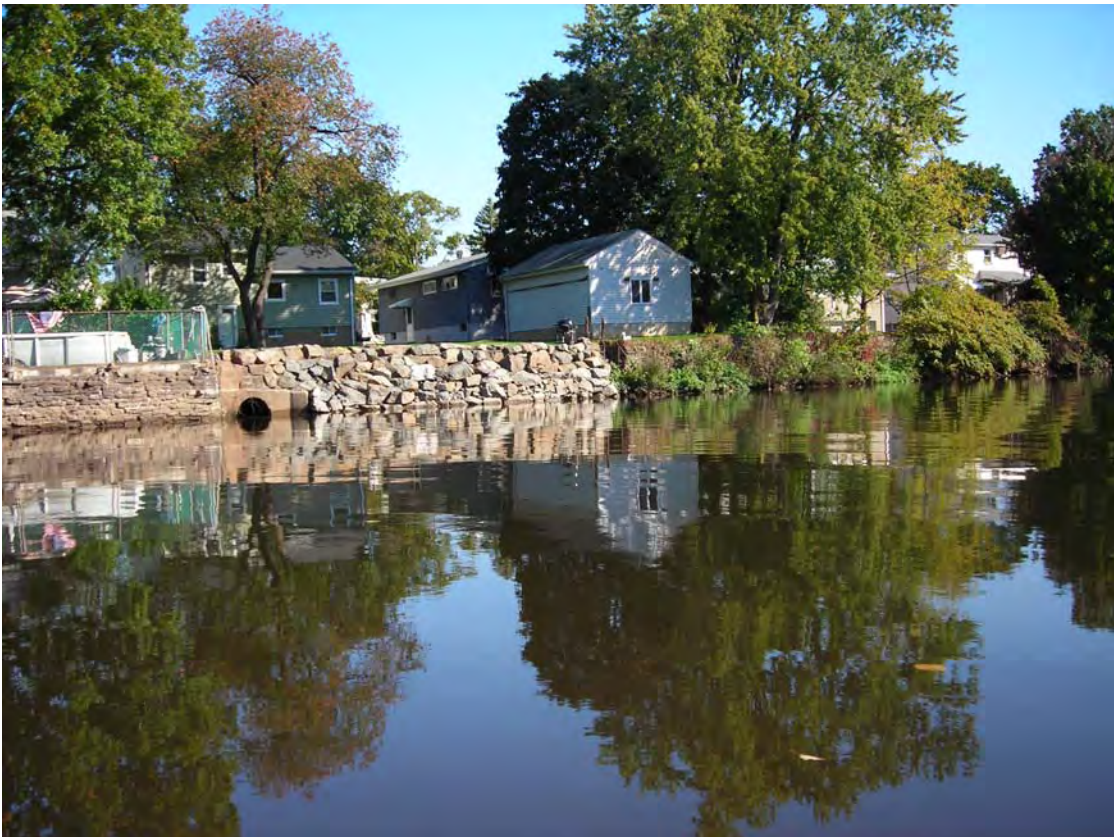
Photo 8. Most of the shoreline along RM12.8 consists of concrete or stone walls bordering residential areas.

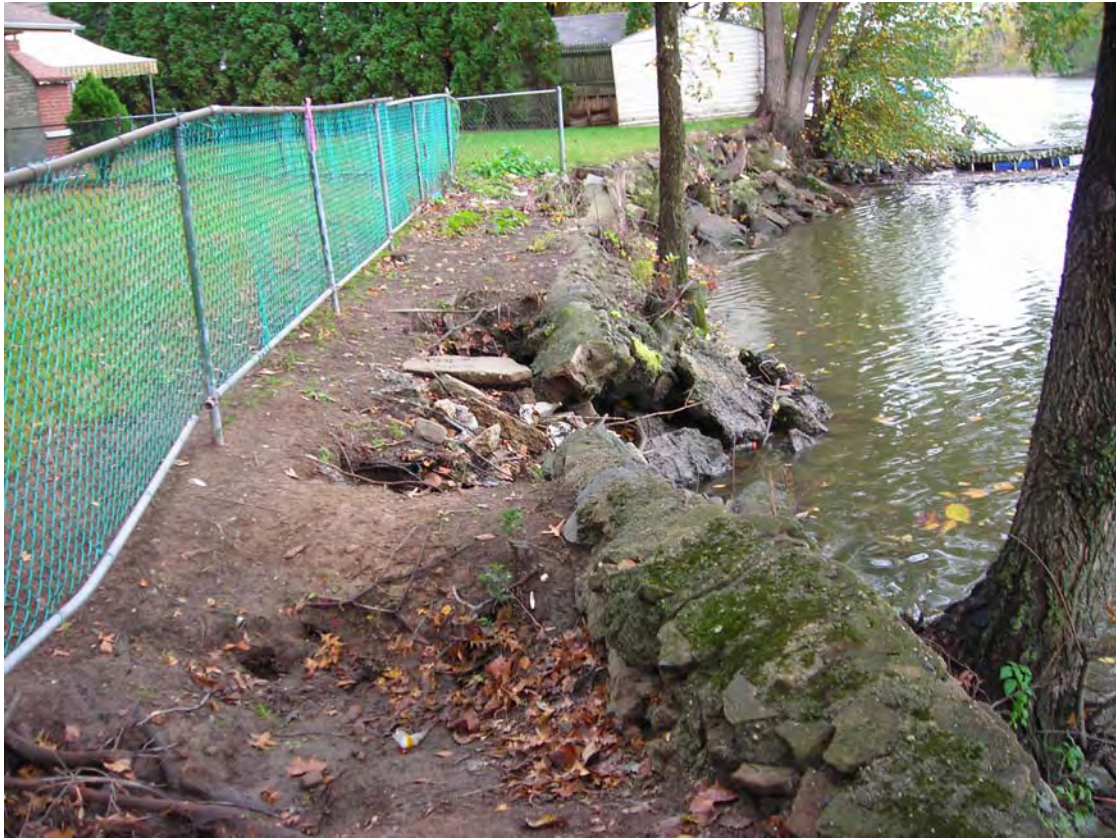
Photo 11. Retaining wall along RM12.3 (Van Winkle Park) crumbling in several places.

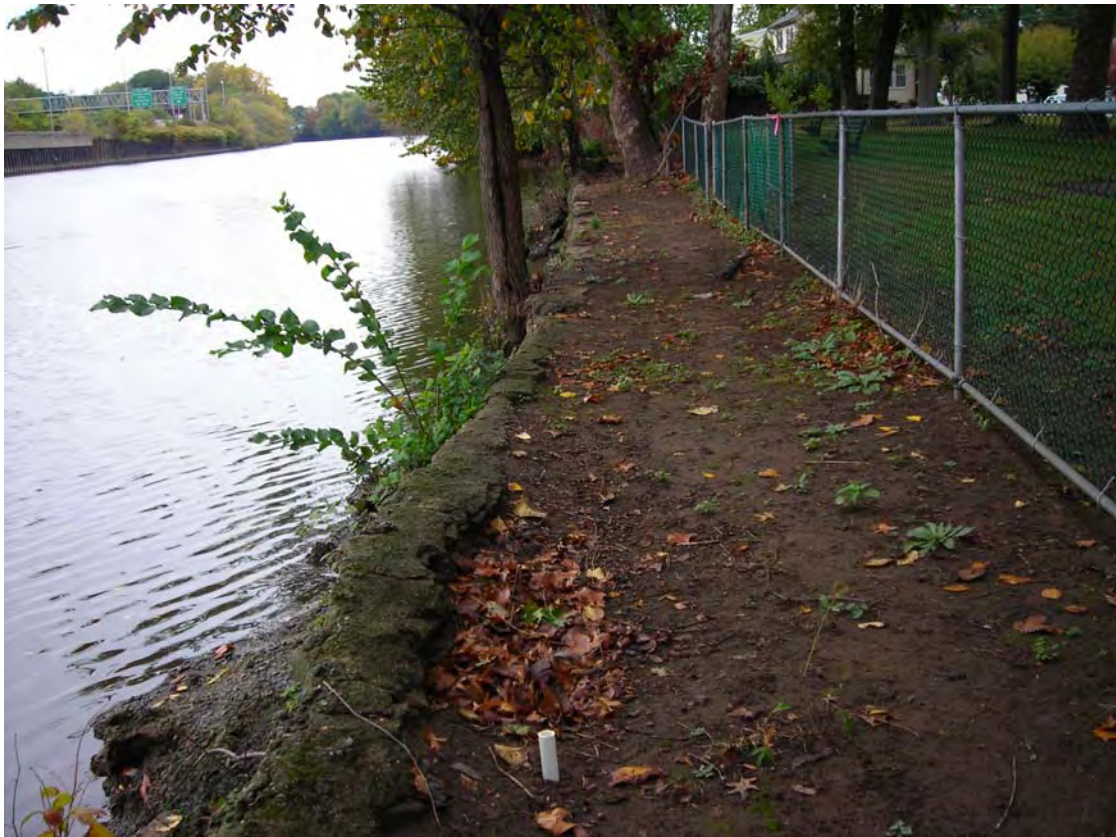
Photo 12. Shows lack of riparian vegetation at RM12.3 (Van Winkle Park).

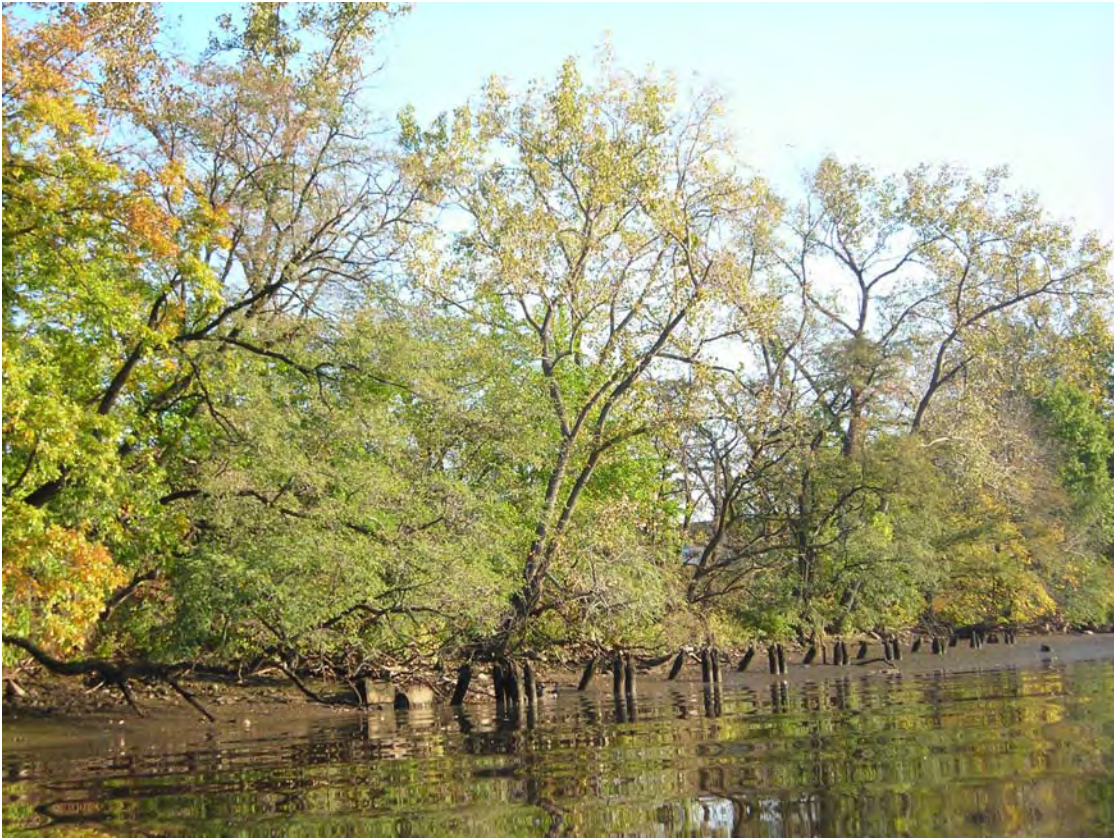
Photo 15. Pilings observed along the shoreline of RM11.6.

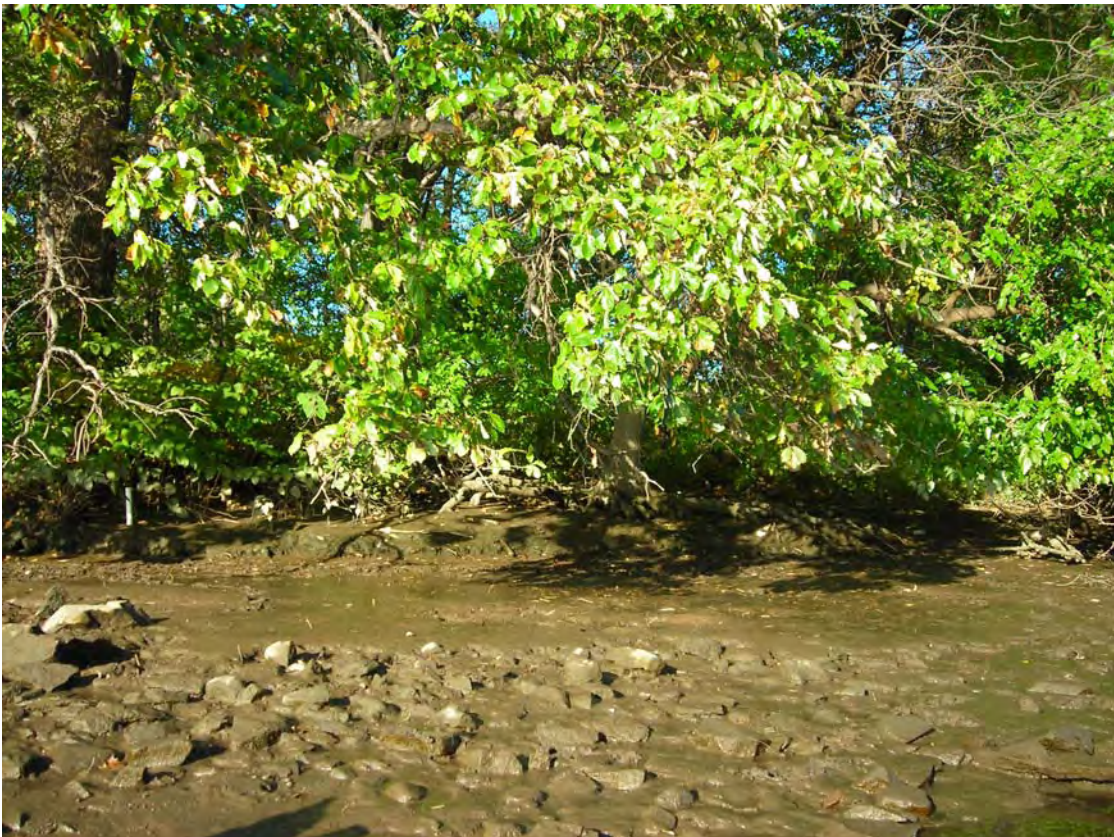
Photo 16. Mudflat at RM11.6 exposed at low tide.

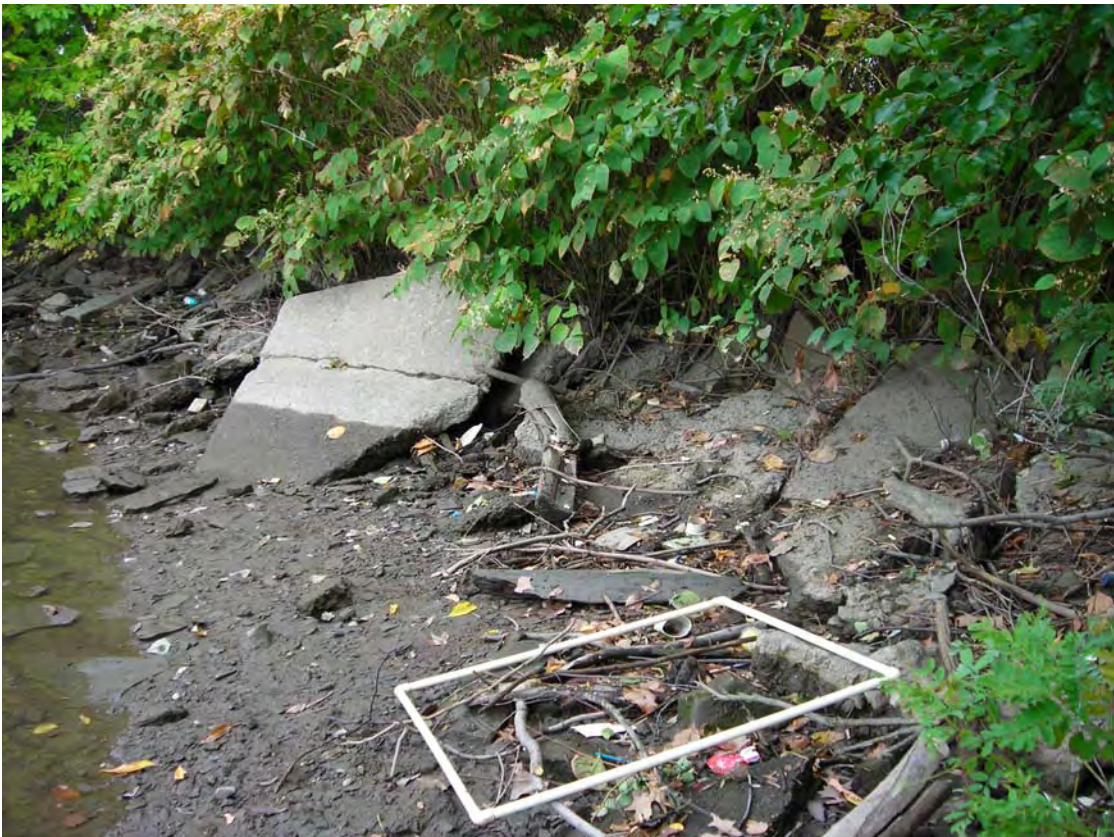
Photo 20. View of shoreline and dense Japanese knotweed along the northern portion of RM10.3 (Riverside County Park).

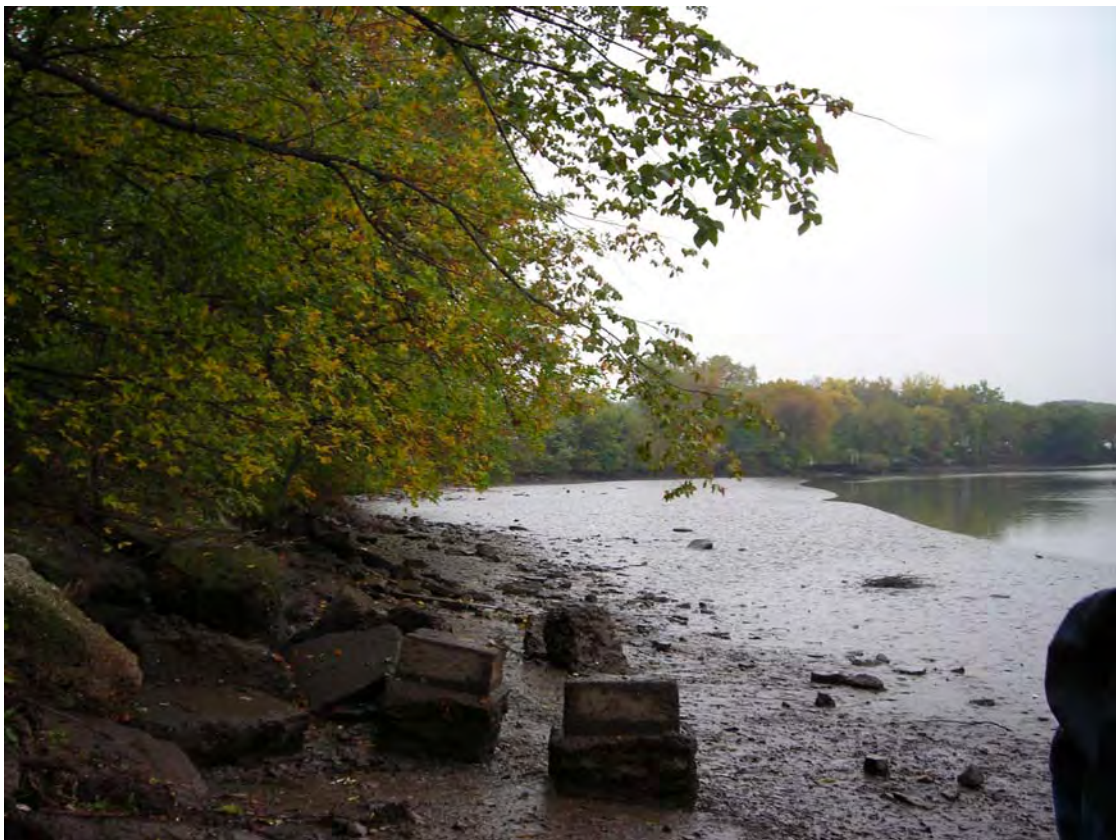
Photo 22. View of shoreline at RM9.9 (Riverside County Park). Also visible in photo is the large mudflat that exists at this location.

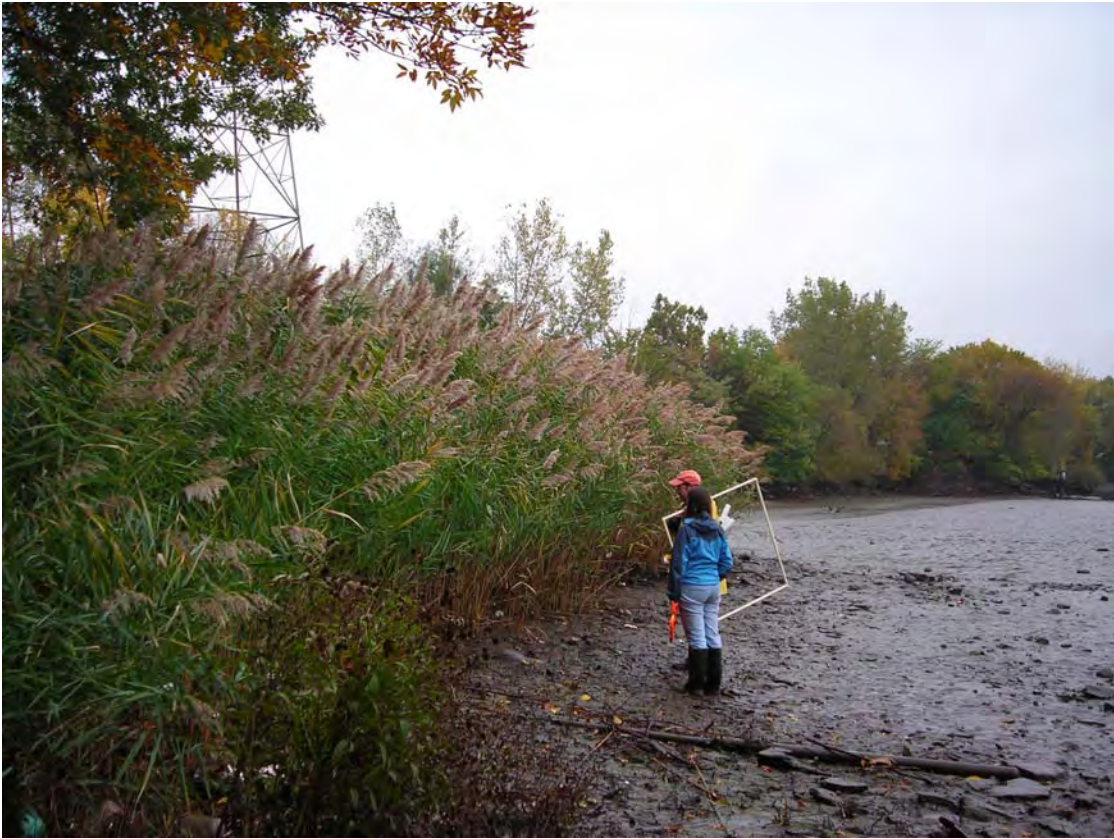
Photo 23. Large stand of *Phragmites australis* at the south end of RM9.9 (Riverside County Park).

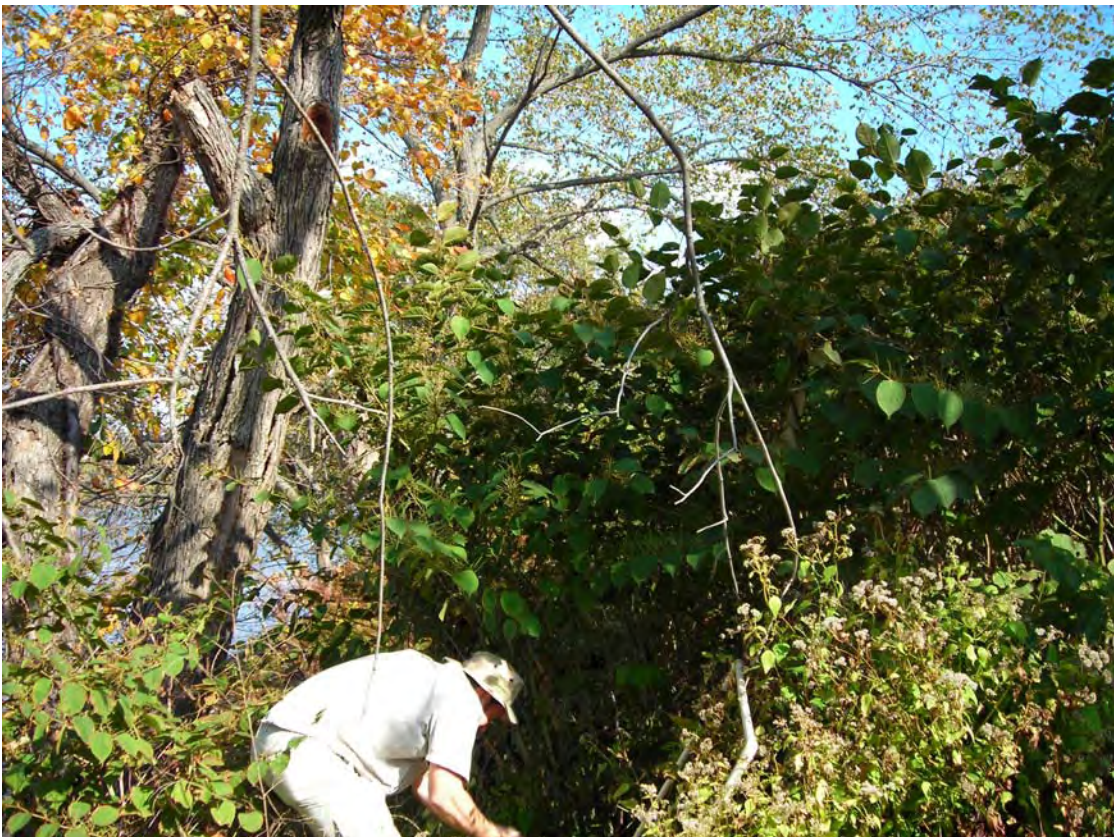
Photo 26. Vegetation at RM7.7East (Kearny Riverbank Park), half of the site was densely covered with Japanese knotweed, the other half had more native herbaceous vegetation.

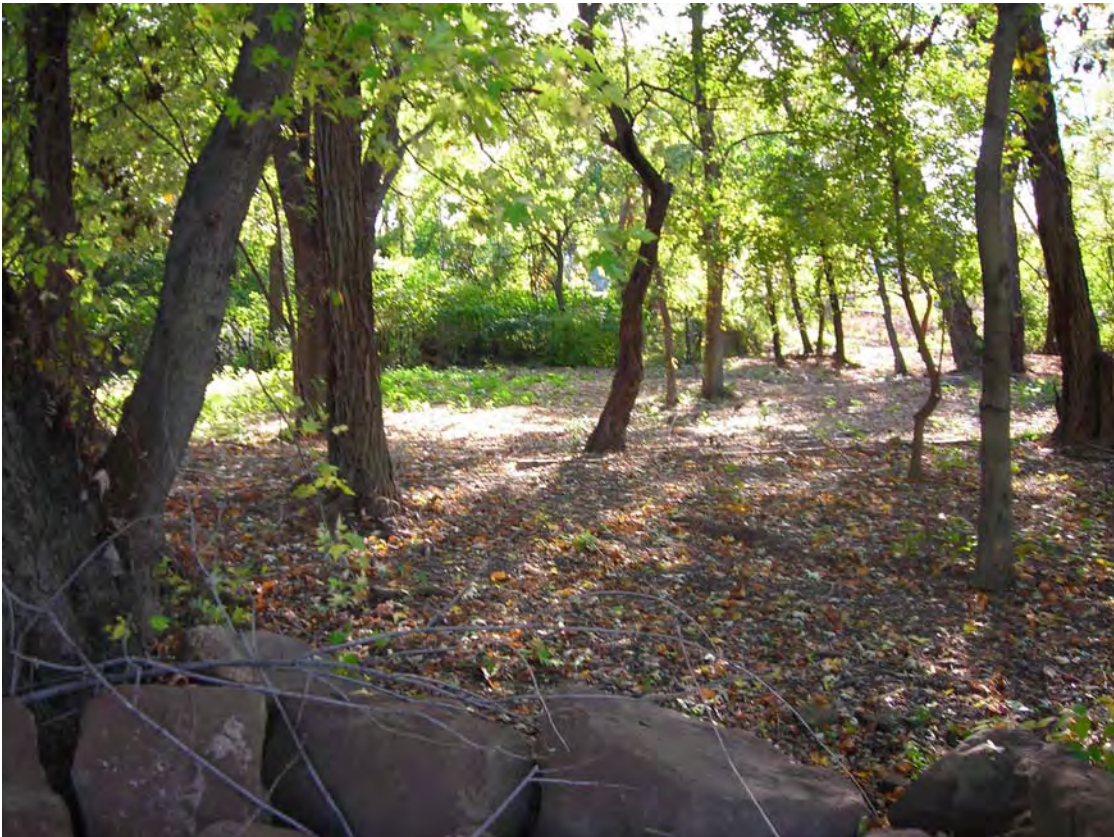
Photo 28. RM17.6 – Dundee Island Park. Most of the site appears to have been recently cleared, except for the larger trees.

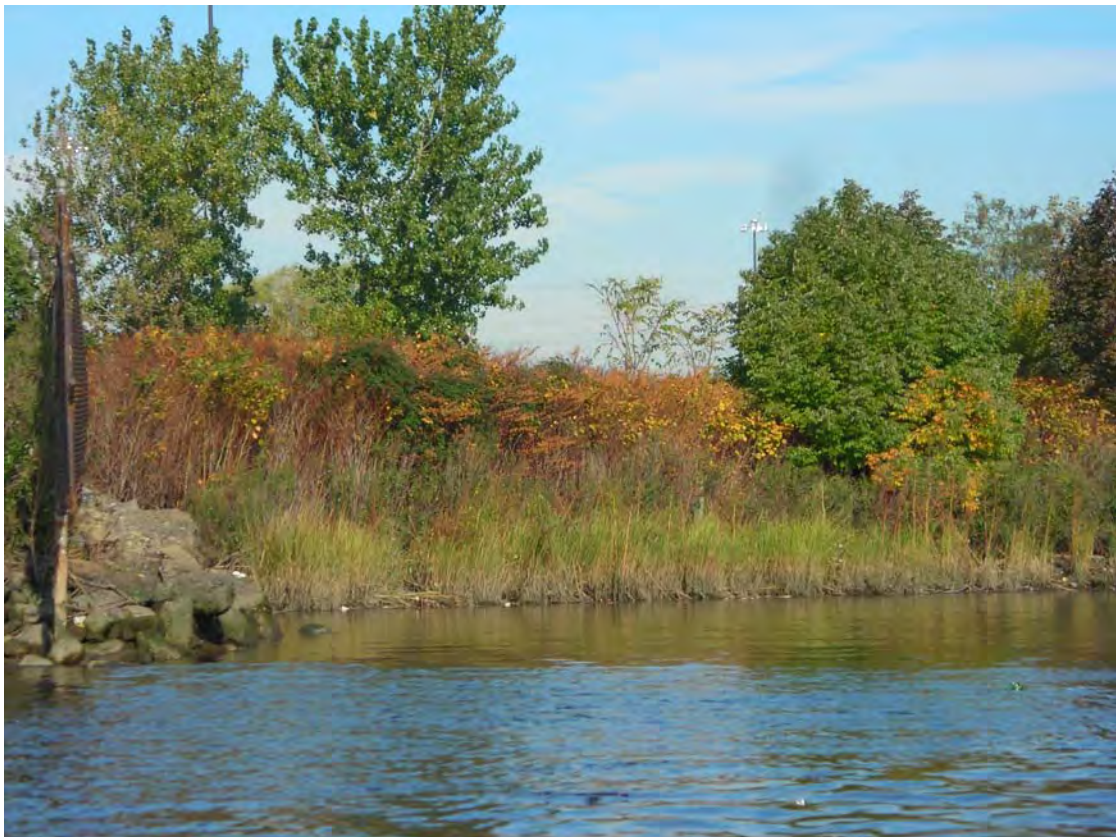
Photo 34. RM3.8 – Wetland sampled across from Minish Park.
Note *Spartina alterniflora* growing below the high tide line.

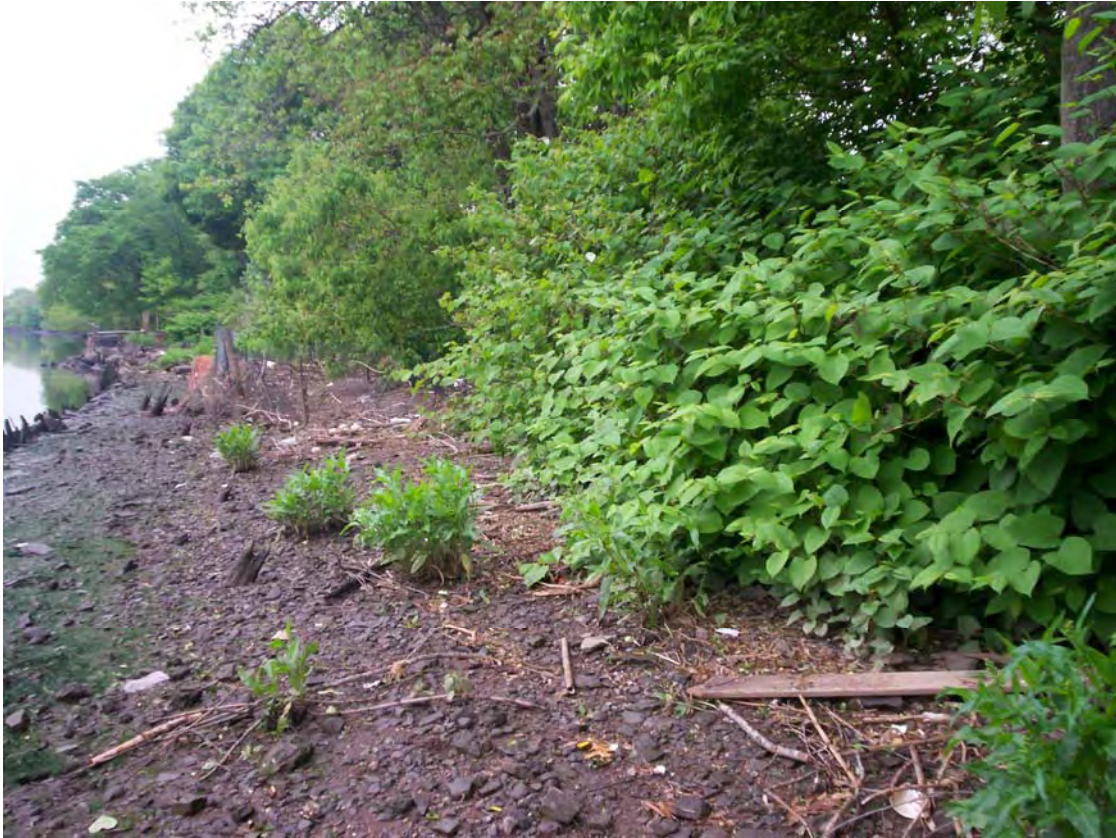
Photo 37. RM7.1 – Kearny Boat Ramp Module. Dense Japanese knotweed in the riparian zone. Sparse vegetation below the high tide line, including *Polygonum hydropiperoides*.

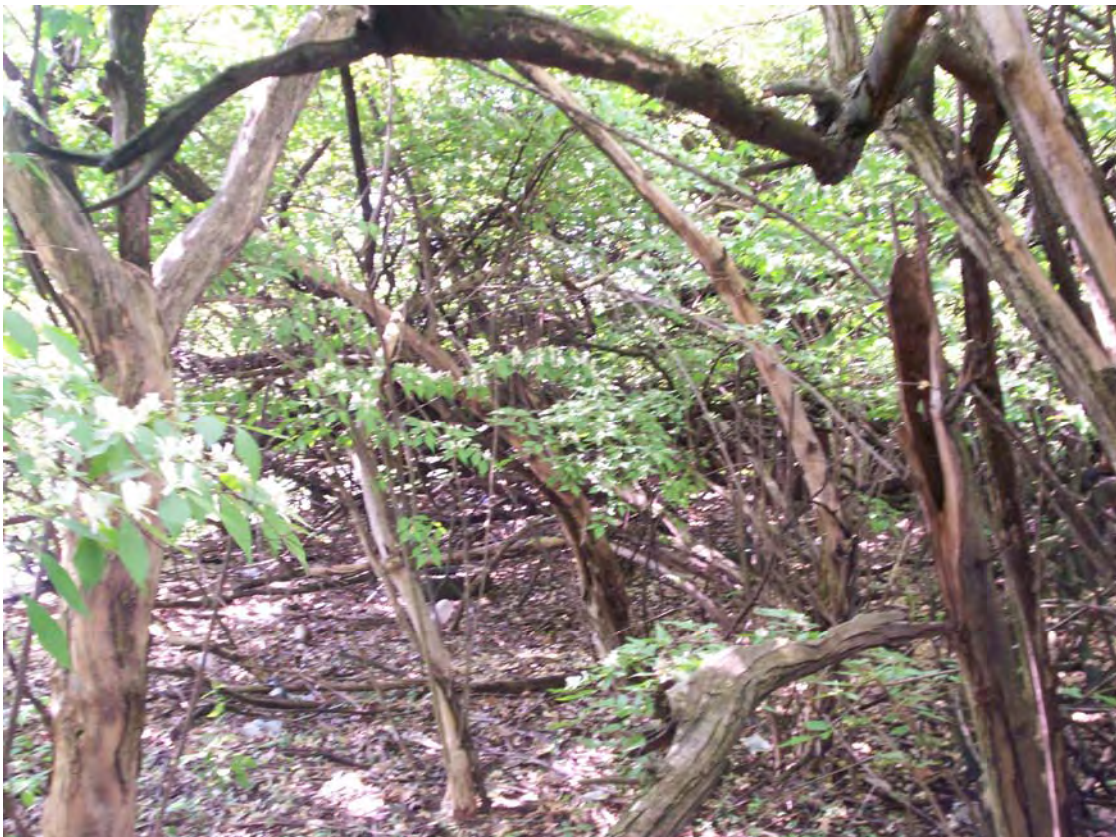
Photo 38. RM 9.7 – Stonewall Module. Parts of this site consist of dense shrub cover of non-native honeysuckle.

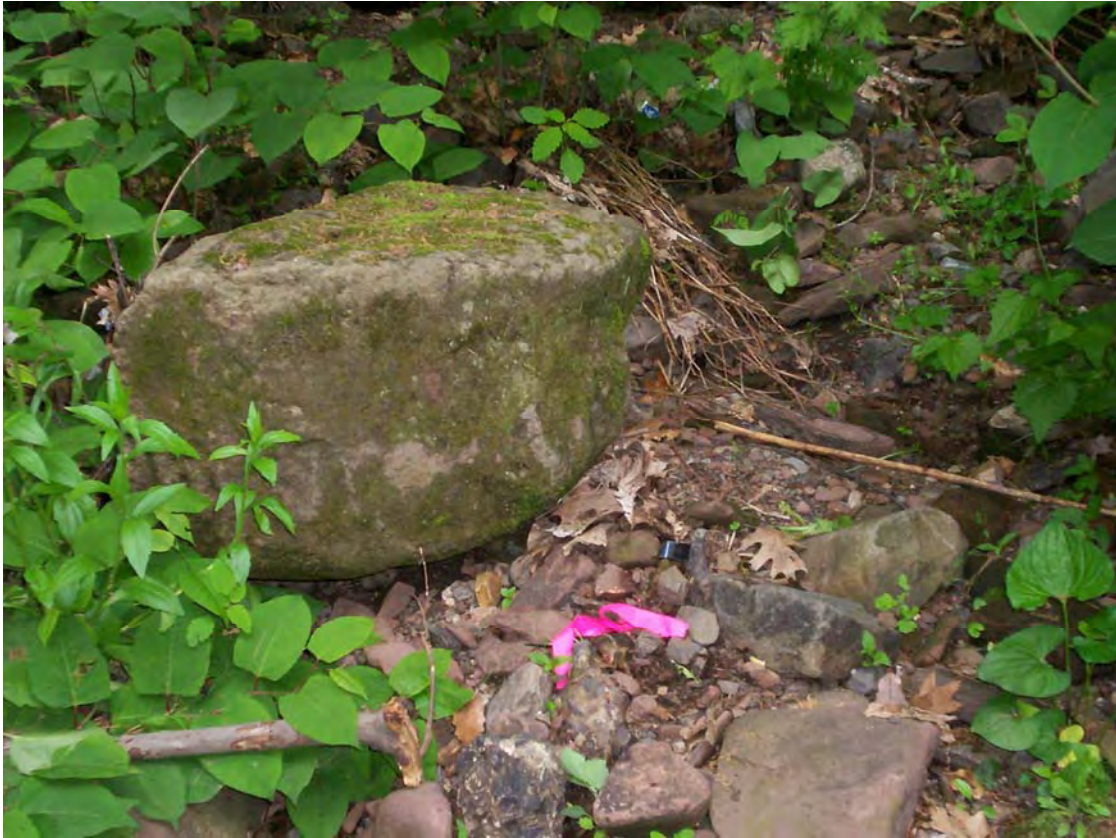
Photo 41. SR5 – Toney's Brook tributary site. Herbaceous cover dominated by Japanese knotweed, also *Impatiens capensis* and *Eupatorium rugosum*.

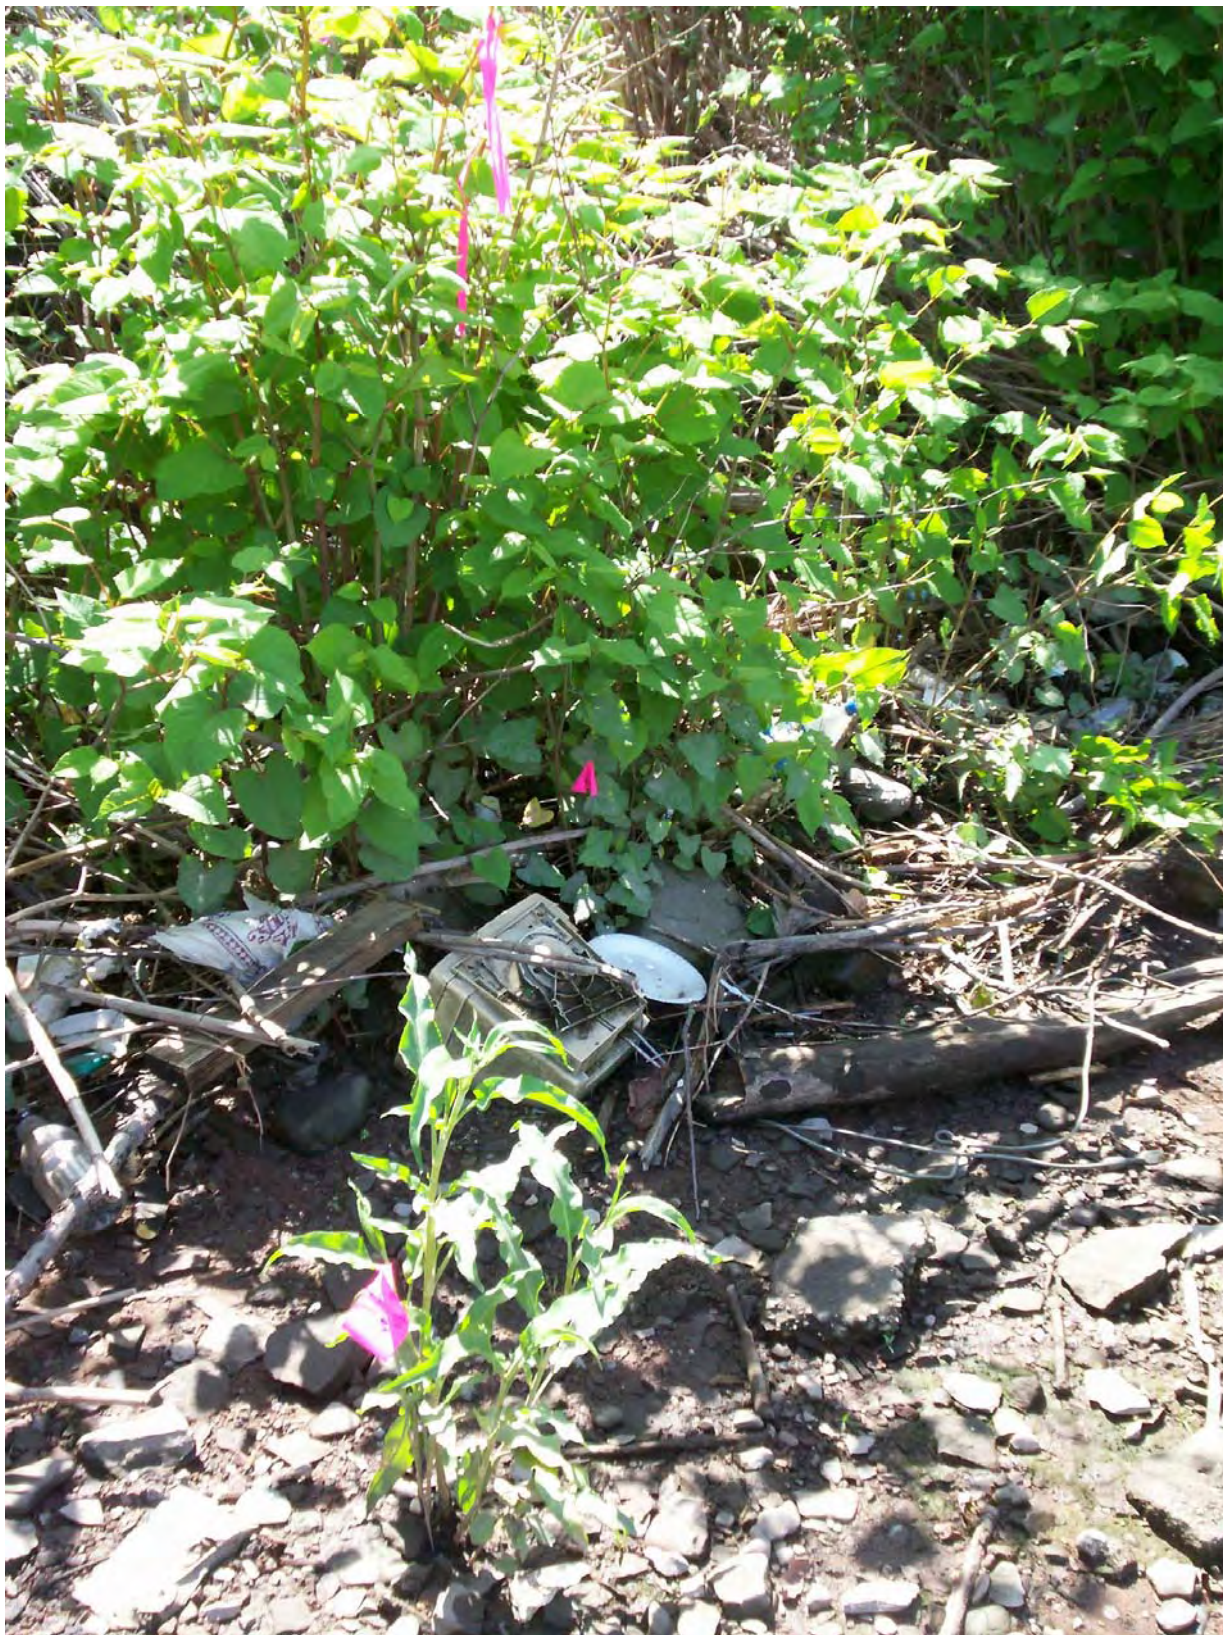
Photo 1. RM7.7 Bio-benchmark studies measuring lowest elevation of vegetation and lowest elevation of invasive species growth.

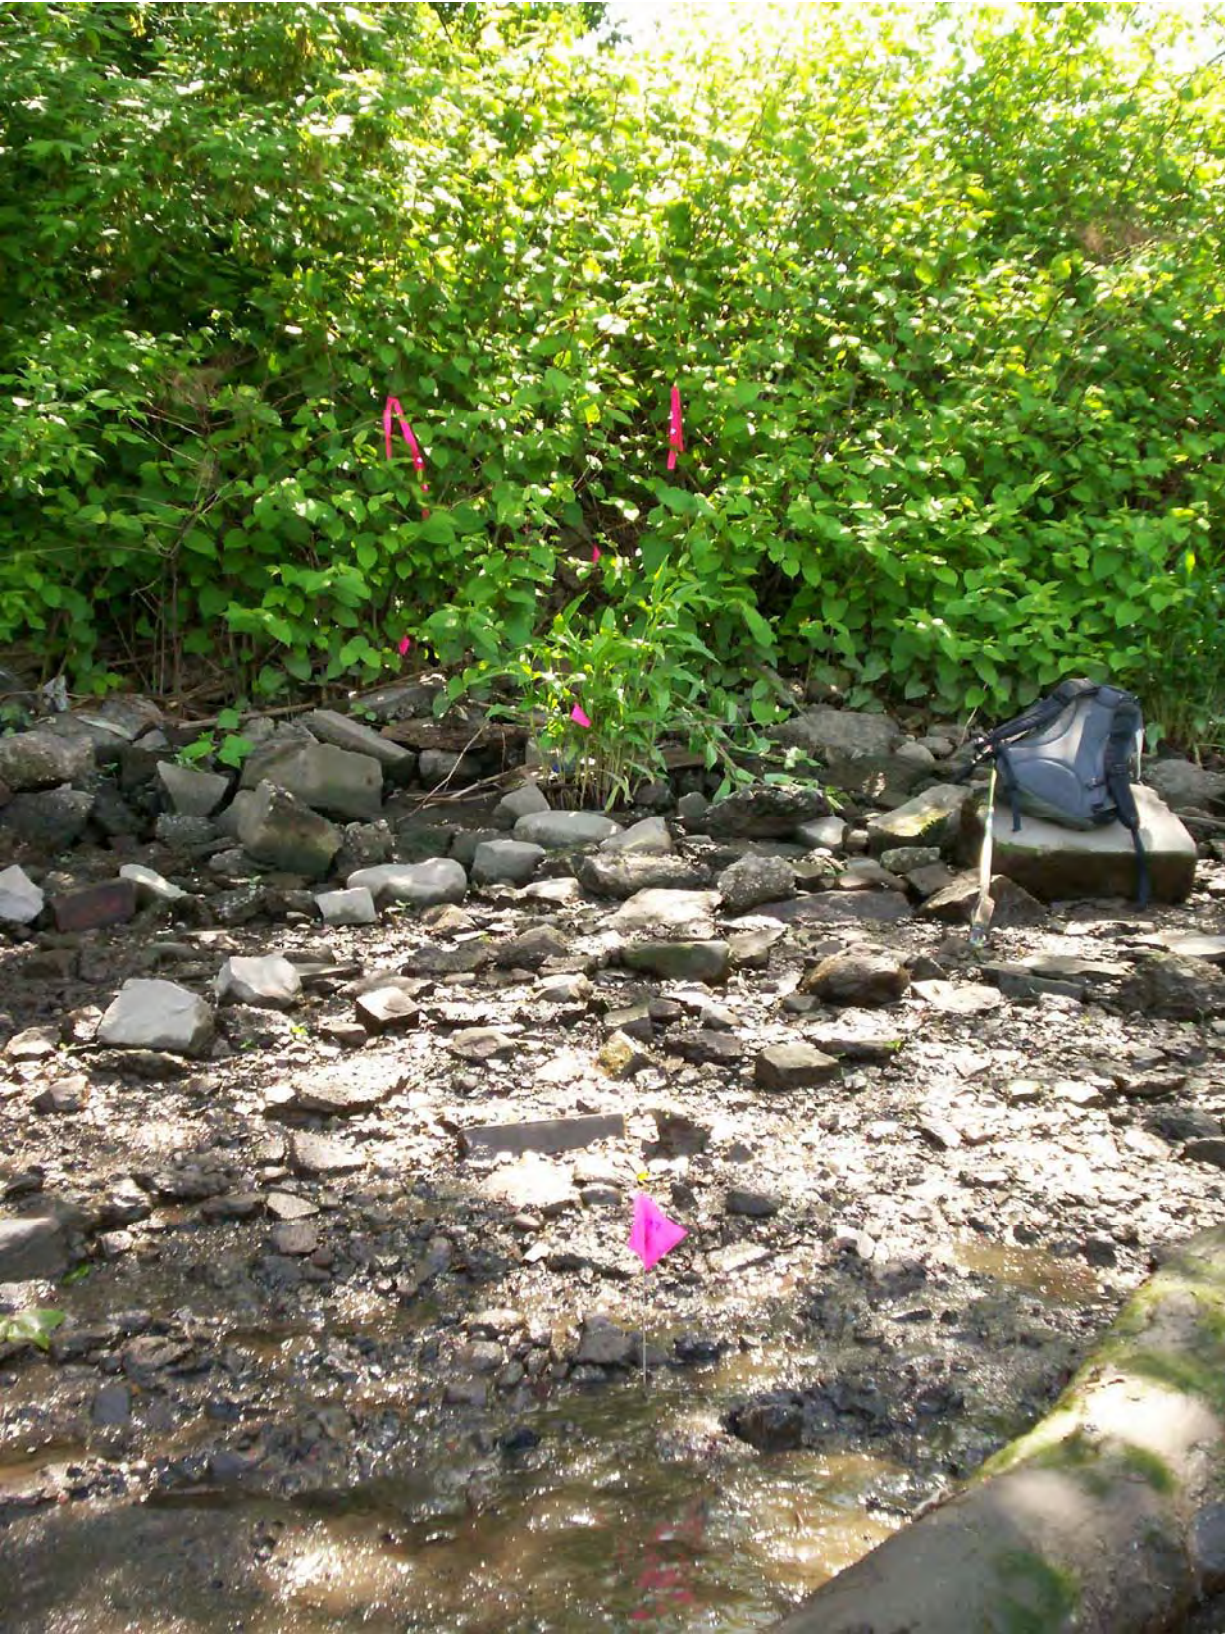
Photo 2. RM7.7 Second bio-benchmark studies location measuring lowest elevation of vegetation, lowest elevation of invasive species growth, and location of unvegetated mudflat.

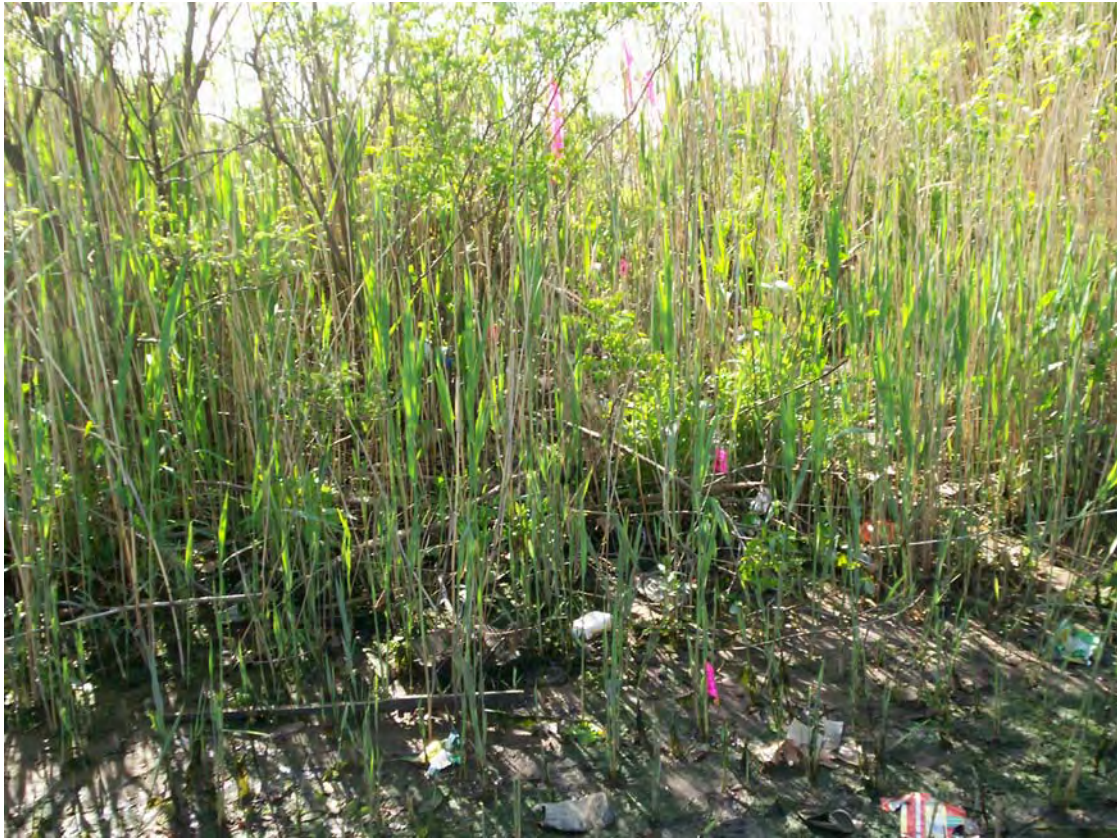
Photo 3. RM10.9 Bio-benchmark studies measuring lowest elevation of vegetation and lowest elevation of invasive species growth.
