Lower Passaic River Restoration Project

Vegetation Sampling, Wetland Delineation, and Bio-Benchmark Report

December 2008

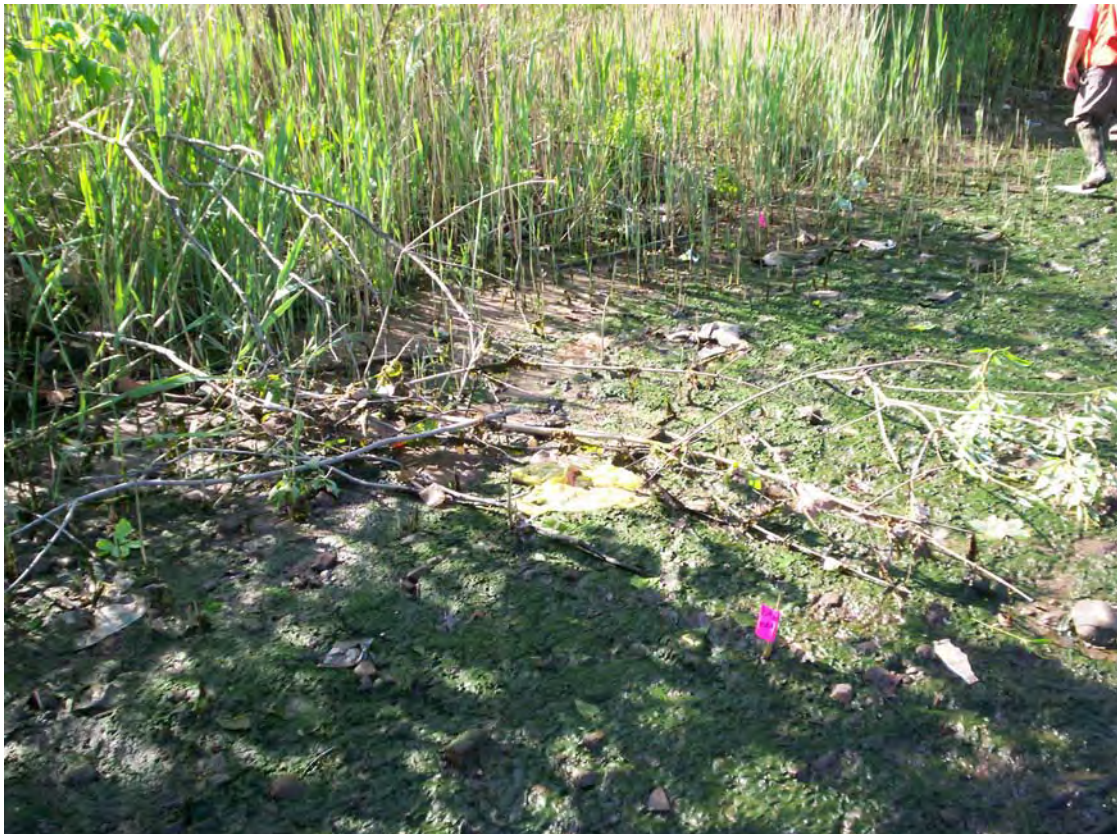
Photo 4. RM10.9 Second bio-benchmark studies location measuring lowest elevation of vegetation, lowest elevation of invasive species growth, and location of unvegetated mudflat.

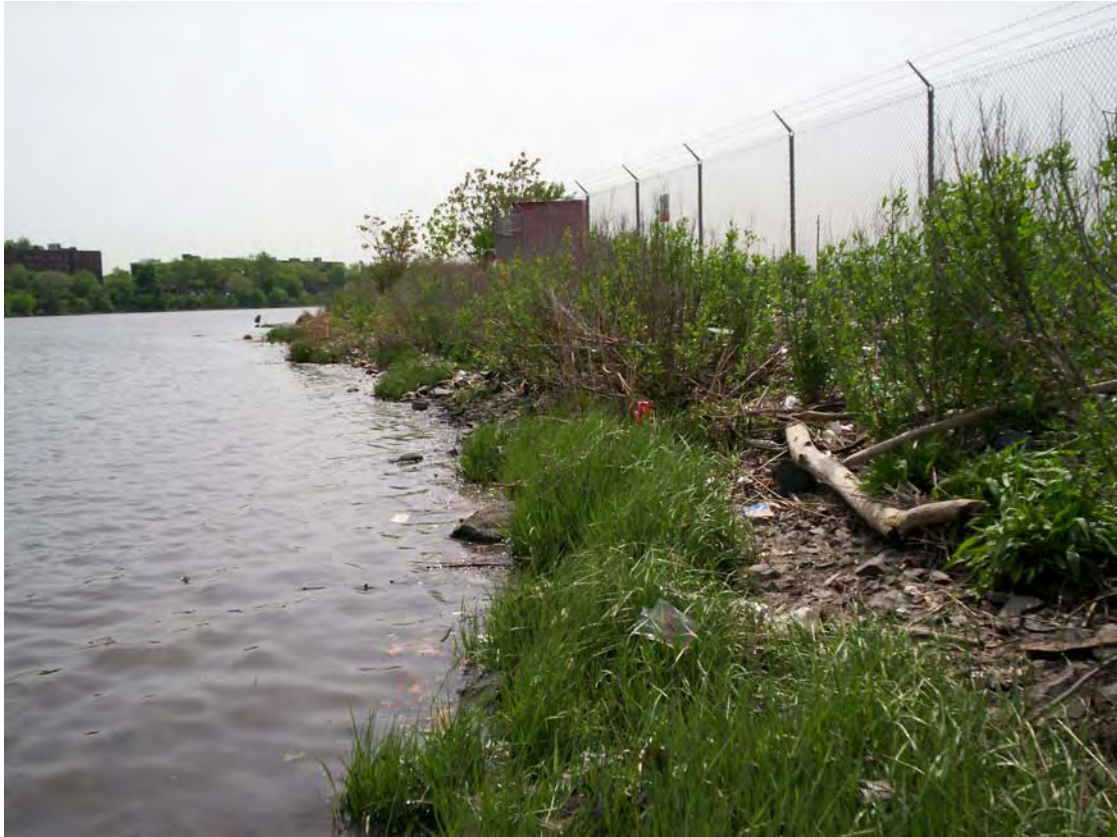
Photo 5. Location of wetland delineation conducted at the Harrison Wetland (RM 3.9).

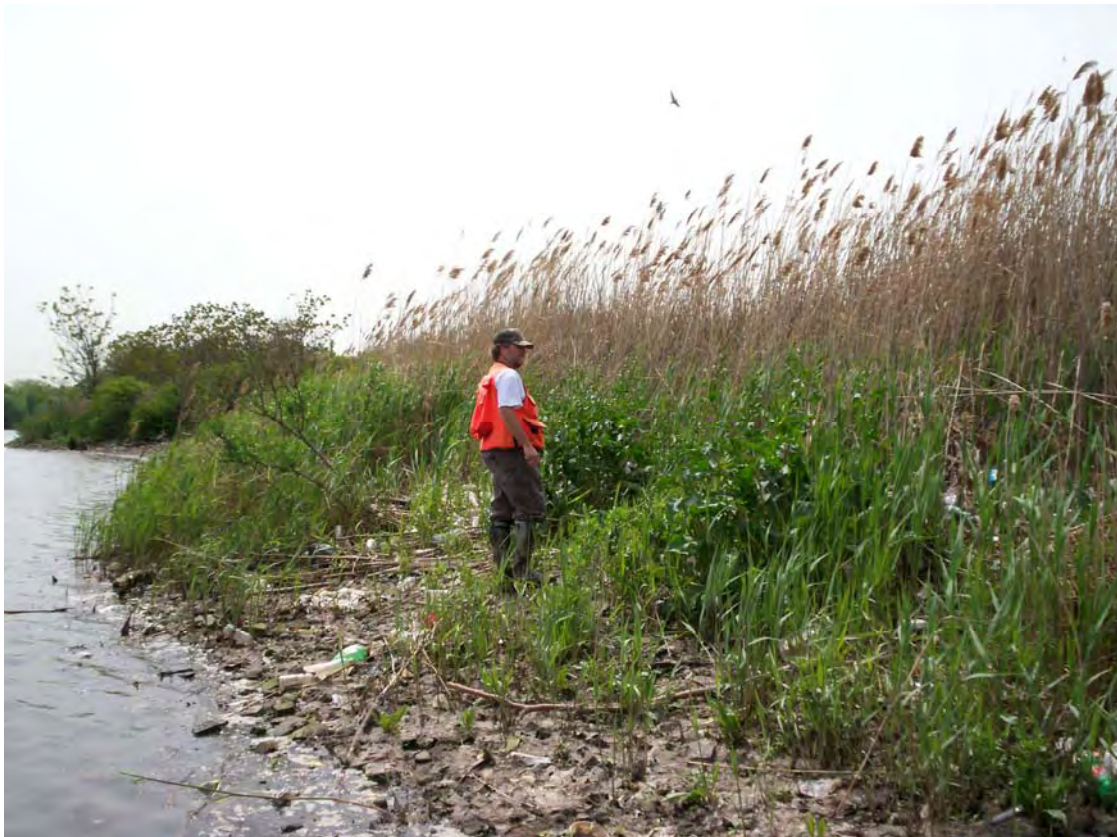
Photo 6. Location of wetland delineation conducted at the Harrison Wetland (RM 3.9).

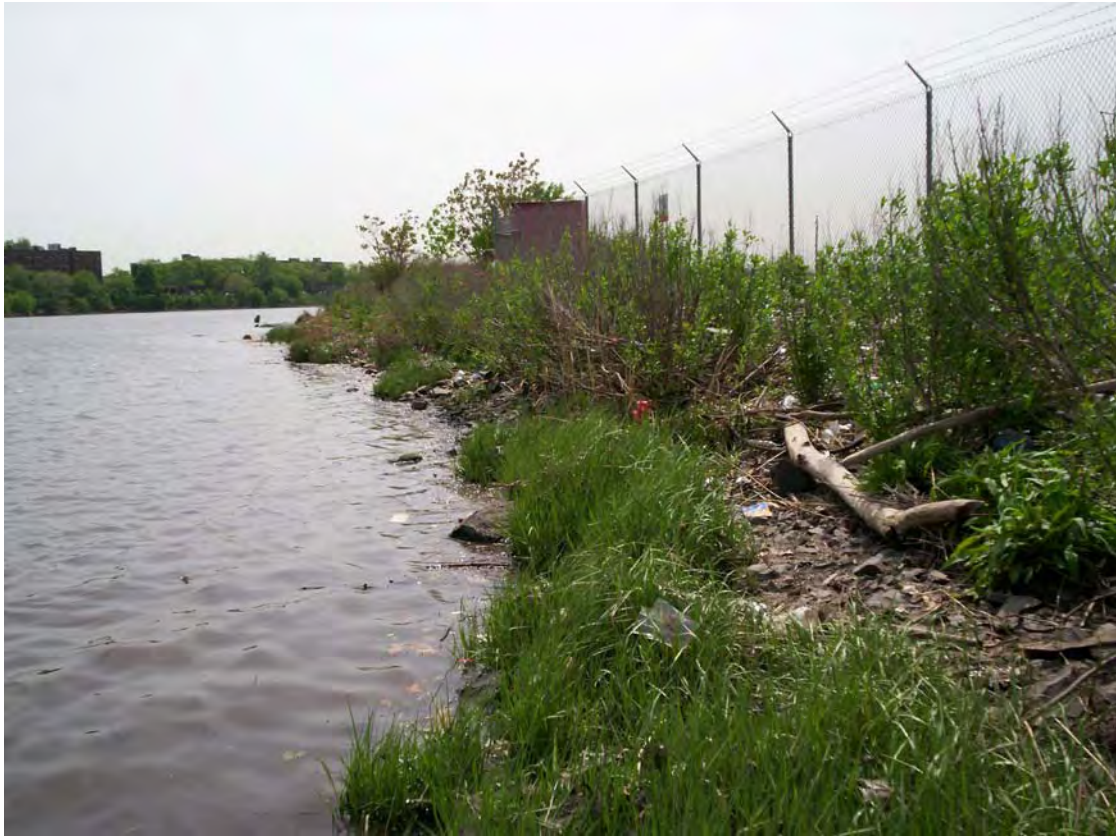
Photo 5. Harrison Wetland Reference Site (RM3.9);
note *Spartina alterniflora* growing at this site.

On October 31, 2002, bio-benchmark studies of the Minish Restoration Site and the Harrison Reference Wetland (River Mile 3.9) were conducted. Elevations of the existing sparse communities of *Spartina alterniflora* within the Joseph G. Minish Wetland Restoration Site and Harrison reference wetland were measured during the bio-benchmark studies. It should be noted that these communities are rare in the Lower Passaic River, and no *Spartina alterniflora* was observed at the Minish site during the 2007/2008 sampling efforts. Much of the shoreline of the Passaic River in this area consists of cement or sheetpile bulkheads. In areas where the shoreline is composed of rubble fill material (i.e. stone, brick, and cement), mudflats are exposed at low tide. The bio-benchmark data included the lowest and highest elevations of both *Spartina alterniflora* and *Phragmites australis* communities.

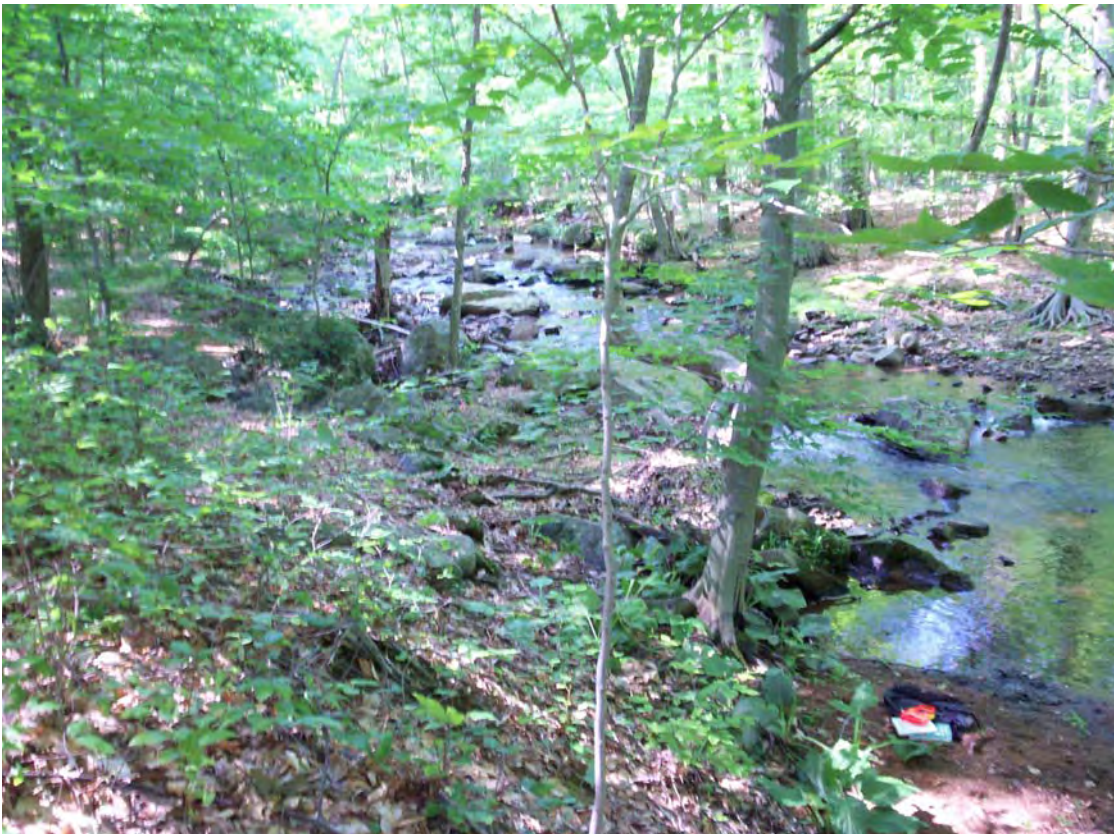
Photo 8. Scherman-Hoffman Wildlife Sanctuary; steep banks at this vegetation sampling plot; Native woody vegetation and sparse herbaceous layer including skunk cabbage.
