**Passaic River Post Dredging
Sediment Profile Imaging Survey,
December 2005**

January 2006
(Text Revised October 2006)

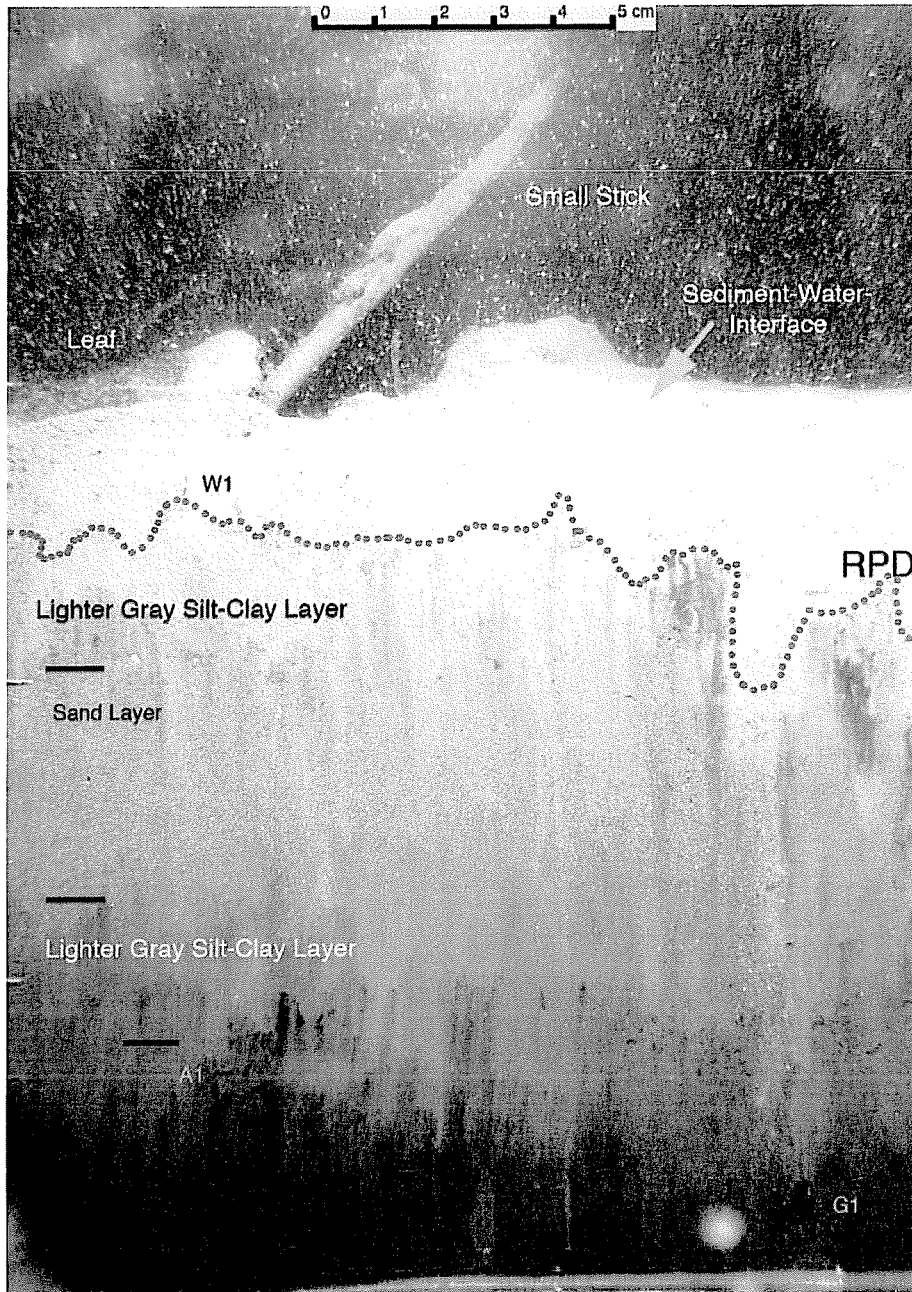
Figure 4. SPI from station A1-West, replicate 1 with labeled features. Light brown oxidized sediments at the surface had a thin layer of lighter gray sediments underneath than a fine-sand layer and another lighter gray layer. Sediment at the bottom of the image was darker gray. Red dotted line is the approximate location of the apparent color RPD layer. A1 is an anaerobic void and G1 is a gas-filled void. W1 appears to be a worm.

not intensely reducing. This is in accordance with the classical concept of RPD layer depth, which associates it with sediment color (Fenchel, 1969; Vismann, 1991). The RPD boundary was traced across the SPI by eye then the area of the image from the sediment-water-interface to the boundary was calculated and divided by the width of the image to get an estimate of the average RPD layer depth for the image. See Figure 4 for an example RPD layer trace.

Subsurface Features – These parameters included a wide variety of features (such as infaunal organisms, burrows, water filled voids, gas voids, or sediment layering) that reveal a great deal about physical and biological processes influencing the bottom. For example, habitats with grain-size layers or homogeneous color layers are generally dominated by physical processes while habitats with burrows, infaunal feeding voids, and/or visible infaunal organisms are generally dominated by biological processes (Rhoads and Germano, 1986; Diaz and Schaffner, 1988; Valente et al., 1992; Nilsson and Rosenberg, 2000). Subsurface features were visually evaluated from each image and compiled by type and frequency of occurrence. Up to five subsurface features in each image were labeled (see Appendix D images) and their distance from the sediment surface measured (see Appendix A). See Figure 4 for examples.

Grain-size layering occurred at stations A1-West and E1-East, also outside the sediment-coring grid (Figure 10). At A1-West replicate 1, a layer of lighter gray silt-clay overlaid a layer of fine-sand that overlaid another layer of lighter gray silt-clay. The other two replicate SPI at A1-West did not have sediment layering and were mostly brownish silt-clay (Figure 8). At station E1-East replicates 1 and 2 had a layer of medium-coarse-sand at the surface overlying silt-clay. Replicate 3 from E1-East was silt-clay at the surface with no indication of sandy sediment, but had a lighter gray color layer overlying a layer of dark colored detritus (Figure 9). At A3-West, the only other station outside the grid, sediments were almost completely brownish in color with no layering (Figure 8). The brownish color tones and uniform texture or fabric of the silt-clay sediments are both indications that the sediments have been recently deposited, likely from the dredging event.

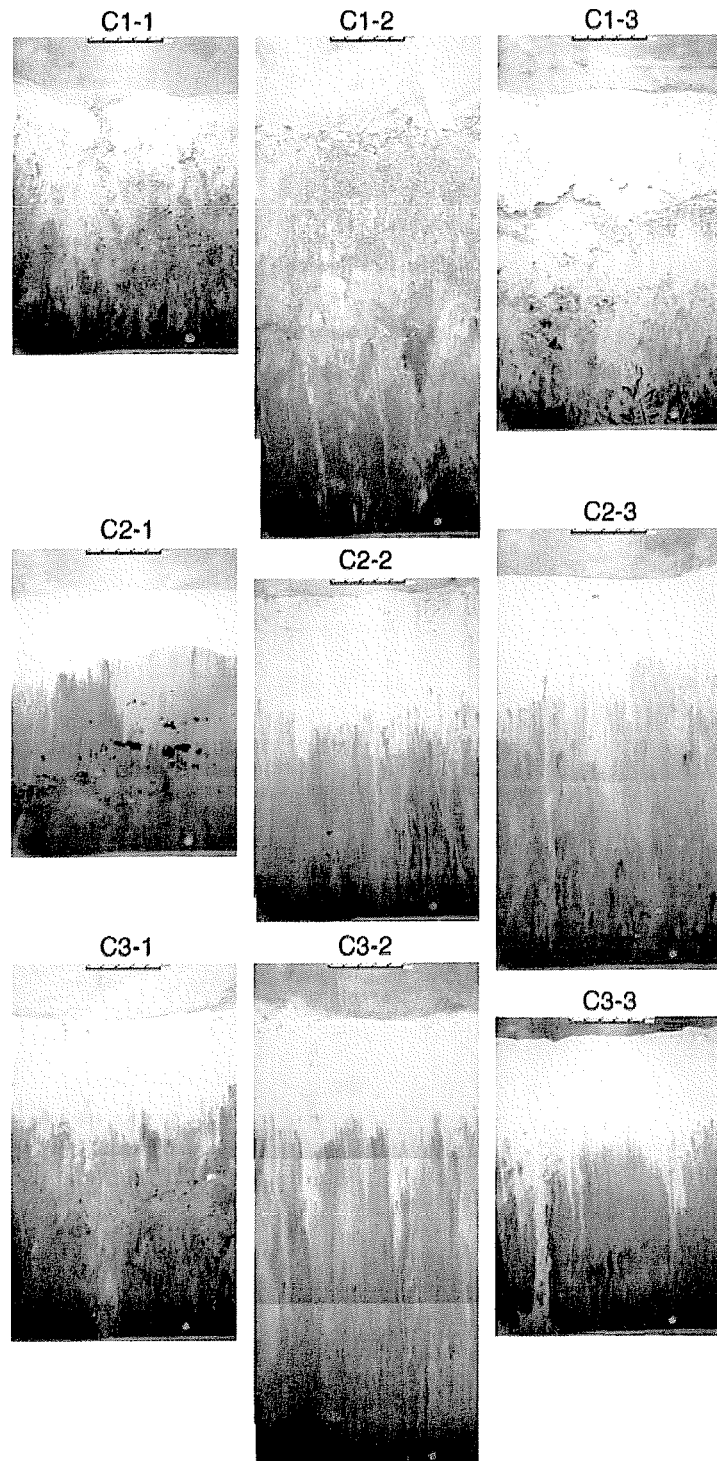
Figure 6. SPI replicates from stations C1, C2, and C3. A is anaerobic void, G is gas void, V is oxic void, and W is worm.

Physical processes appeared to dominate the study area with the sediment surfaces being unconsolidated silt-clay greater than 4 Phi at all stations except E1-East where a 6.8 cm layer of medium-coarse-sand (2 to 0 Phi) was present. There was no evidence of biological processes structuring surface sediments at any of the stations. Surface sediments were also unconsolidated, flocculent, and easily disturbed by the SPI frame (Figure 11). Even at E1-East with a medium-coarse-sand layer at the surface there was silt-clay mixed in the sandy layer (Figure 9). Bed roughness at all stations was due to uneven sediment surfaces and ranged from 0.7 cm at station C2 to 3.1 cm at station E3-East (Table 4, Figures 5 to 9).

The average station Organism Sediment Index (OSI) ranged from 0.7 at station D1-North (Figure 9) to 7.0 at stations A3, C1, C3, and A3-West (Figures 5, 6, and 8). However, the higher OSI values were determined mainly by the deeper RPD layer depths, which appeared to be physical in origin and likely related to the dredging, as stations A3, C1, and C3 were within the area dredged. There was no evidence that the deep RPD layers were related to bioturbation by infauna, which is the premise upon which the OSI scoring for RPD is based (Rhoads and Germano, 1986). This problem compromises the value of OSI in assessing relative benthic habitat conditions. The lowest values of the OSI were associated with stations that had both shallow RPD layer depths and gas voids (Table 4).

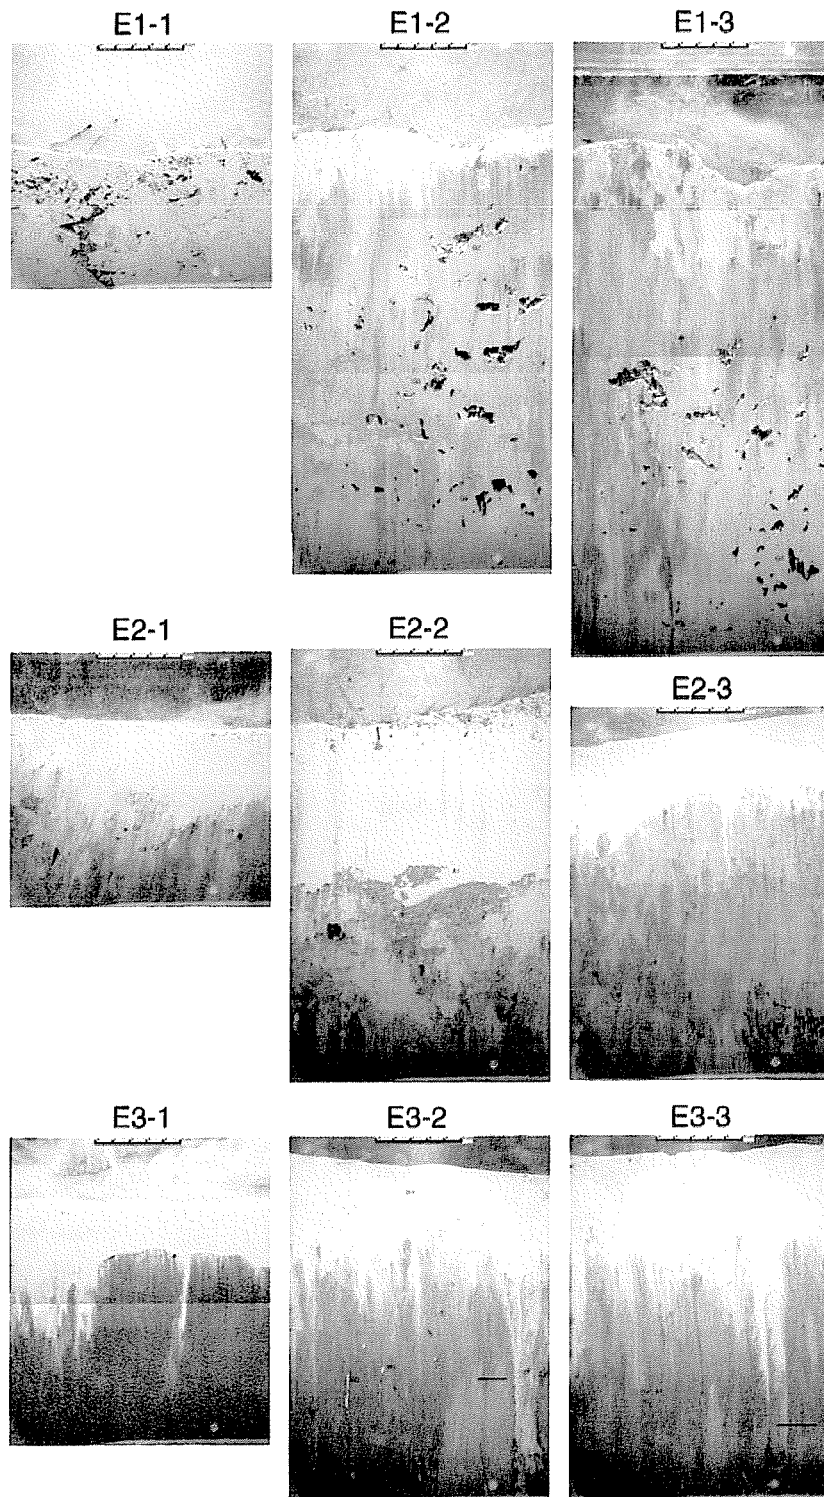
Figure 7. SPI replicates from stations E1, E2, and E3. A is anaerobic void, G is gas void, V is oxic void, and W is worm.

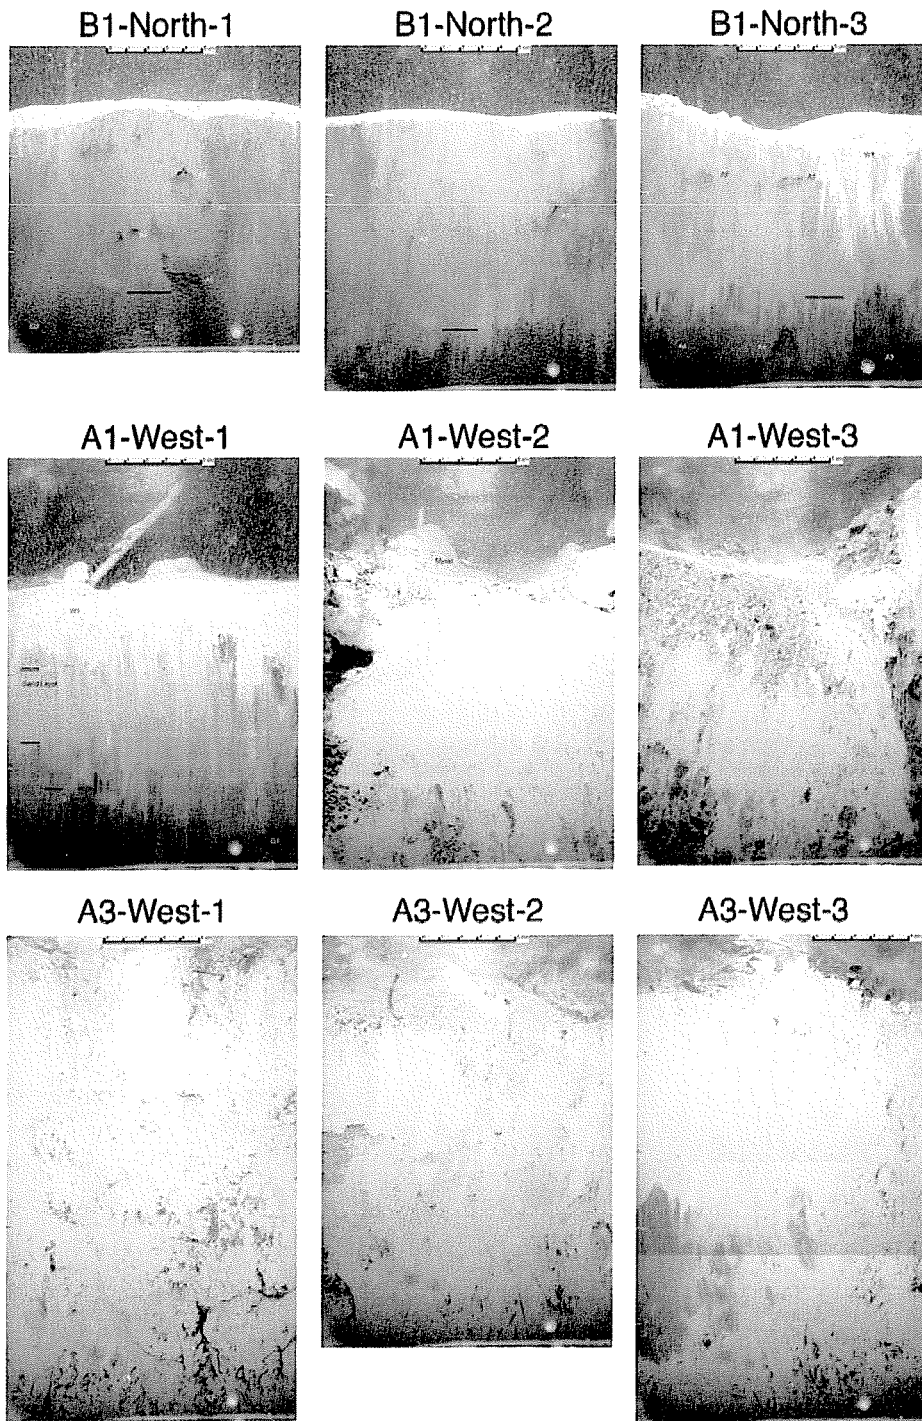
Figure 8. SPI replicates from stations B1-North, A1-West, and A3-West. A is anaerobic void, G is gas void, V is oxic void, and W is worm.

Color layering of sediments occurred at stations E3-East, B1-North, and D1-North all outside of the sediment-coring grid (Figure 10). At station D1-North, darker gray sediments overlaid lighter gray sediments (Figure 8). At station E3-East there were two color layers observed with the first a darker gray sediments over a second lighter gray sediment layer that was over darker gray

sediments (Figure 9). Layering at B1-West was lighter gray sediments over darker gray (Figure 8). The stations with the most uniform brownish silt-clay surface sediments were A2, C2, C3, E2, E3, and E3-East (Figures 5, 6, 7, and 9). At stations A1, A3, C1, E1, A1-West, A3-West, and E1-East the brownish silt-clay sediments also had small gray colored clasts included (Figures 5, 6, 7, 8, and 9), which could also be an indication of a recent major deposition event. The only stations to have brownish surface sediments that did not appear to be recently deposited were B1-North and D1-North (Figures 8 and 9).

Average station RPD layer depths ranged from 0.6 cm at station D1-North (Figure 9) to 10.4 cm at station A3-West (Figure 8). All of the RPD layers appeared to be associated with physical processes and not with biological processes. In silty-clay sediments physical diffusion limits oxygen penetration to <1 cm (Jørgensen and Revsbech, 1985). This was likely the case for stations D1-North and B1-North (Figures 7 and 8) where the shallower RPD layer depths were examples of diffusion-limited RPD layers. When the RPD layers in fine sediments are >1 cm, it is bioturbation by infauna (Rhoads, 1974; Aller and Aller, 1998) or major resuspension/deposition events (Don Rhoads, personal communication) that are responsible for oxygenating sediments. For all other stations, the >1 cm RPD layer depths appeared to be related to resuspension/deposition events as there was no evidence that the deeper RPD layer depths were related to biogenic activity of infauna. The most important factors determining the depth of the RPD layers at the 15 stations sampled appeared to be the recent dredging event that resuspended large quantities of muddy fine-grained sediments, subjected them to oxidation, and then subsequent rapid deposition into layers.

As expected after the dredging and removal of 2 to 3 feet of material from the pilot area, there was little evidence in the SPI that biological processes were important in structuring sediments at any of the 15 stations sampled. No tubes were observed at the sediment-water-interface and no active burrows were observed in the sediments. At about half of the stations what appeared to be infaunal organisms occurred (Table 4). Given the amount of detritus and leafs seen in the images, however, the organism-like structures may have been bits of detritus. The only mobile epifaunal organism observed was a single mysid shrimp at station A1-West replicate 2 swimming above the sediment-water-interface (Figure 8).

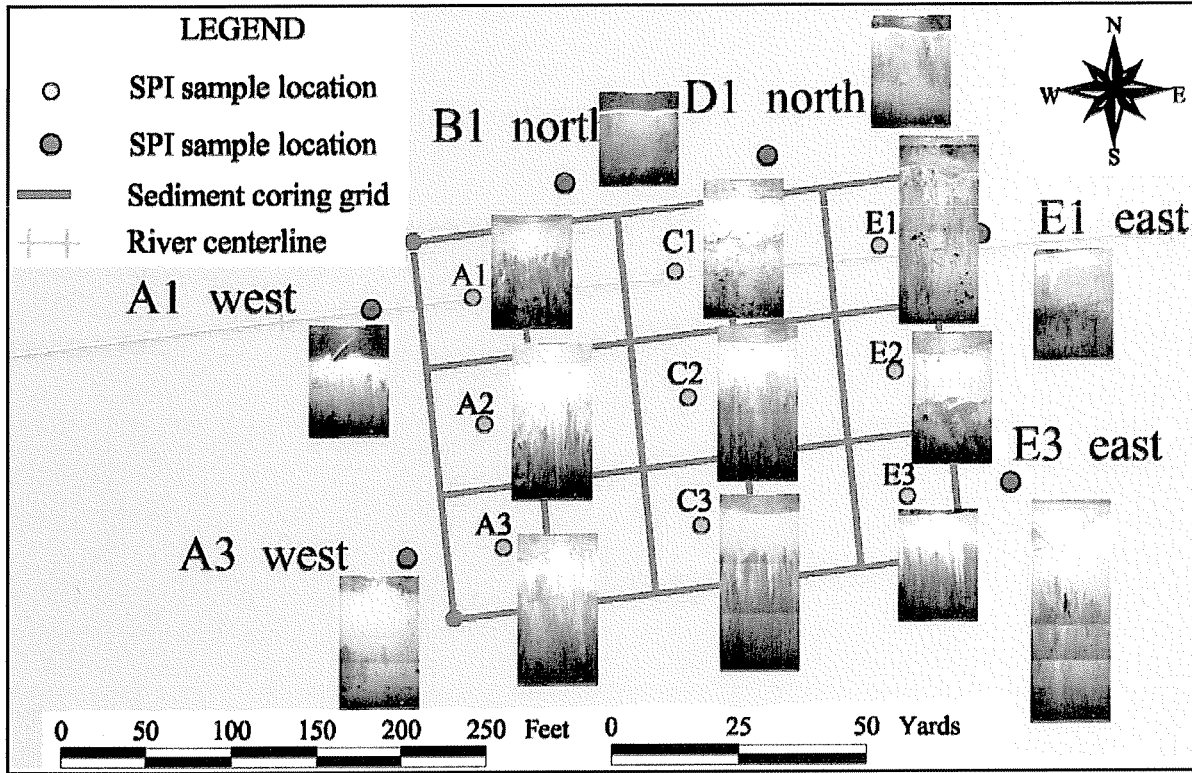
Figure 10. Mosaic of selected SPI arranged over the sediment-coring grid. Scale at top of images is 5 cm.

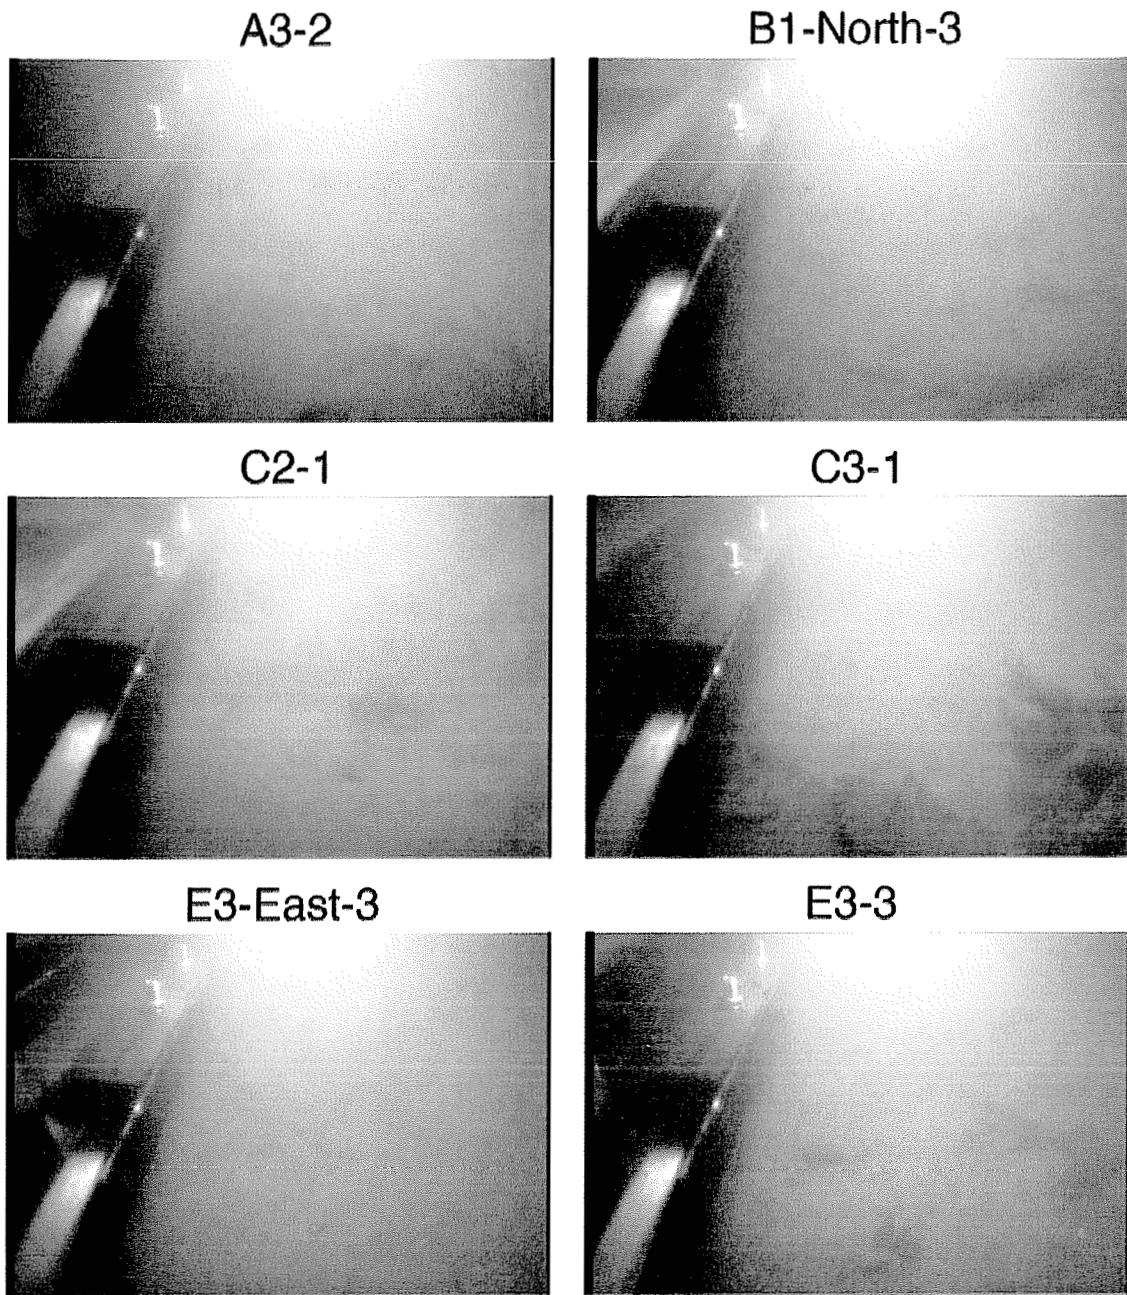
Figure 11. Frames extracted from the surface video showing the sediment surface in front of the profile camera prism. Sediment surfaces are unconsolidated with many leaves. Top of image is about 40 cm wide and bottom about 30. The prism wiper bar is to the left.

Because of high turbidity levels, the resolution from the surface video camera was poor. The bottom was observed with some clarity at only stations A3, C2, C3, E3, B1-North, and E3-East (Figure 11). The area viewed by the surface video was in front of the profile camera prism with the field of view being about 0.12 m² (30 by 40 cm). The video revealed that a strong ebb current was flowing during the collection of SPI.
