Pre-Dredging Monitoring Measurements at Mooring 1 for December 1-3, 2005

*Lower Passaic River Restoration Project*

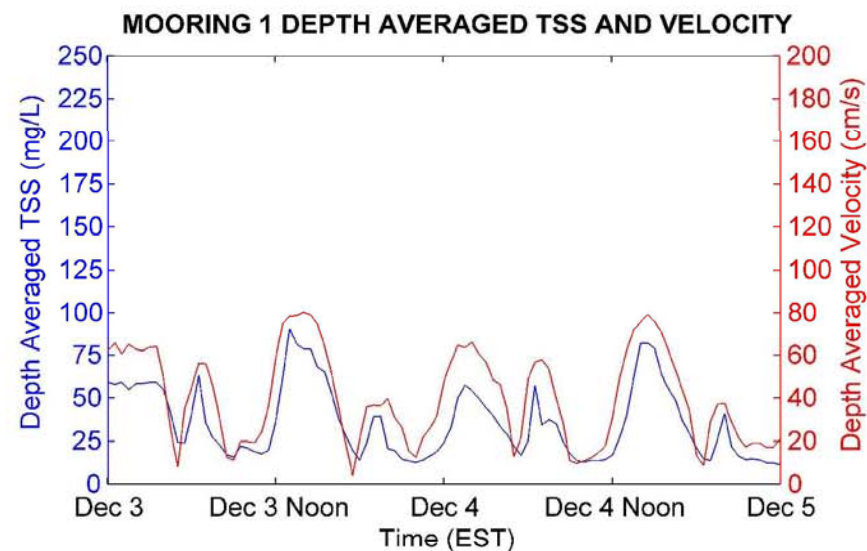
Figure 2

Pre-Dredging Monitoring Measurements at Mooring 1 for December 3-5, 2005

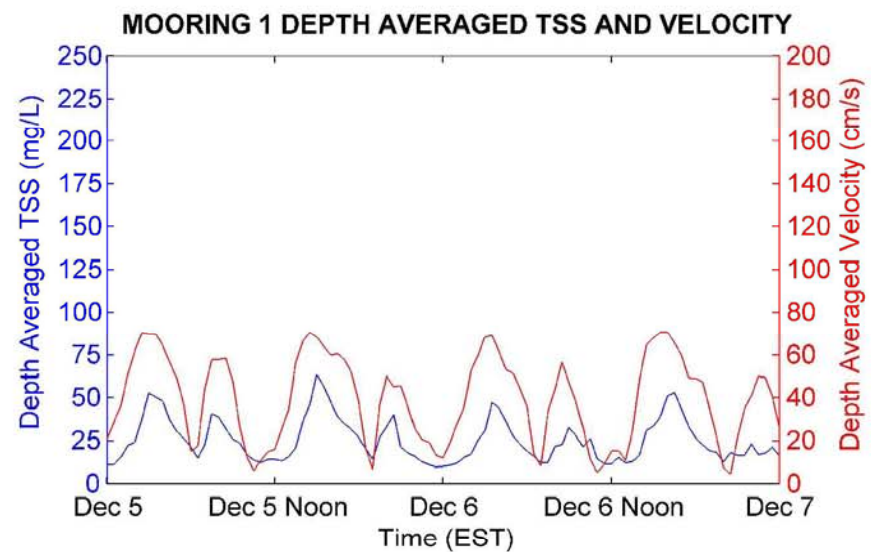
Figure 3

During Dredging Monitoring Measurements at Mooring 1 for December 5-7, 2005

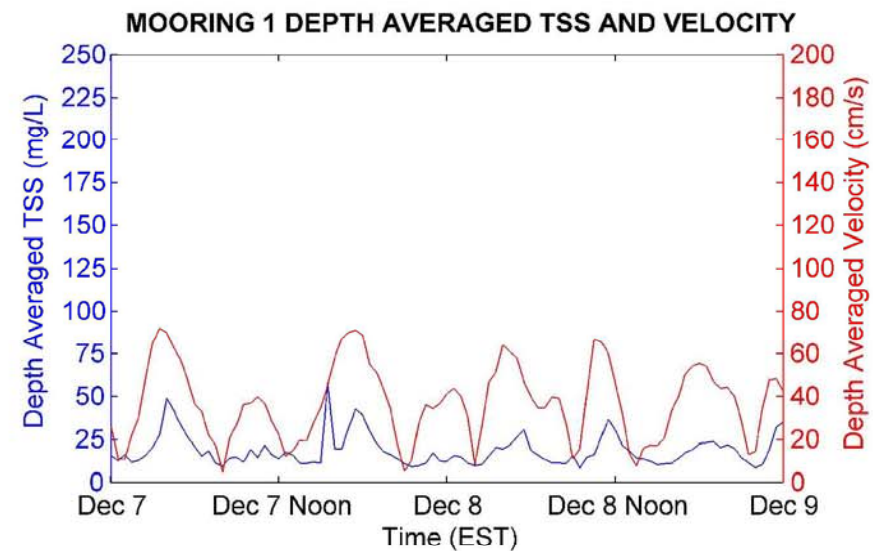
Figure 4

During Dredging Monitoring Measurements at Mooring 1 for December 7-9, 2005

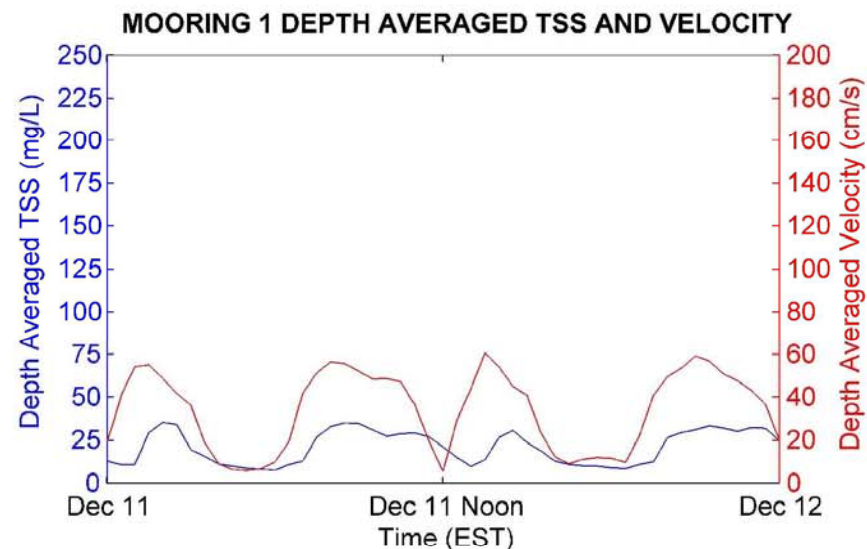
Figure 6

Post-Dredging Monitoring Measurements at Mooring 1 for December 11-12, 2005

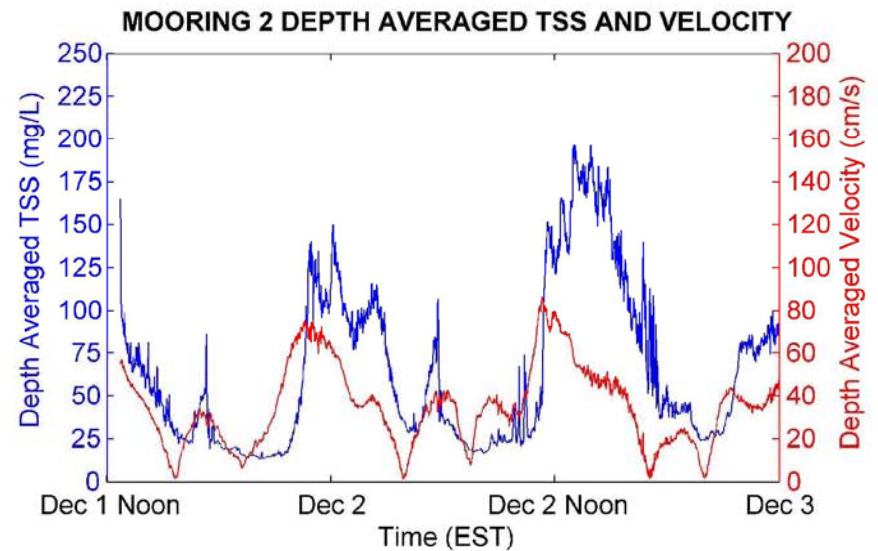
Figure 7

Pre-Dredging Monitoring Measurements at Mooring 2 for December 1-3, 2005

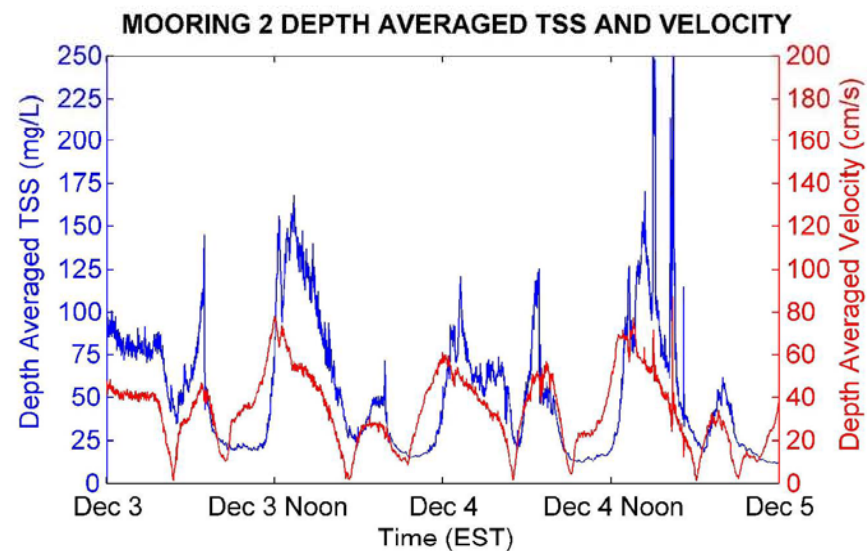
Figure 8

Pre-Dredging Monitoring Measurements at Mooring 2 for December 3-5, 2005

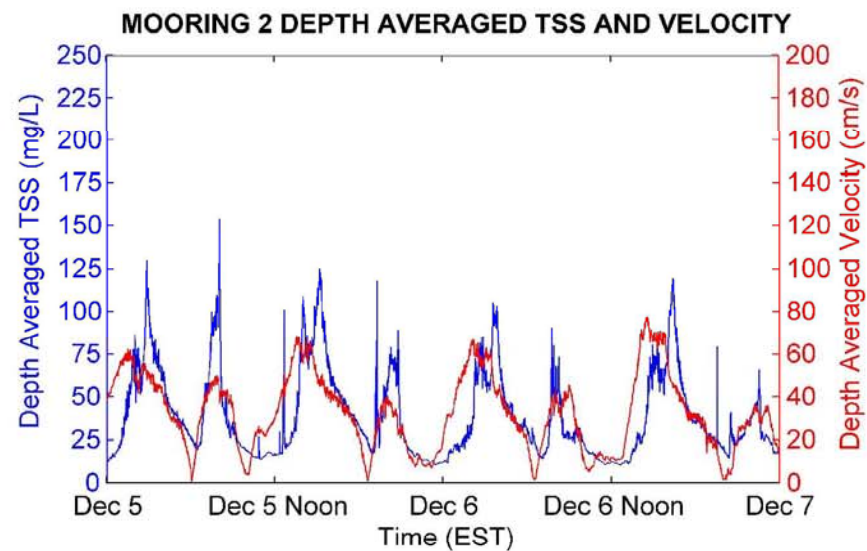
Figure 9

During Dredging Monitoring Measurements at Mooring 2 for December 5-7, 2005

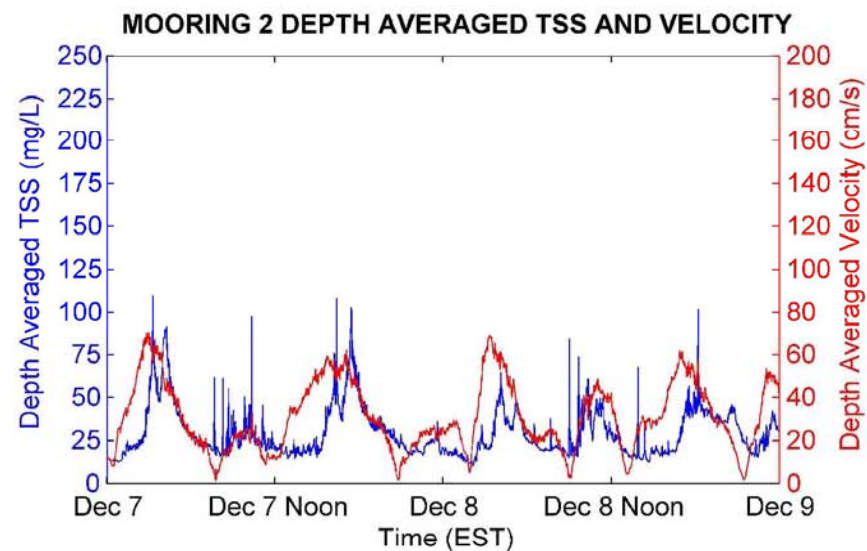
Figure 10

During Dredging Monitoring Measurements at Mooring 2 for December 7-9, 2005

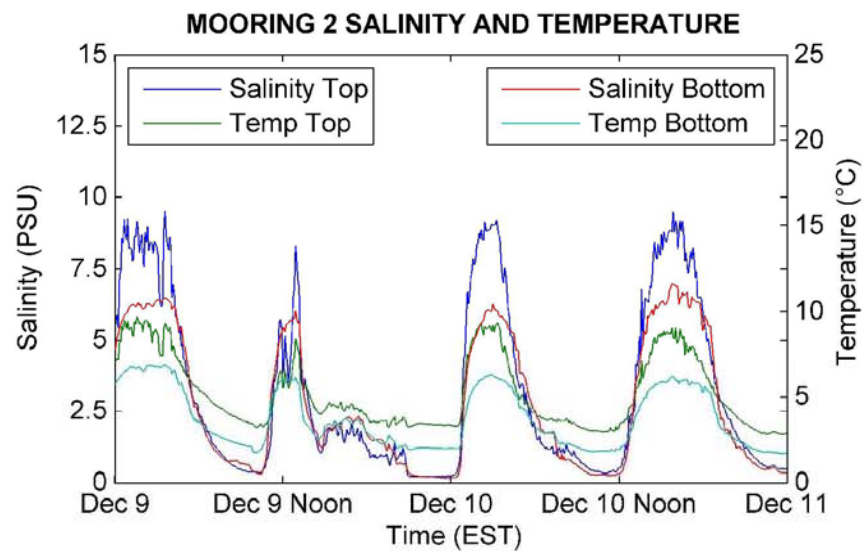
Figure 11

During Dredging Monitoring Measurements at Mooring 2 for December 9-11, 2005

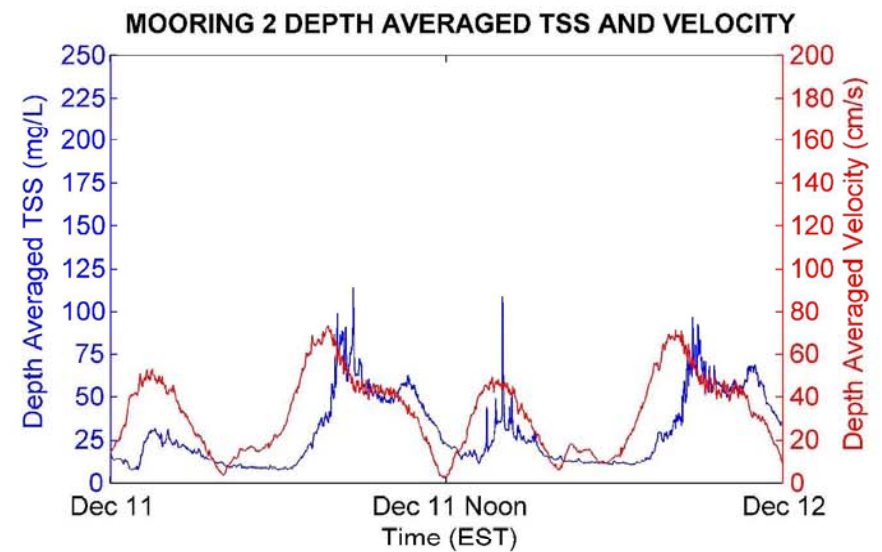
Figure 12

Post-Dredging Monitoring Measurements at Mooring 2 for December 11-12, 2005

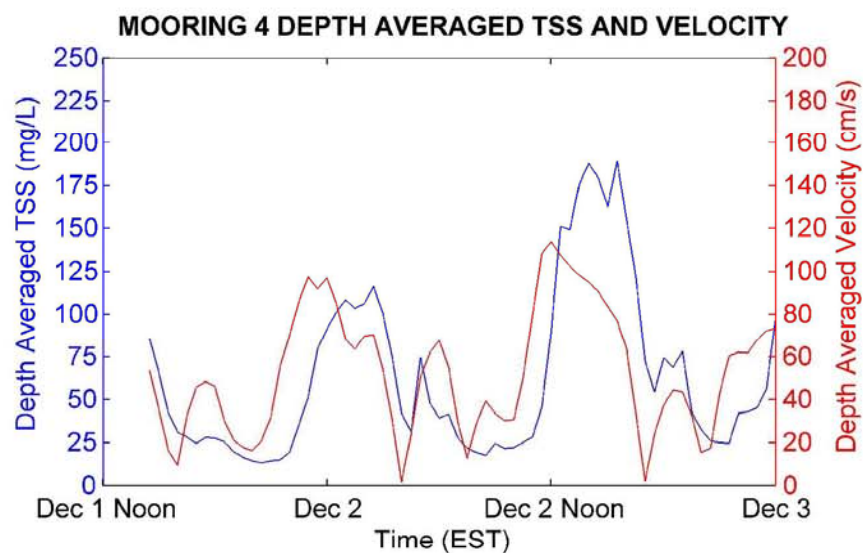
Figure 13

Pre-Dredging Monitoring Measurements at Mooring 4 for December 1-3, 2005

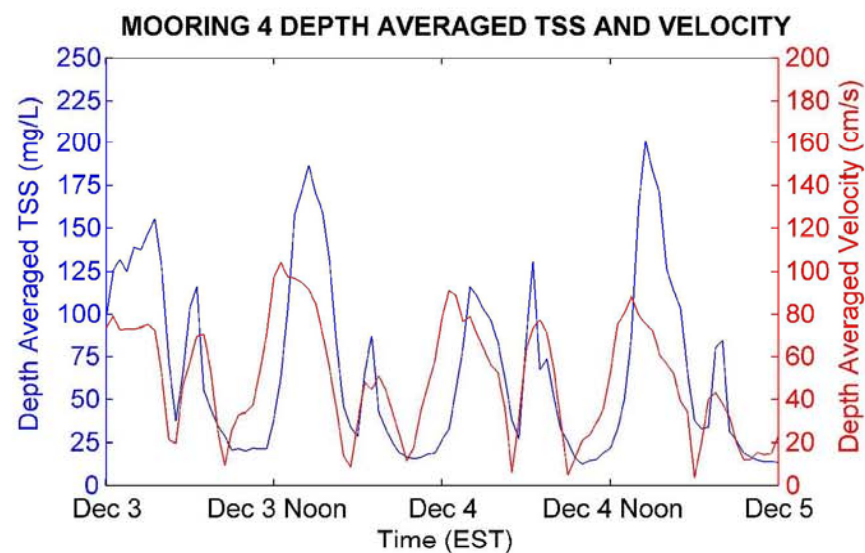
Figure 14

Pre-Dredging Monitoring Measurements at Mooring 4 for December 3-5, 2005

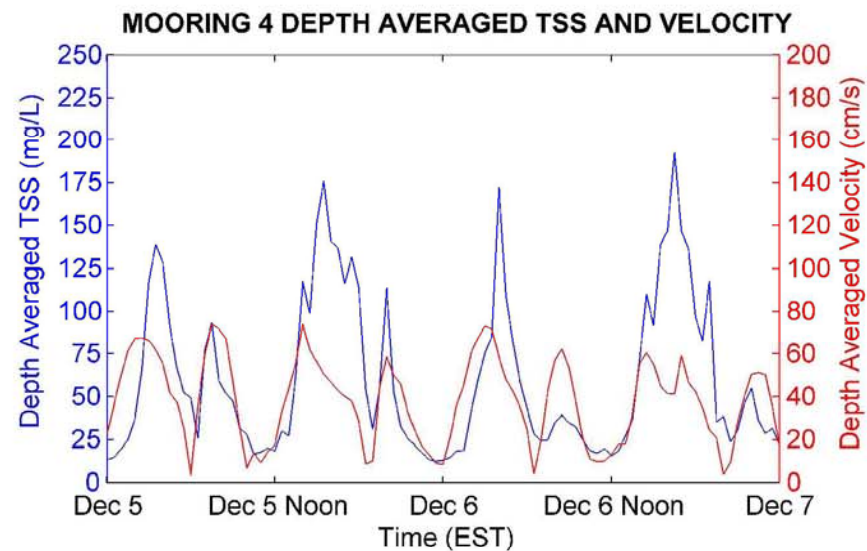
Figure 15

During Dredging Monitoring Measurements at Mooring 4 for December 5-7, 2005

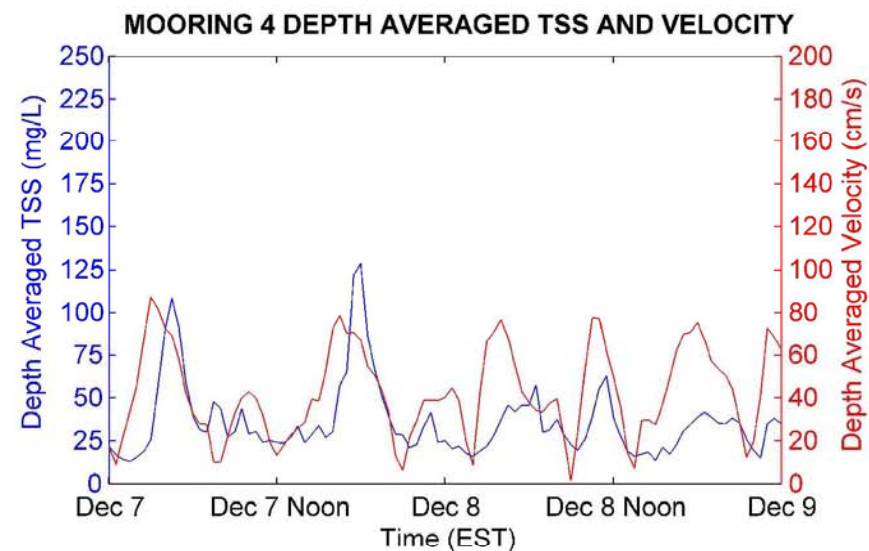
Figure 16

During Dredging Monitoring Measurements at Mooring 4 for December 7-9, 2005

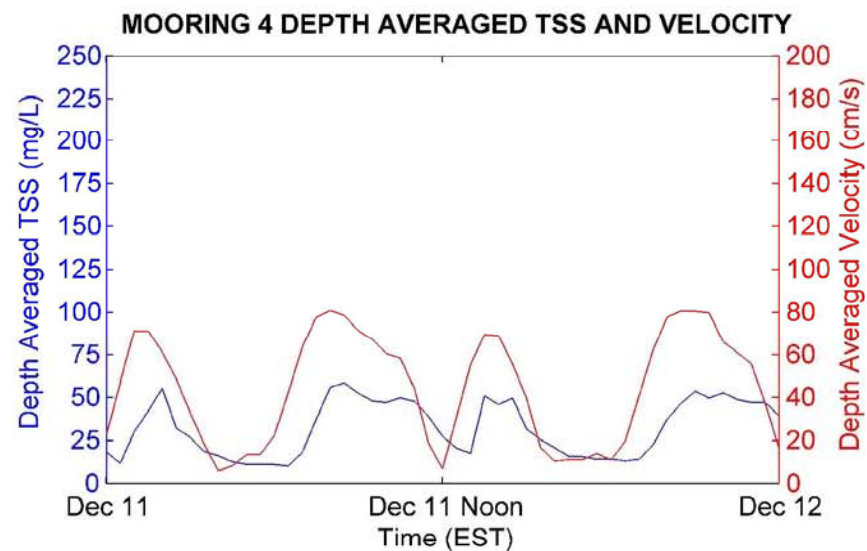
Figure 18

Post-Dredging Monitoring Measurements at Mooring 4 for December 11-12, 2005

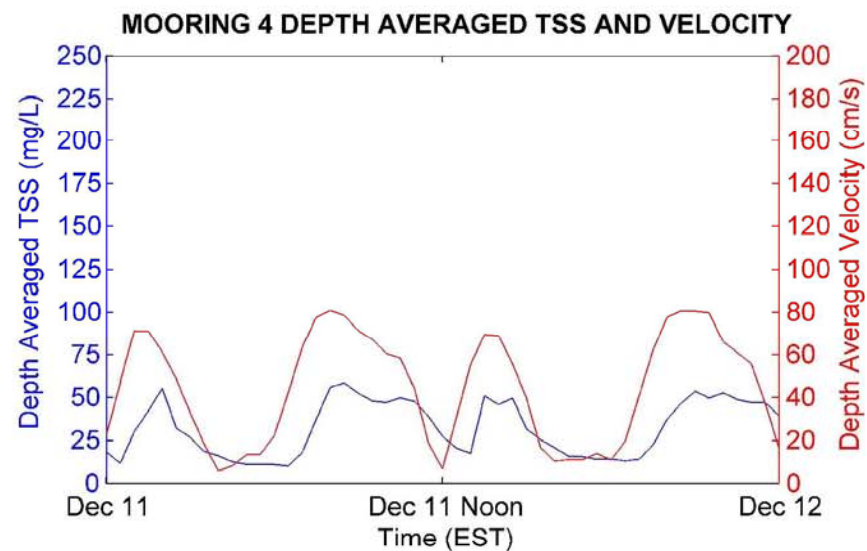
Figure 19

Post-Dredging Monitoring Measurements at Mooring 4 for December 11-12, 2005

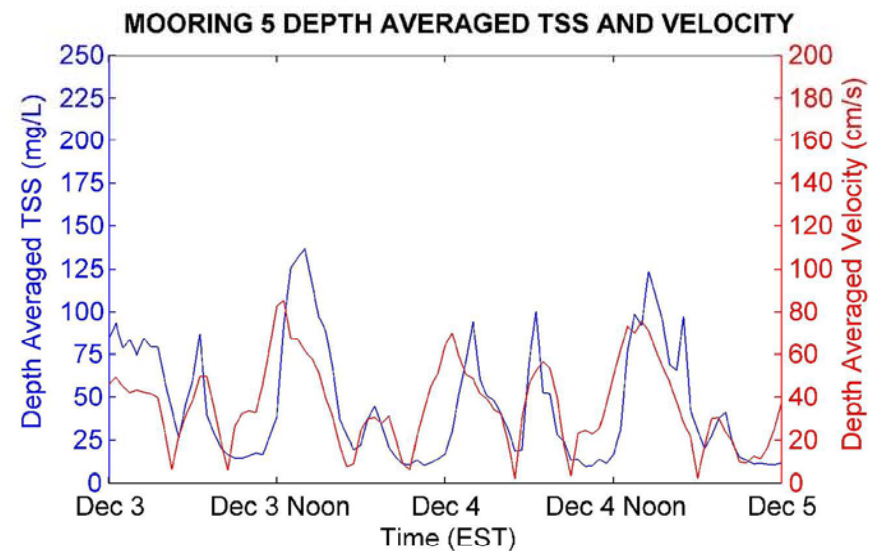
Figure 20

Pre-Dredging Monitoring Measurements at Mooring 5 for December 3-5, 2005

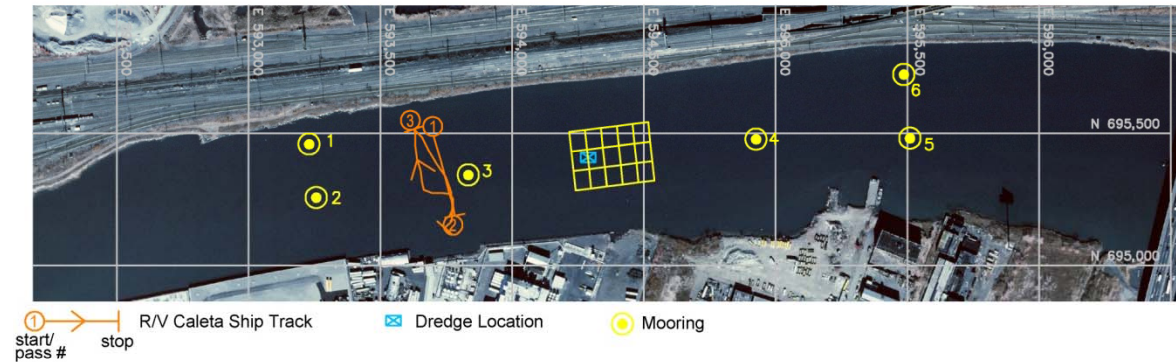
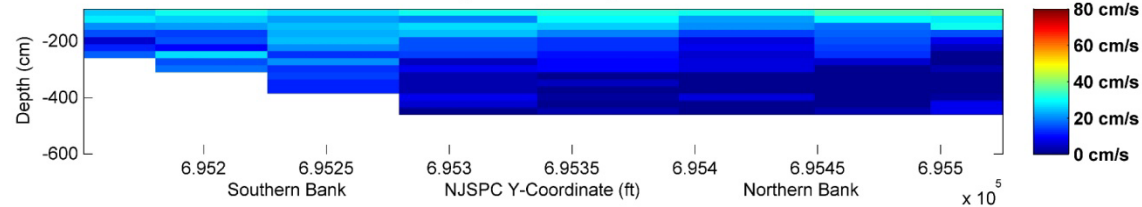
Figure 31

Dec 5 11:45-12:15 (EST) - Max Ebb Conditions  
 Pass 1 - Along Channel Velocity - UPRIVER

Pass 2 - Along Channel Velocity - UPRIVER

Pass 3 - Along Channel Velocity - UPRIVER

RV Caleta Shiptrack and Velocity Cross Sections for December 5, 2005  
 1145-1215 EST

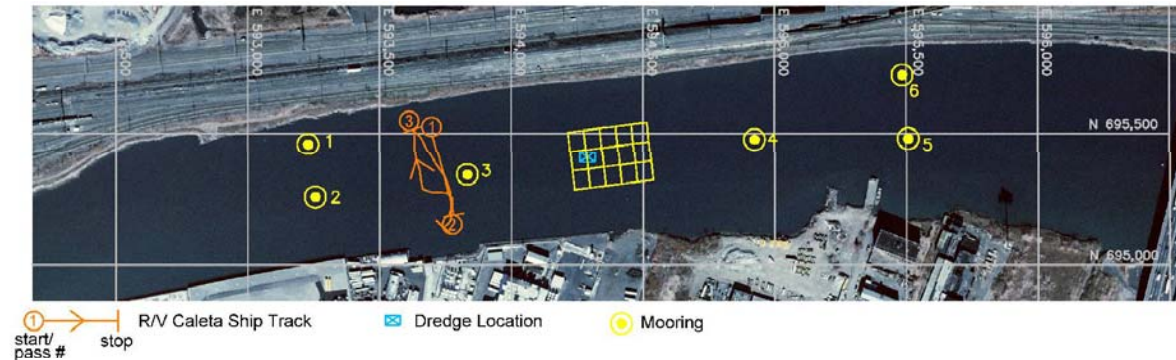
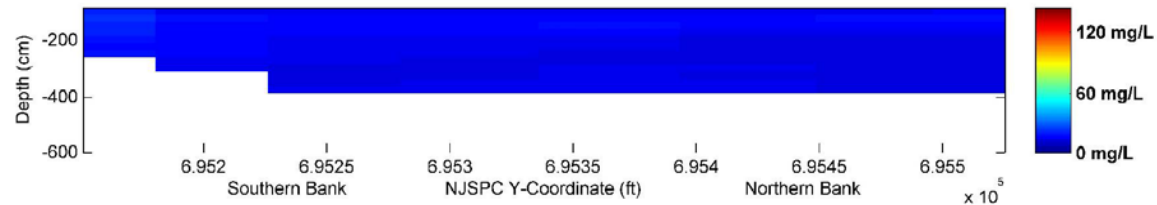
Figure 32

Dec 5 11:45-12:15 (EST) - Max Ebb Conditions  
Pass 1 - Total Suspended Solids

Pass 2 - Total Suspended Solids

Pass 3 - Total Suspended Solids

RV Caleta Shiptrack and TSS Cross Sections for December 5, 2005  
1145-1215 EST

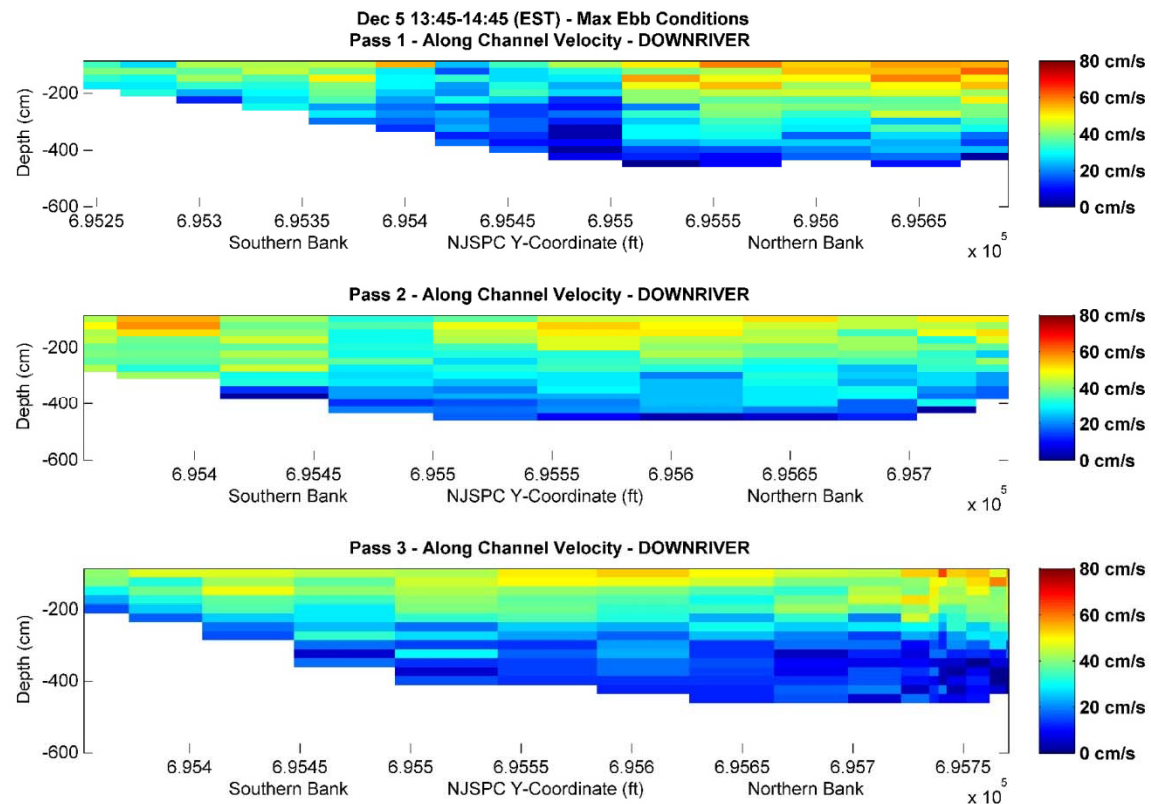
Figure 33

RV Caleta Shiptrack and Velocity Cross Sections for December 5, 2005  
 1345-1445 EST

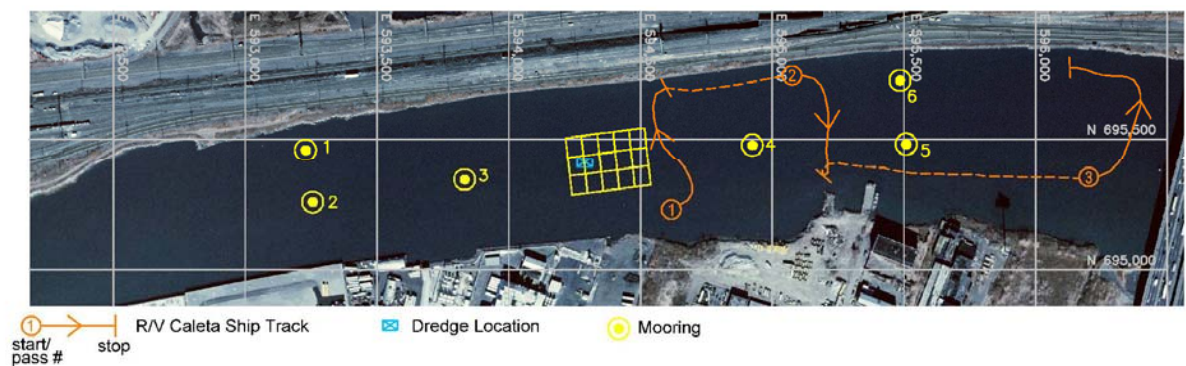
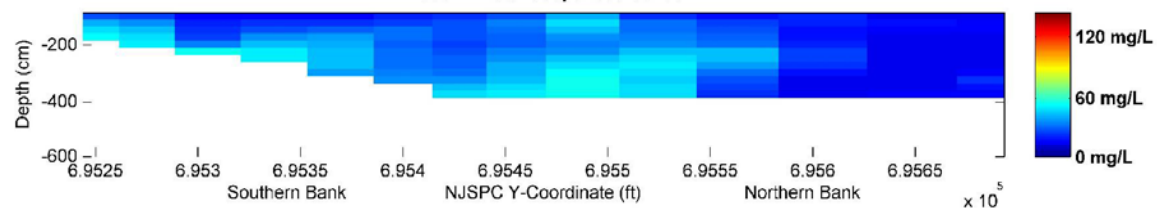
Figure 34

Dec 5 13:45-14:45 (EST) - Max Ebb Conditions  
Pass 1 - Total Suspended Solids

Pass 2 - Total Suspended Solids

Pass 3 - Total Suspended Solids

RV Caleta Shiptrack and TSS Cross Sections for December 5, 2005  
1345-1445 EST

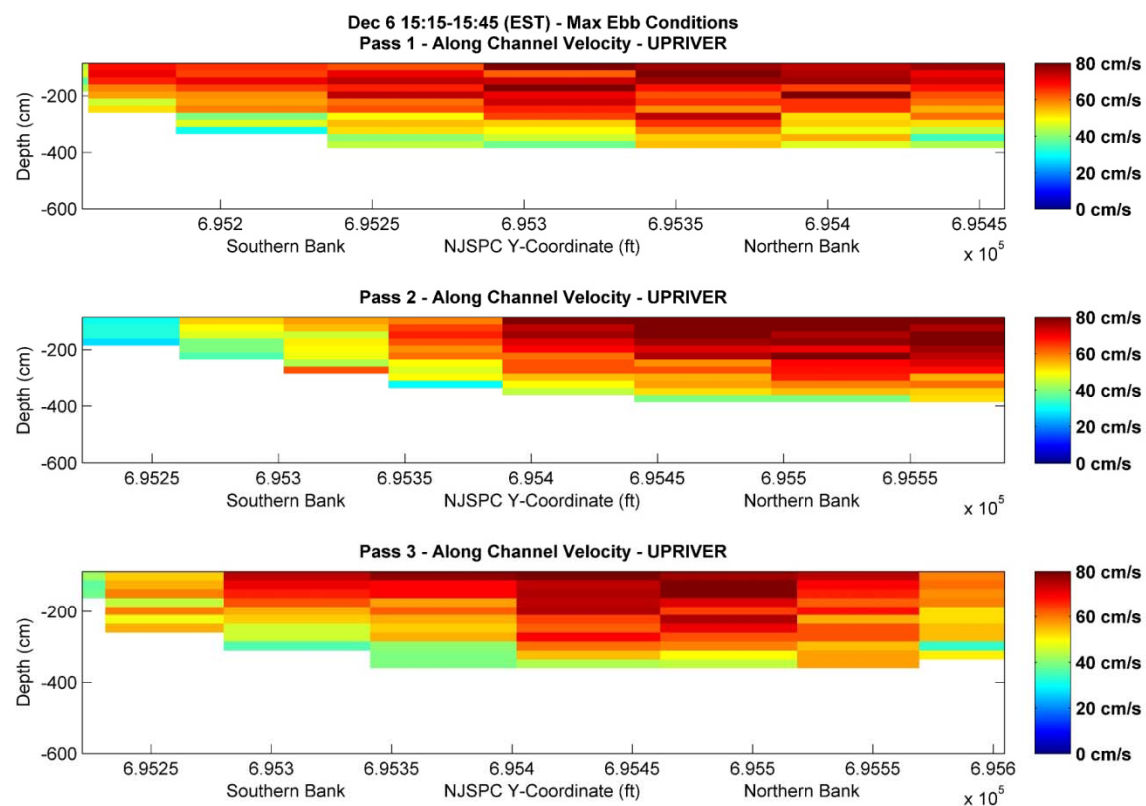
Figure 35

RV Caleta Shiptrack and Velocity Cross Sections for December 6, 2005  
 1515-1545 EST

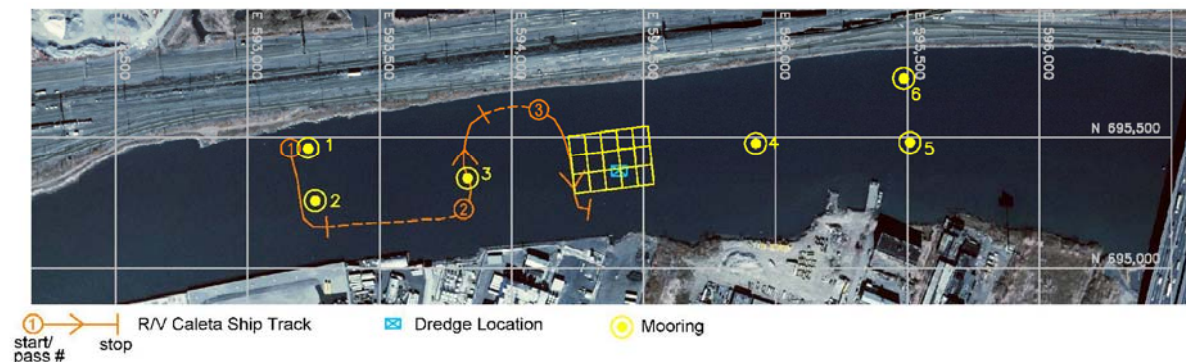
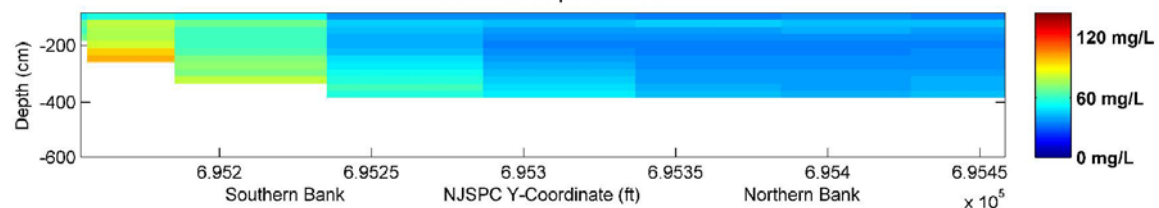
Figure 36

Dec 6 15:15-15:45 (EST) - Max Ebb Conditions  
Pass 1 - Total Suspended Solids

Pass 2 - Total Suspended Solids

Pass 3 - Total Suspended Solids

RV Caleta Shiptrack and TSS Cross Sections for December 6, 2005  
1515-1545 EST

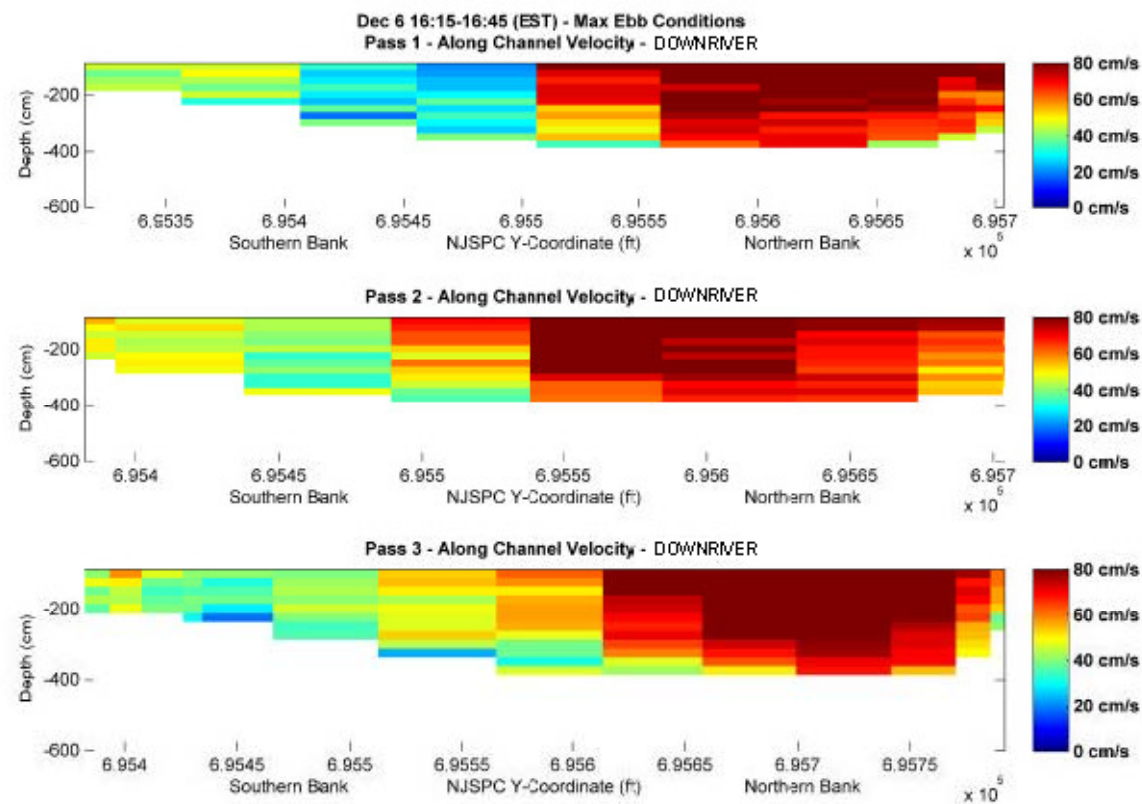
Figure 37

RV Caleta Shiptrack and Velocity Cross Sections for December 6, 2005  
 1615-1645 EST

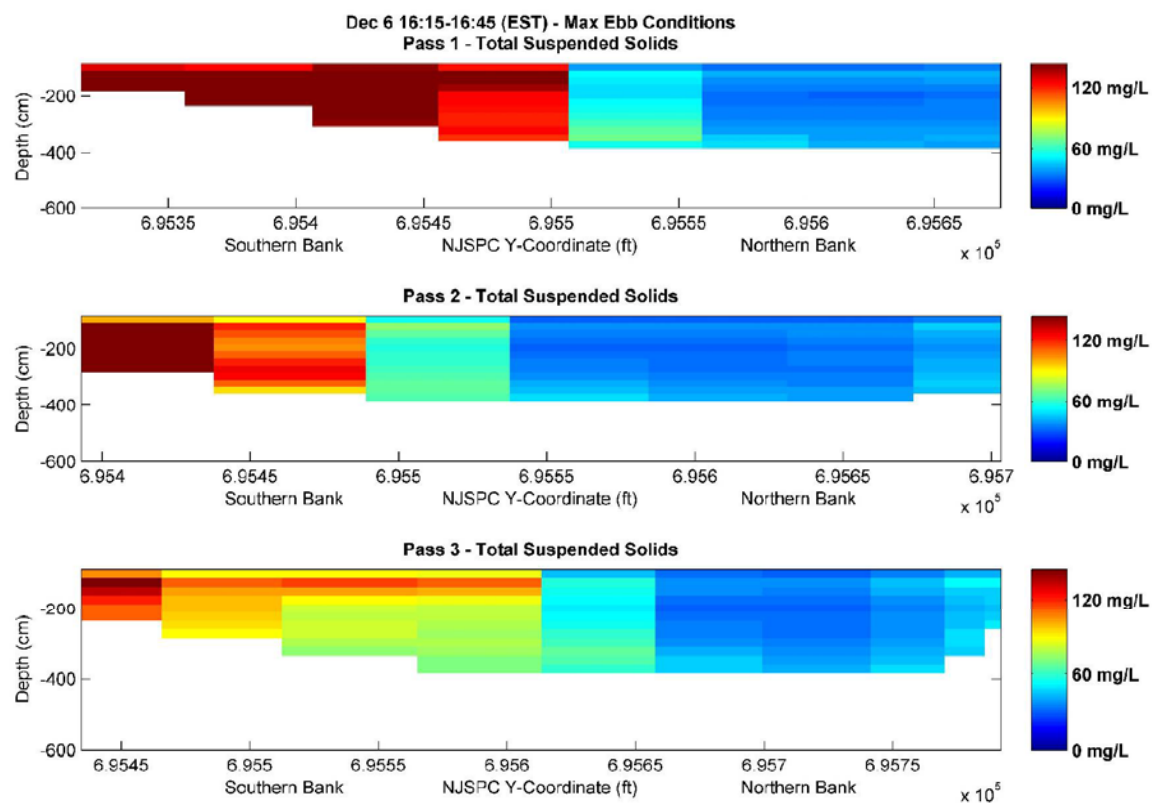
Figure 38

RV Caleta Shiptrack and TSS Cross Sections for December 6, 2005  
 1615-1645 EST

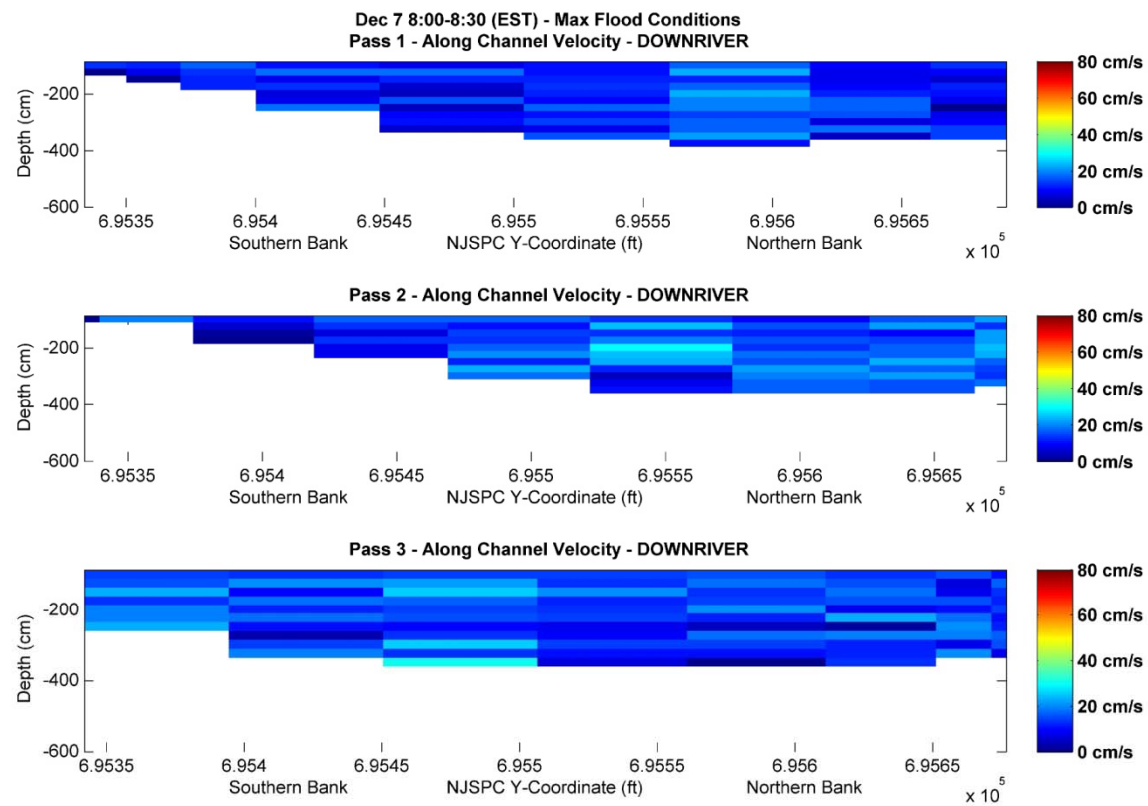
Figure 39

RV Caleta Shiptrack and Velocity Cross Sections for December 7, 2005  
 0800-0830 EST

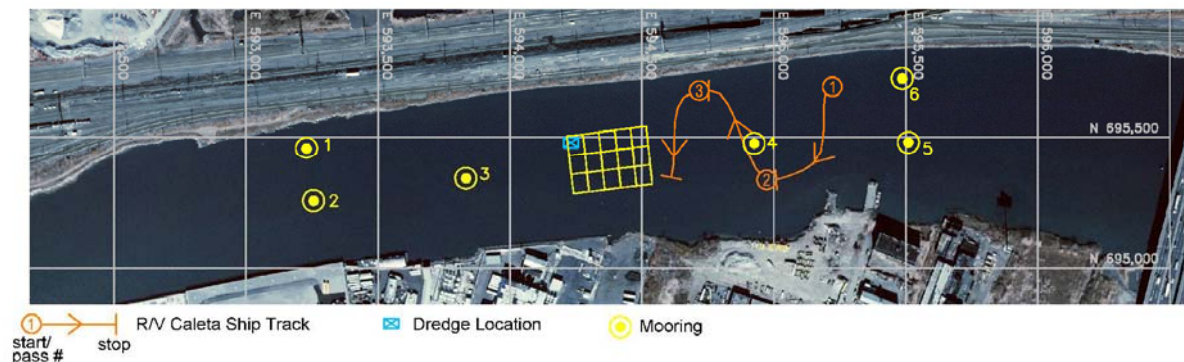
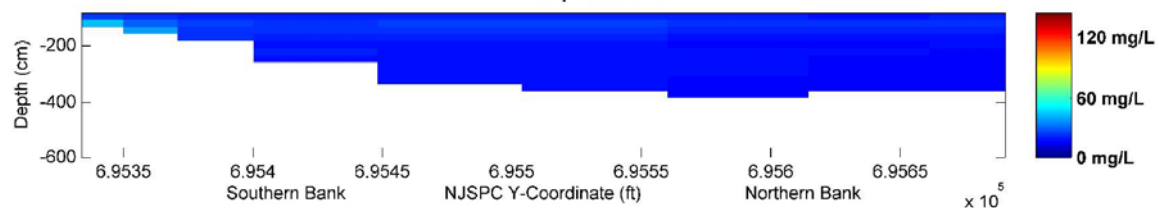
Figure 40

Dec 7 8:00-8:30 (EST) - Max Flood Conditions  
Pass 1 - Total Suspended Solids

Pass 2 - Total Suspended Solids

Pass 3 - Total Suspended Solids

RV Caleta Shiptrack and TSS Cross Sections for December 7, 2005  
0800-0830 EST  
Lower Passaic River Restoration Project

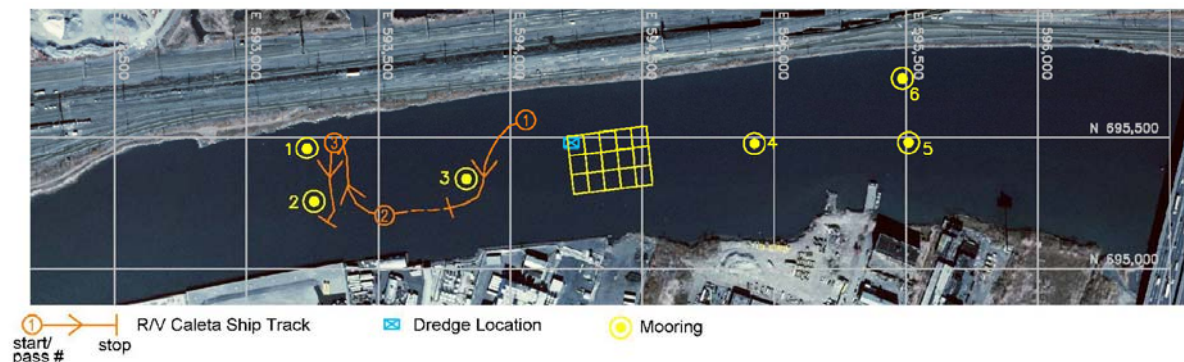
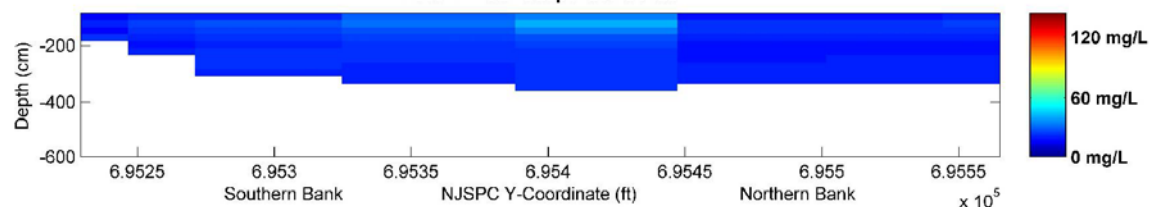
Figure 42

Dec 7 9:30-10:00 (EST) - Max Flood Conditions  
Pass 1 - Total Suspended Solids

Pass 2 - Total Suspended Solids

Pass 3 - Total Suspended Solids

RV Caleta Shiptrack and TSS Cross Sections for December 7, 2005  
0930-1000 EST

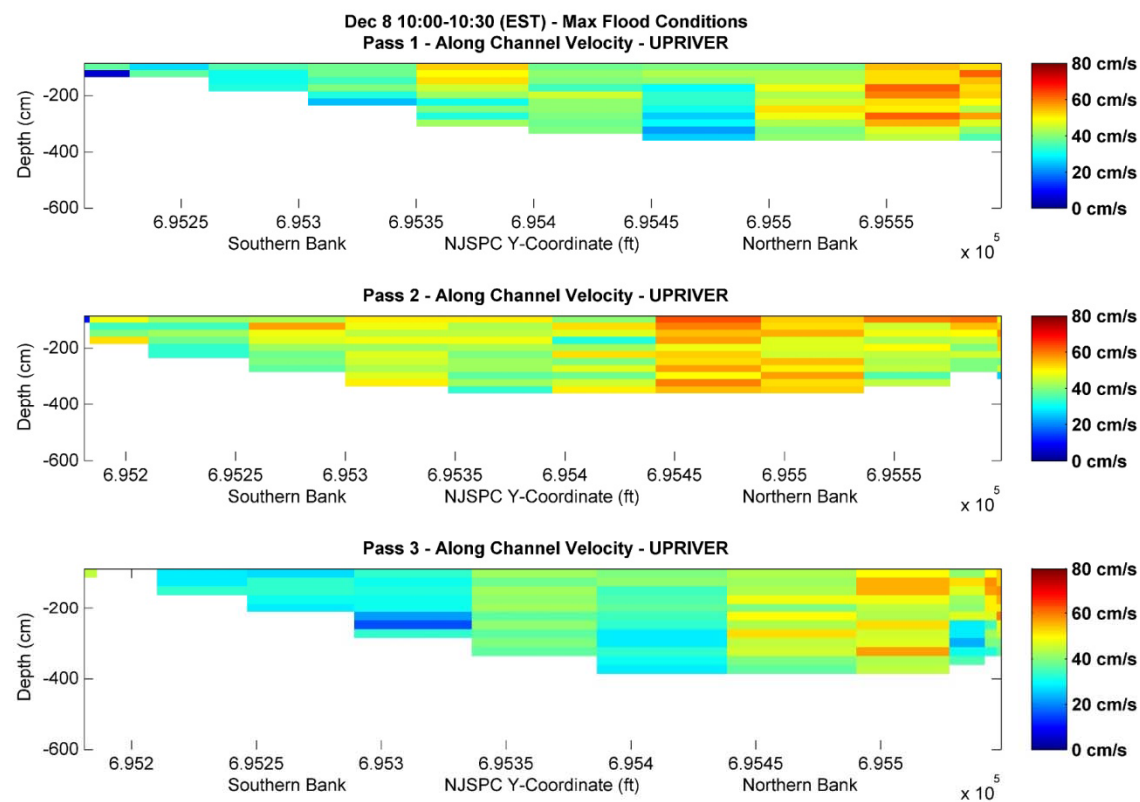
Figure 43

RV Caleta Shiptrack and Velocity Cross Sections for December 8, 2005  
 1000-1030 EST  
 Lower Passaic River Restoration Project

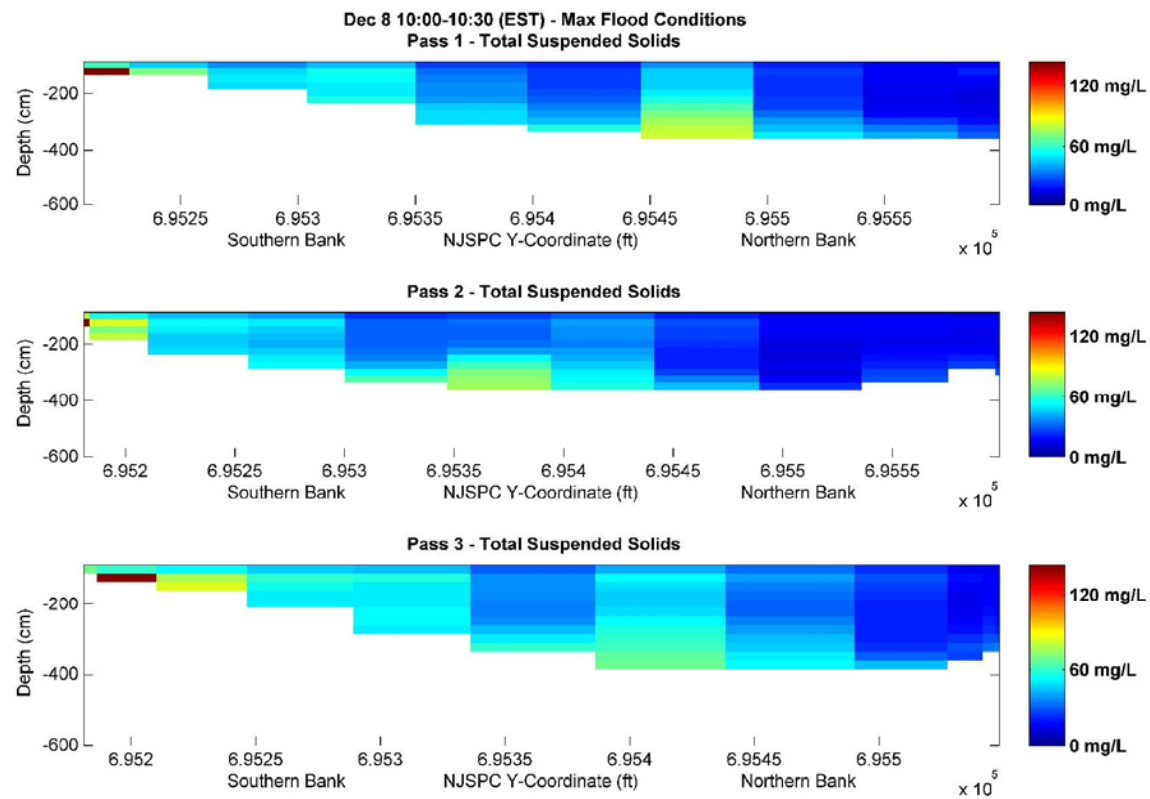
Figure 44

RV Caleta Shiptrack and TSS Cross Sections for December 8, 2005  
 1000-1030 EST

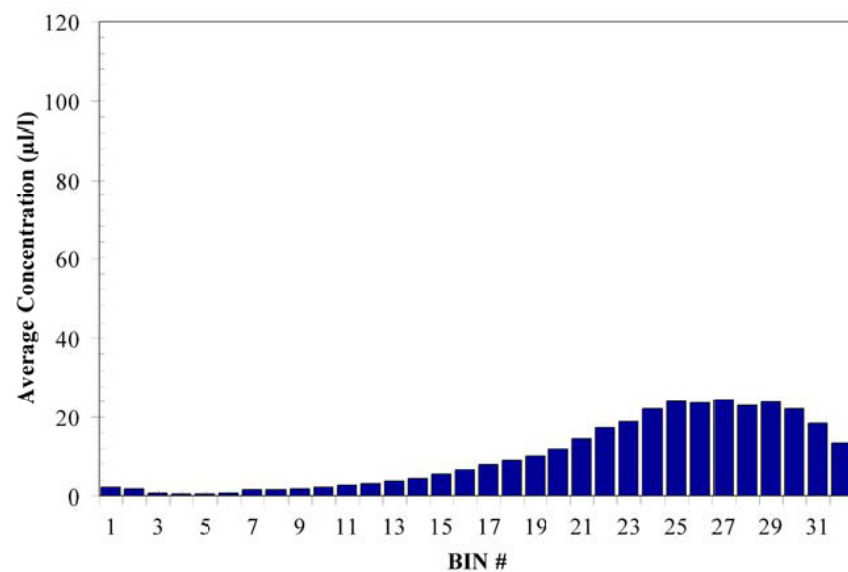
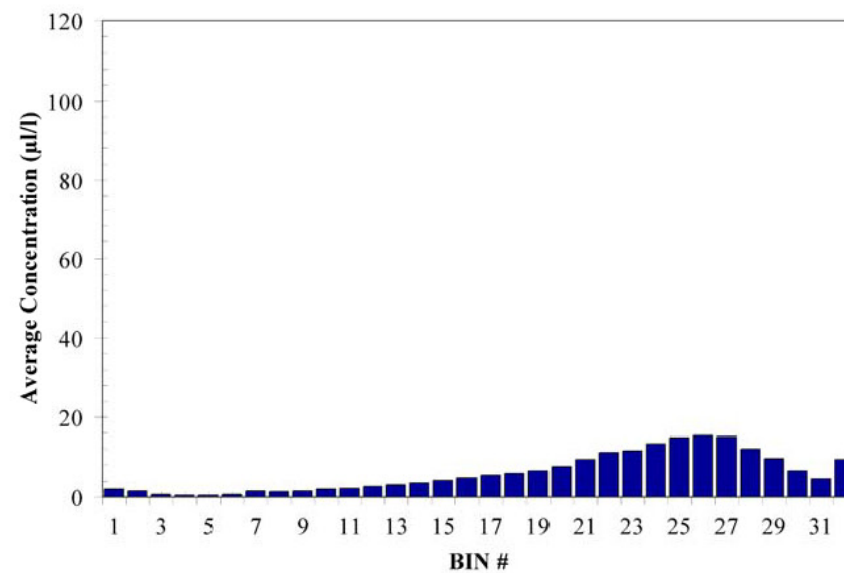
Figure 59

Upriver, Max. Ebb (14:40-15:00) 12/5/05

Downriver, Max. Ebb (15:40-16:00) 12/5/05

RV Julia Miller Ship Location and LISST Data Concentrations by Bin Size  
for December 5, 2005

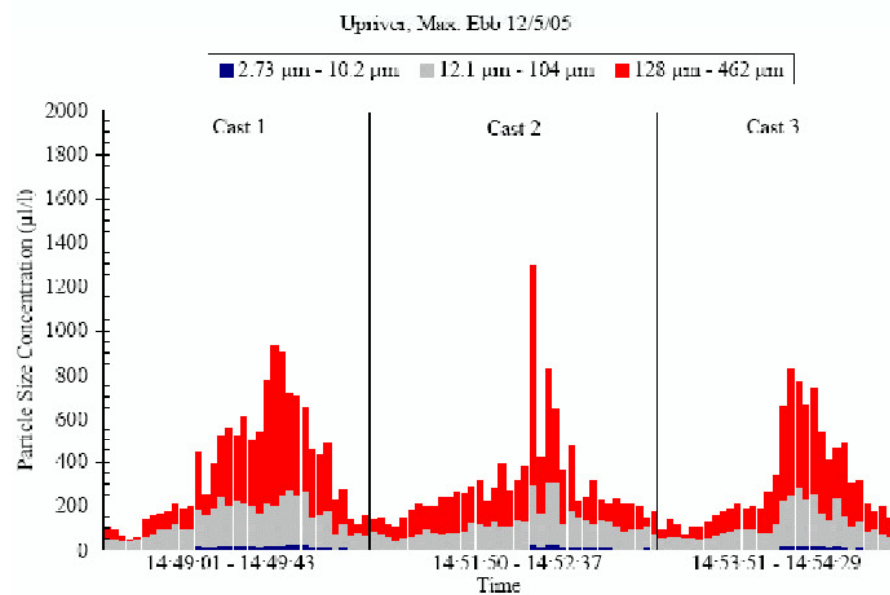
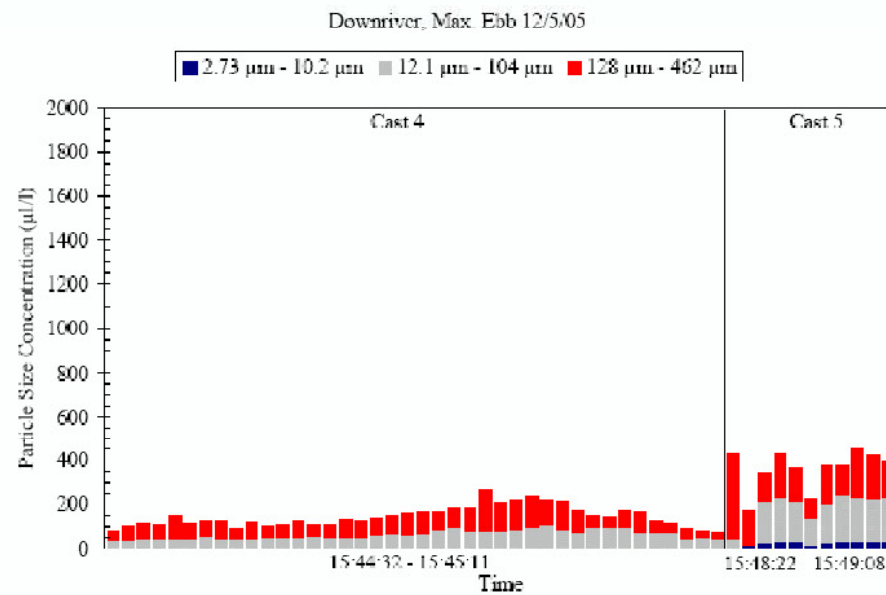
Figure 60

RV Julia Miller Ship Location and LISST Data Particle Size Concentrations for December 5, 2005

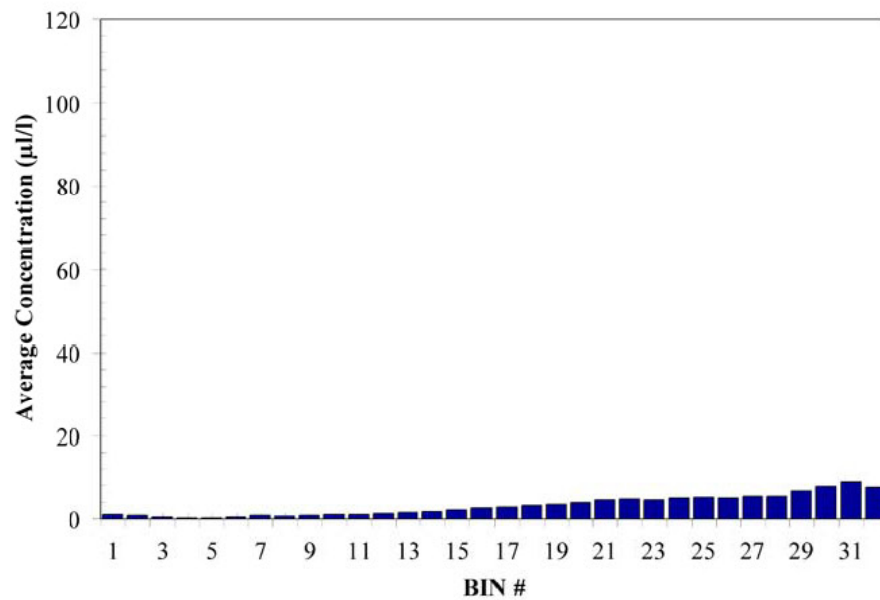
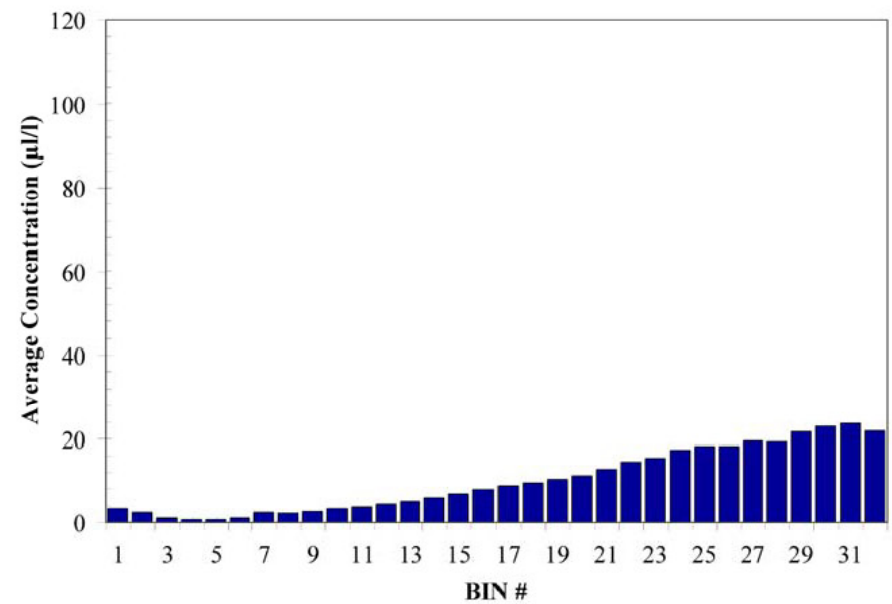
Figure 61

Upriver, Max. Ebb (14:20-14:40) 12/6/05

Downriver, Max. Ebb (14:30-14:50) 12/6/05

RV Julia Miller Ship Location and LISST Data Concentrations by Bin Size  
for December 6, 2005
