Pre-Dredging Monitoring Measurements at Mooring 1 for December 1-3, 2005

*Lower Passaic River Restoration Project*

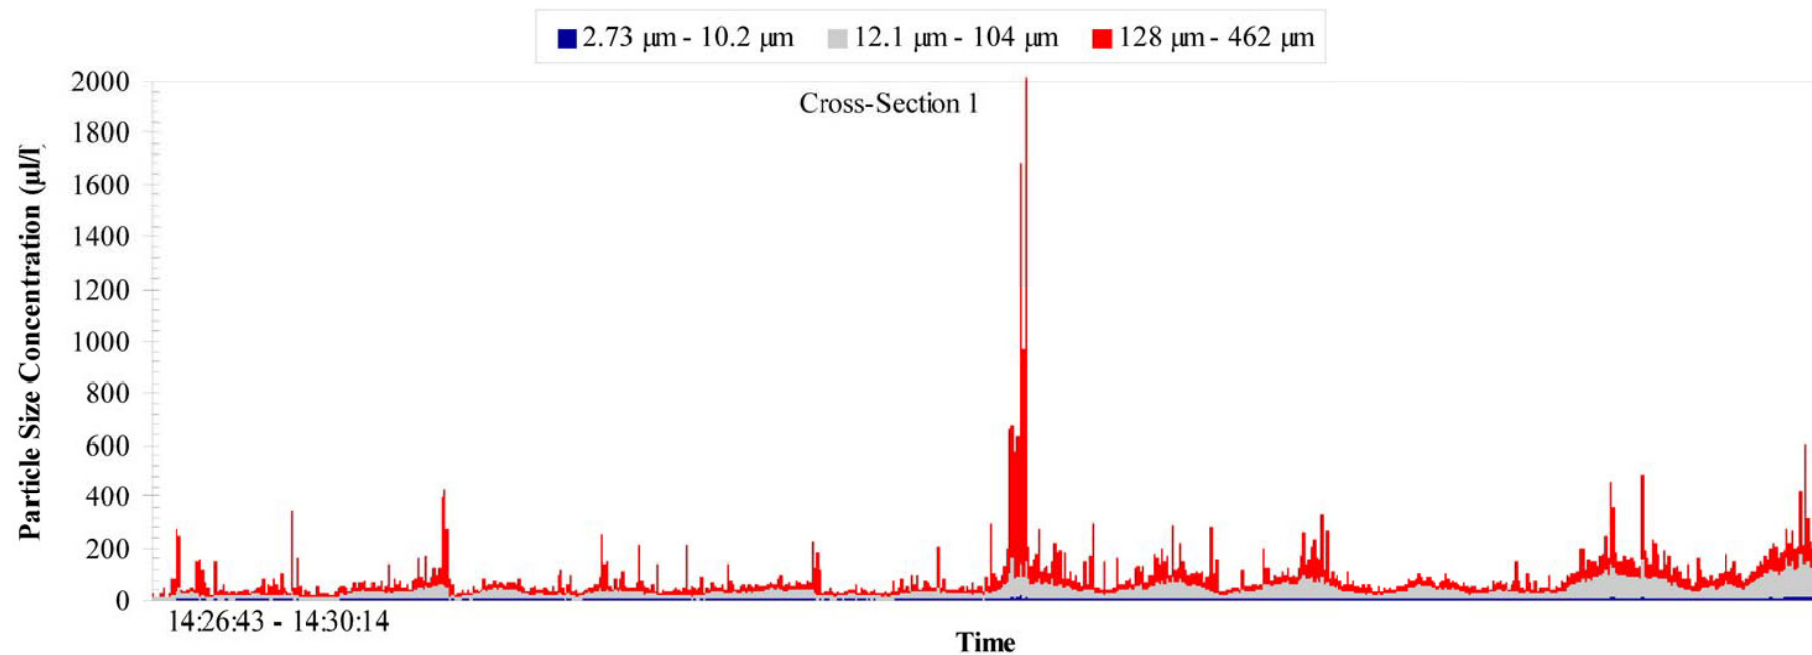
Figure 62

Upriver, Max. Ebb 12/6/05

RV Julia Miller Ship Location and LISST Data Upriver Particle Size Concentrations for December 6, 2005

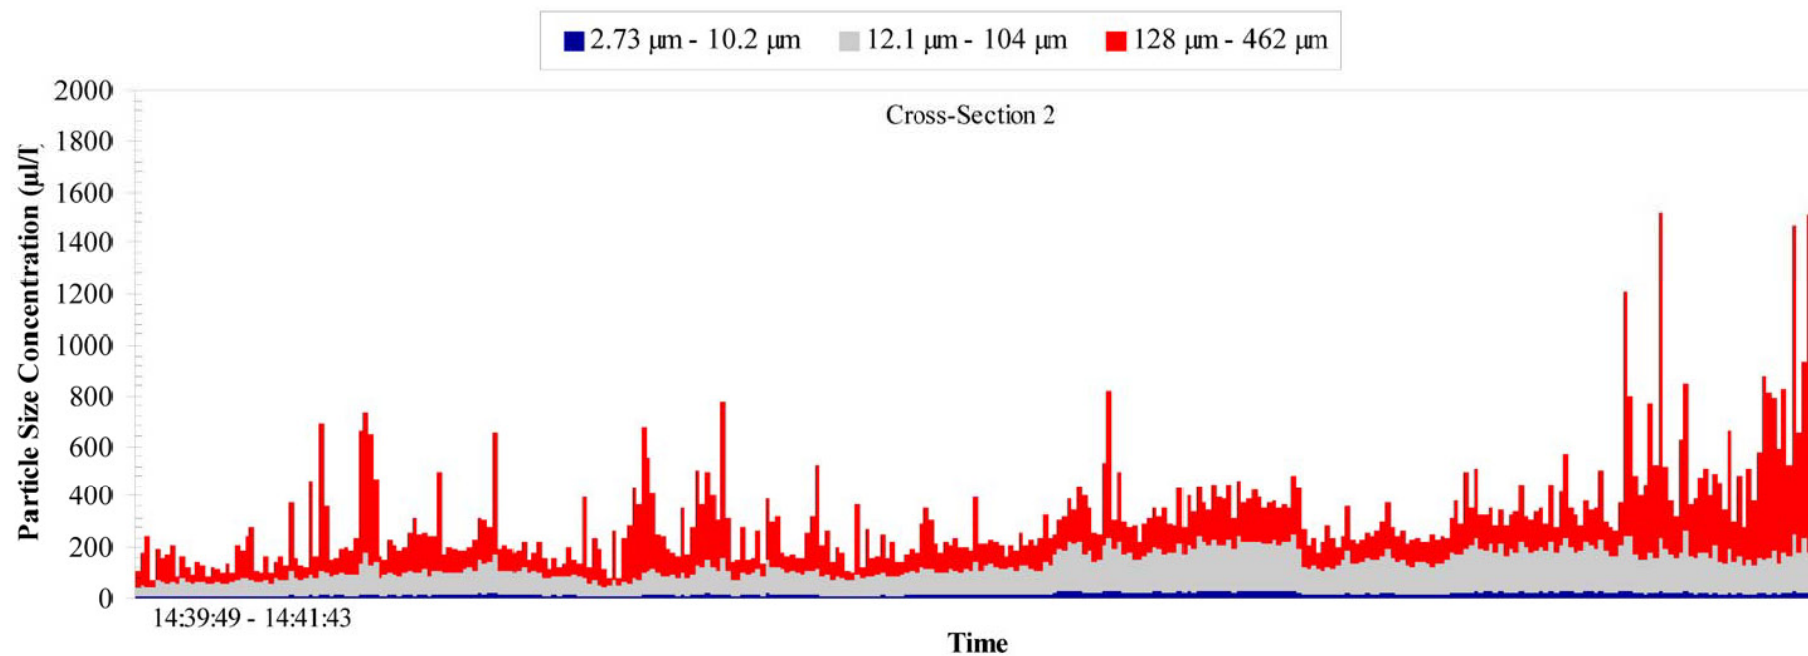
Figure 63

Downriver, Max. Ebb 12/6/05

RV Julia Miller Ship Location and LISST Data Downriver Particle Size Concentration for December 6, 2005

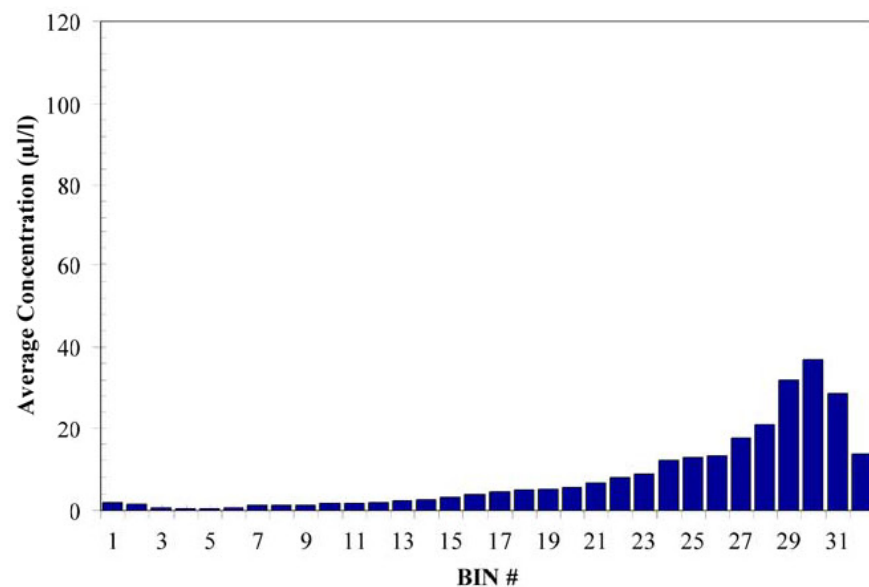
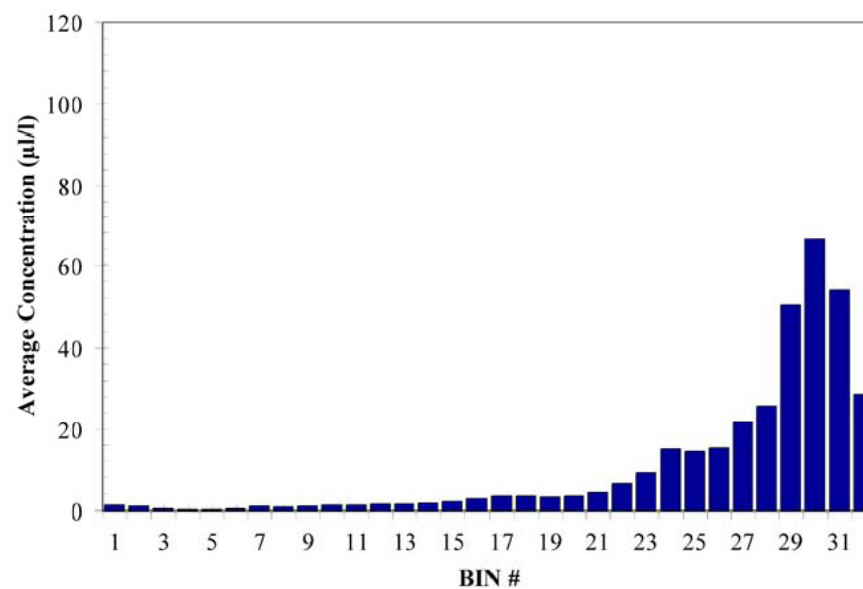
Figure 64

Upriver, Max. Flood (10:50-11:10) 12/7/05

Downriver, Max. Flood (9:50-10:10) 12/7/05

RV Julia Miller Ship Location and LISST Data Concentrations by Bin Size  
for December 7, 2005

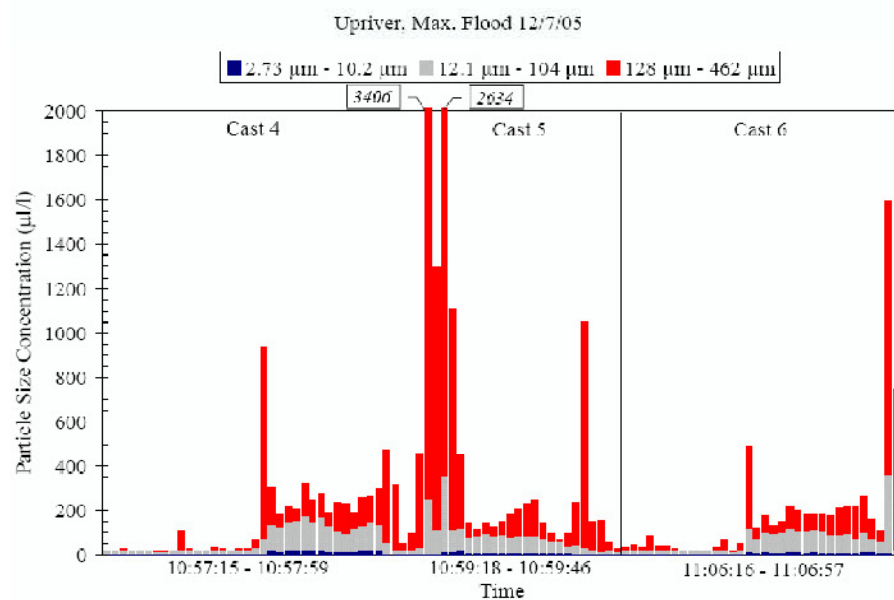
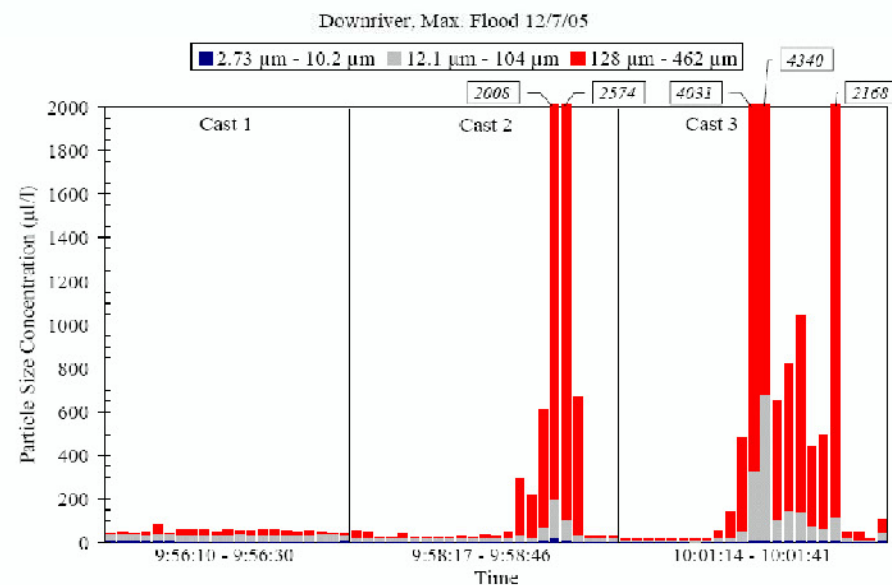
Figure 65

RV Julia Miller Ship Location and LISST Data Particle Size Concentrations for December 7, 2005

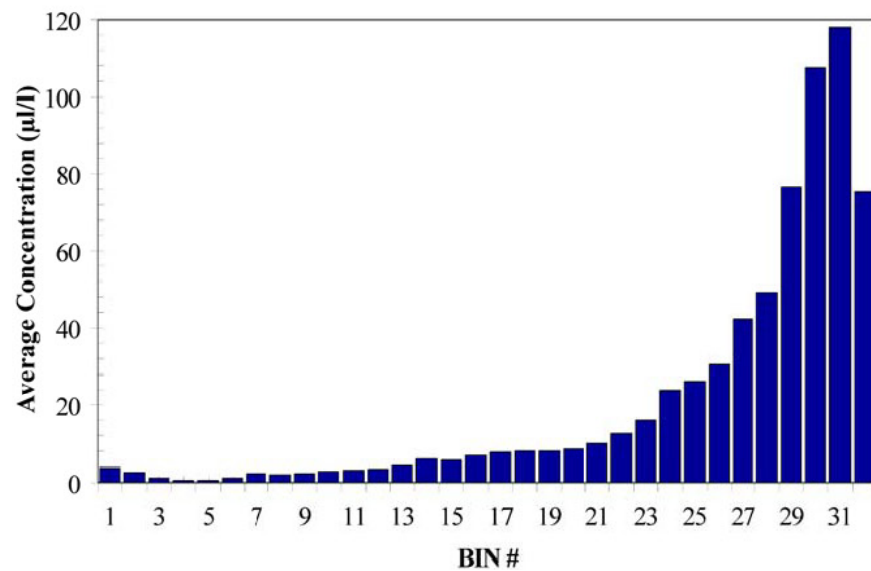
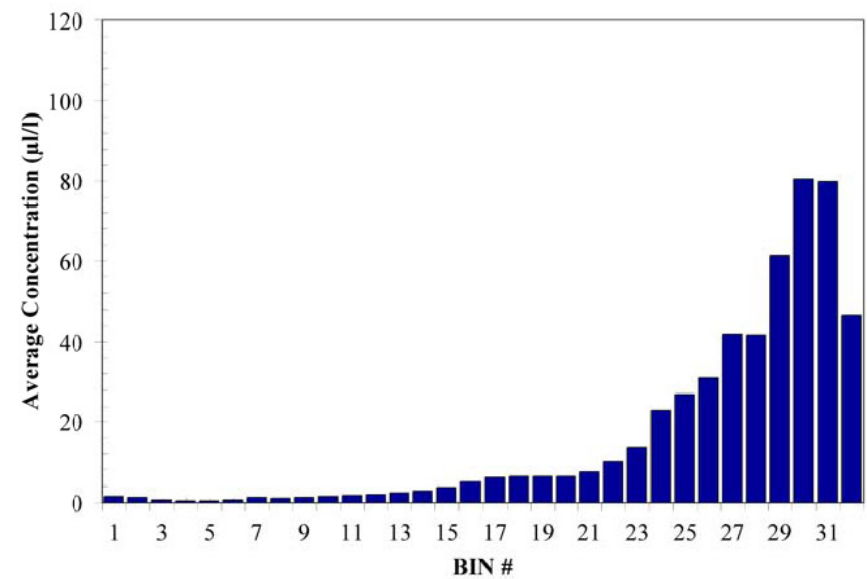
Figure 66

Upriver, Max. Flood (11:20-11:40) 12/8/05

Downriver, Max. Flood (10:30-10:50) 12/8/05

RV Julia Miller Ship Location and LISST Data Concentrations by Bin Size  
for December 8, 2005

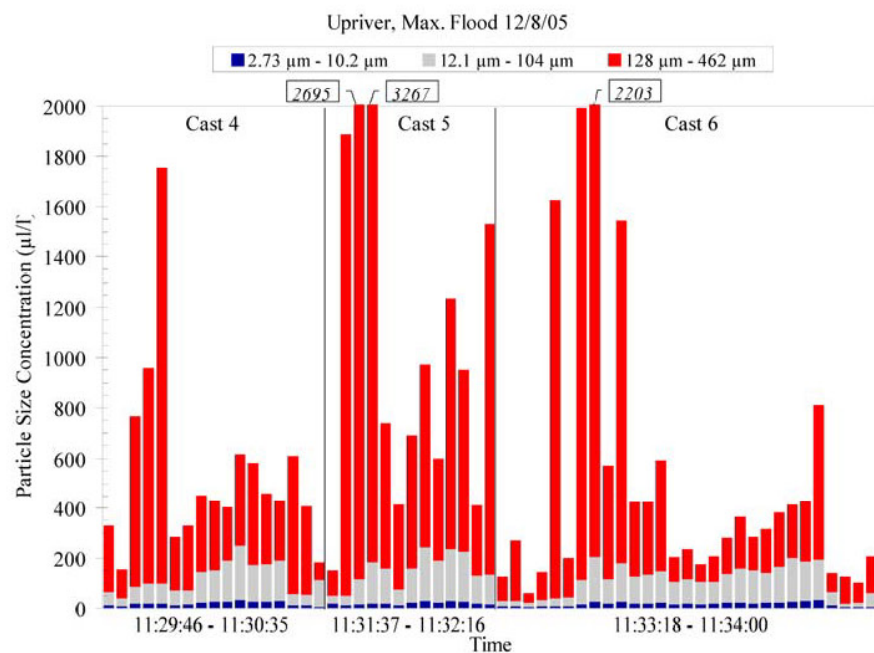
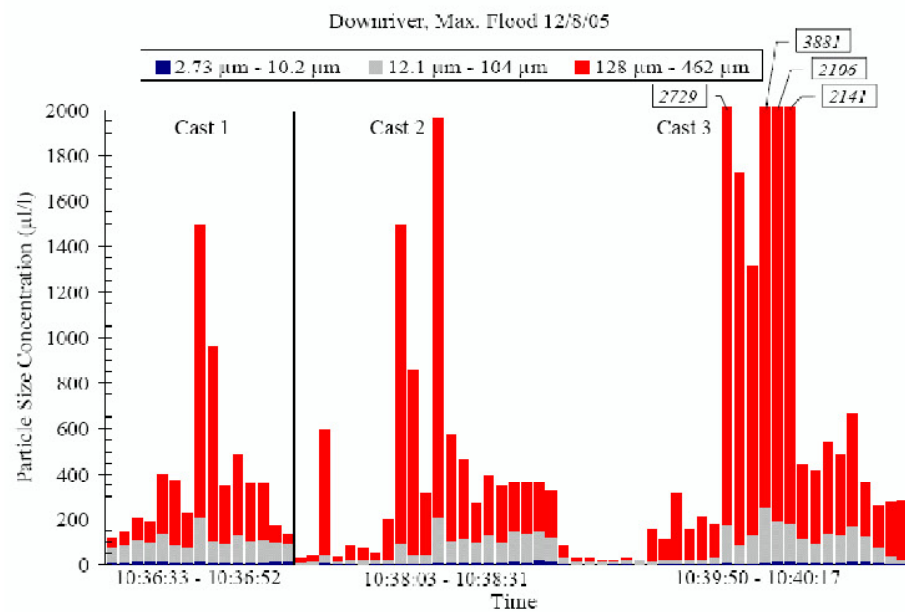
Figure 67

RV Julia Miller Ship Location and LISST Data Particle Size Concentrations  
for December 8, 2005
