February 28, 2005

Re: Report for December 14, 2004 – February 24, 2005 Field Reconnaissance
Lower Passaic River Restoration Project
NJDOT Agreement No. 2001-NJM02

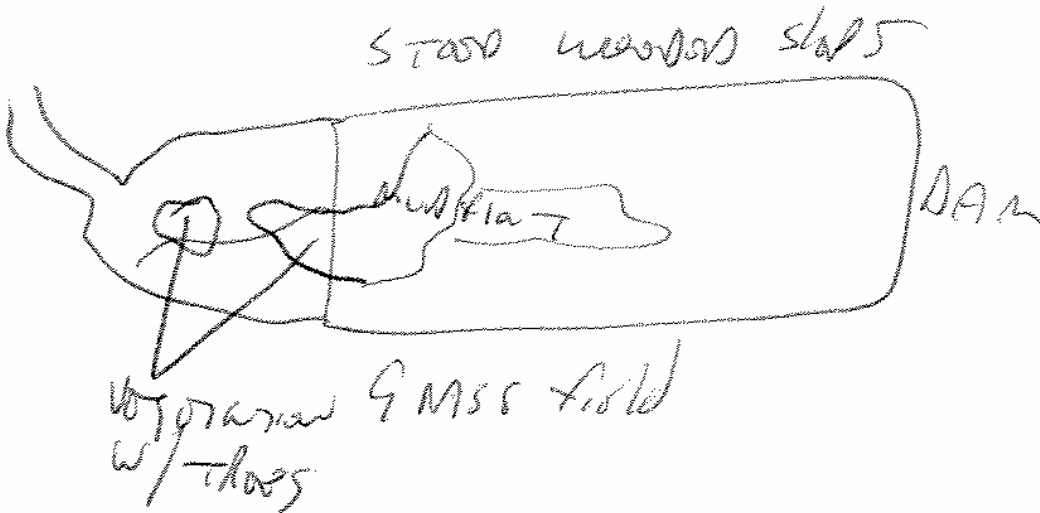
In the north-central portion of the pond, there is a vegetated island. The island consists of a mix of facultative herbaceous and woody vegetation. The bottom of the pond consists of soft sediments. These sediments likely have built up since the presence of the dam. It is anticipated that sedimentation will become an issue in the future with the pond. Also, shopping carts and other trash were located along bottom and shoreline of the pond.

Schematic drawing of Clark's Pond and Third River by Field Crew (north is to the left side of the page).
